### FIELD PIT SITE ASSESSMENT FORM

# FIELD PIT REMEDIATION/CLOSURE FORM

FIELD SERVICES LABORATORY  
ANALYTICAL REPORT  
PIT CLOSURE PROJECT - Soil

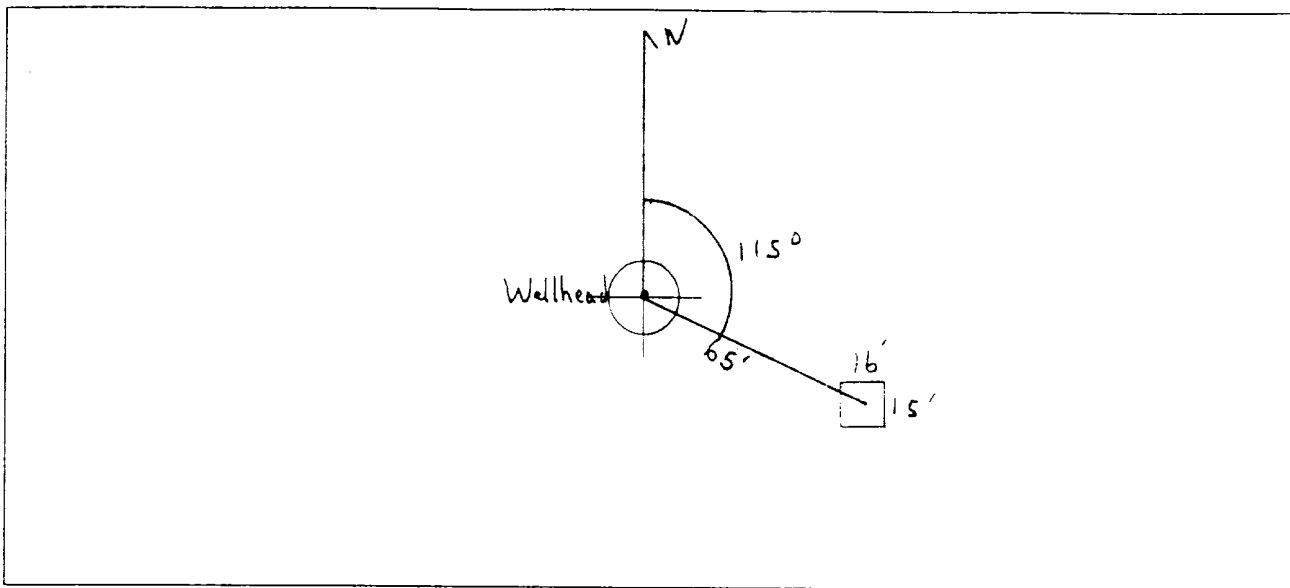
## ORIGINAL PIT LOCATION

Original Pit : a) Degrees from North 115° Footage from Wellhead 65'  
b) Length : 16' Width : 15' Depth : 1'
