Date Remediation Started: 9-7-99 Date Completed: 9-9-99

General Description Of Remedial Action: SAMPLE TAKEN - HIT BED ROCK 2' IN OFF  
OF BOTTOM. TILL BOTTOM OF PIT 1', BACK FILL CLEAN SOIL.

Lease Name: San Juan 28-7 #1, 8 Operator: SM Date: ~~8-3-99~~ 9-3-99

Lease Name: San Juan 28-7 #178  
Federal/ Indian Lease No: SF 078500A  
CA No.: NA  
Unit : P  
Legal Description: Sect: 31 TP: 28N R: 7W  
County: Rio Arriba, NM

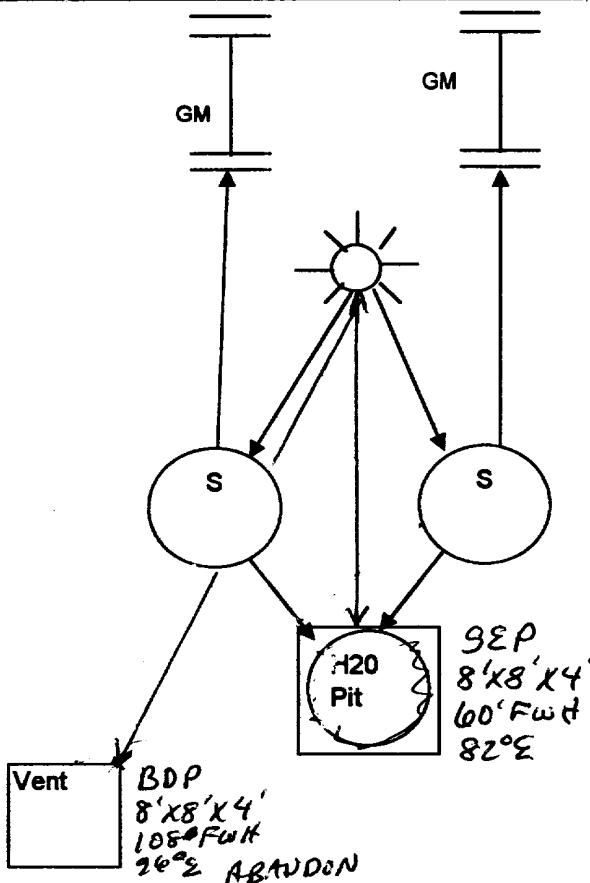
Site Security  
(Indicate North)

Load line valves :  
Sealed during Production

Drain line valves :  
Sealed during Production

Production Line valve:  
Sealed during sales
