**FIELD PIT SITE ASSESSMENT FORM**

| <b>GENERAL</b> | <p>Meter: <u>75223</u> Location: <u>Jennayah A-1</u></p> <p>Operator #: <u>0203</u> Operator Name: <u>Amece</u> P/L District: <u>Blanco</u></p> <p>Coordinates: Letter: <u>H</u> Section <u>36</u> Township: <u>28</u> Range: <u>9</u></p> <p>Or Latitude _____ Longitude _____</p> <p>Pit Type: Dehydrator <input checked="" type="checkbox"/> Location Drip: <input checked="" type="checkbox"/> <sup>cmc 5/17/94</sup> Line Drip: _____ Other: _____</p> <p>Site Assessment Date: <u>5/17/94</u> Area: <u>03</u> Run: <u>82</u></p> |

# FIE/ PIT REMEDIATION/CLOSURE FORM

## PIT CLOSURE PROJECT - Soil

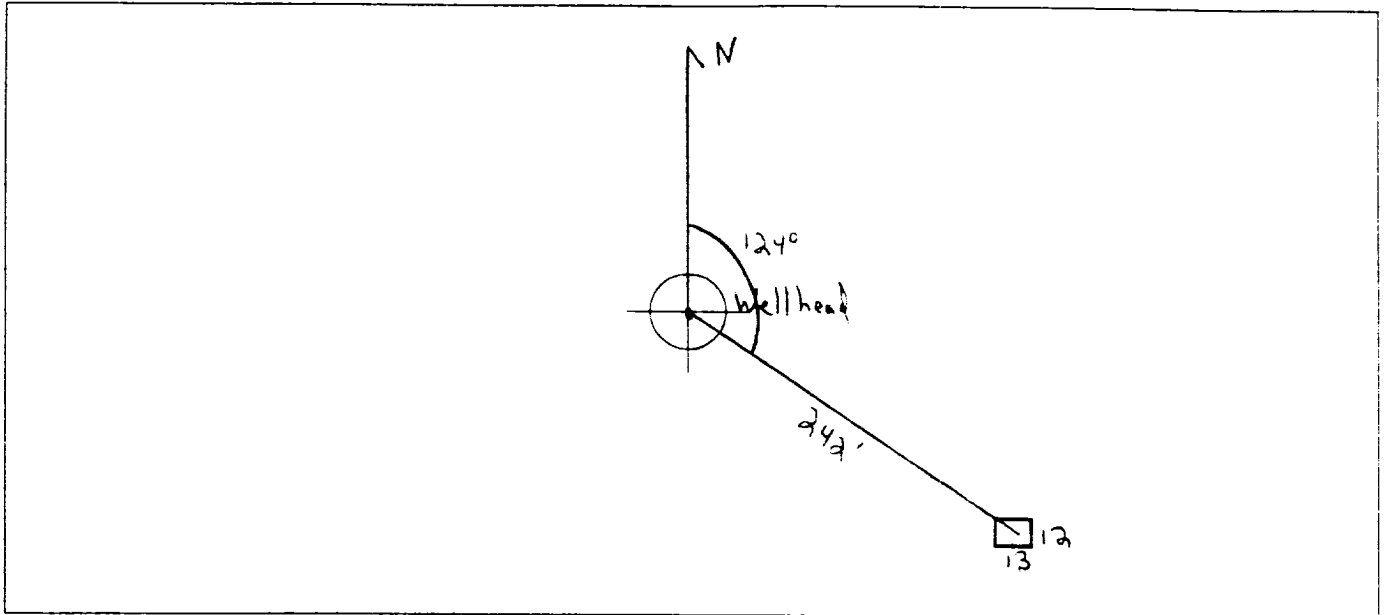
ORIGINAL PIT LOCATION

| <b>REMARKS</b> | <p>Remarks : <u>Redline - Inside, Vuln. - Inside</u></p> <p><u>3 pits. Dig &amp; Haul 1. Pit Dry. Site next to Blanco Canyon</u></p> <p style="text-align: right;"><u>Dig &amp; Haul</u></p> |

Original Pit : a) Degrees from North 124° Footage from Wellhead 242'  
b) Length : 13 Width : 12 Depth : 3
