PIT REMEDIATION AND CLOSURE REPORT

Operator: PNM Gas Services (Energen) Telephone: 324-3764

Facility or Well Name: Eaton Federal #1

Location: Unit A Sec 15 T 28 N R 11 W County San Juan

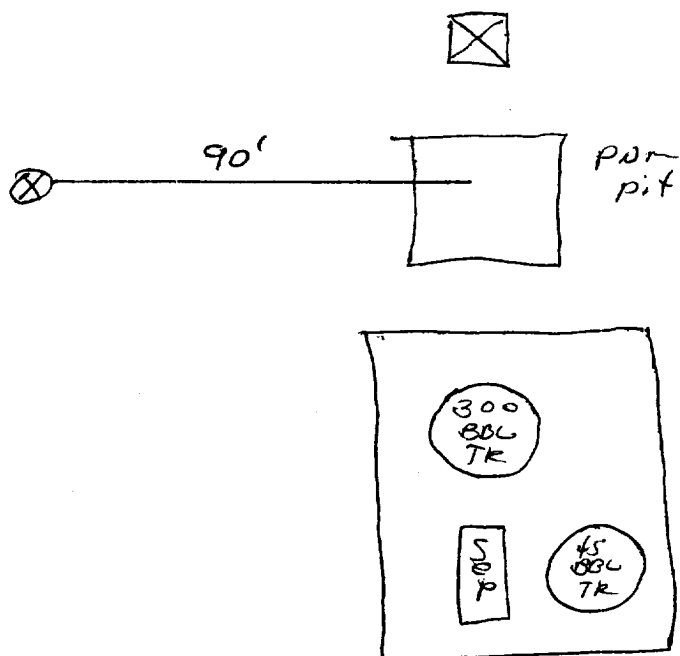
Site Drawing:

Union Federal
Sec. 15 T28N R11W Unit A
Energen

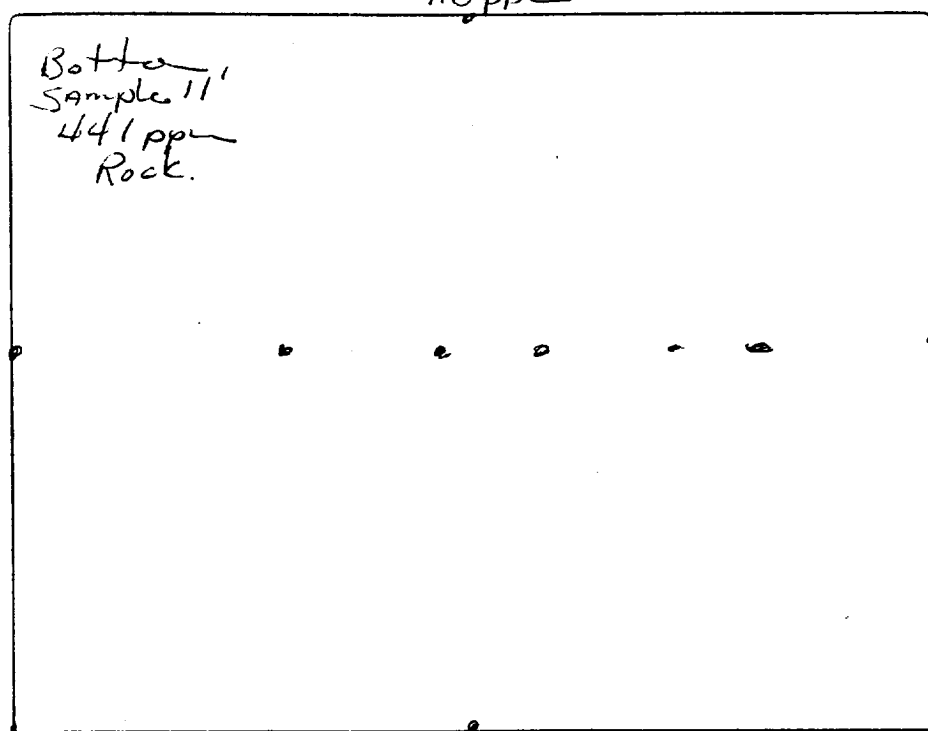
Excavation Drawing

North Wall
Sample 10'
7.3 ppm

5' x 3' x 11'

West Wall
Sample 10'
8.6 ppm

East Wall
Sample 10'
6.2 ppm

Excavated contaminated soil to a pit size of 51' X 31' X 11' and landfarmed soil onsite within a bermed area at a depth of 6" to 12". Soil was aerated by disking/plowing until soil met regulatory levels.

*** Rock encountered at 11'. See attached risk analysis form.
