Meter Number:97113  
Location Name:STATE COM P12  
Location:TN-29 RG-08  
SC-36 UL-M  
1 - State  
NMOCD Zone:OUTSIDE  
Hazard Ranking Score:00

**RATIONALE FOR RISK-BASED CLOSURE OF PRODUCTION PITS  
LOCATED OUTSIDE OF THE VULNERABLE ZONE  
IN THE SAN JUAN BASIN**

# FIELD PIT REMEDIATION/CLOSURE FORM

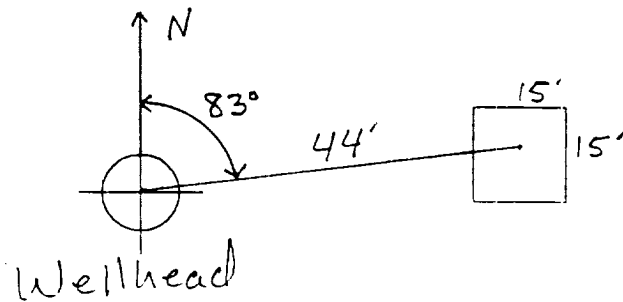
### ORIGINAL PIT LOCATION

Original Pit : a) Degrees from North 83° Footage from Wellhead 44  
b) Length : 15 Width : 15 Depth : 4
