Meter Number: 93892  
Location Name: SIMMONS E #3R  
Location: TN-29 RG-09  
SC-24 UL-L  
2 - Federal  
NMOCD Zone: OUTSIDE  
Hazard Ranking Score: 00

**RATIONALE FOR RISK-BASED CLOSURE OF PRODUCTION PITS  
LOCATED OUTSIDE OF THE VULNERABLE ZONE  
IN THE SAN JUAN BASIN**

# FIELD PIT SITE ASSESSMENT FORM

# FIELD PIT REMEDIATION/CLOSURE FORM

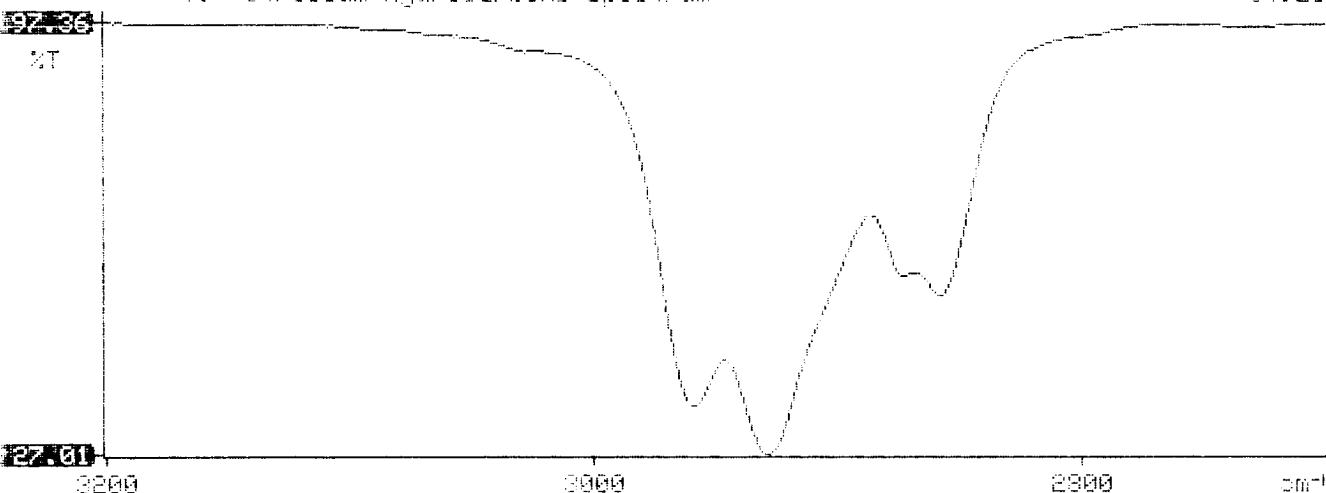
Y: Petroleum hydrocarbons spectrum

Petroleum hydrocarbons, ppm  
 4469.858

Net absorbance of hydrocarbons (2930  $\text{cm}^{-1}$ )  
 0.556
