PIT REMEDIATION AND CLOSURE REPORT

Operator: Conoco Inc.Telephone: 505-324-5813Address: 3315 Bloomfield Hwy - Farmington, NM 87401Facility Or: Kate Standage #1

Location: Unit or Qtr/Qtr Sec J Sec 12 T 30N R 12W County San JuanPit Type: Separator Dehydrator X Other Land Type: BLM State X Fee Other Pit Location: Pit dimension: length 12' width 12' depth 3'
(Attach diagram)Reference: wellhead X other Footage from reference: 100'Direction from reference: 330 Degrees East of X North
X West South

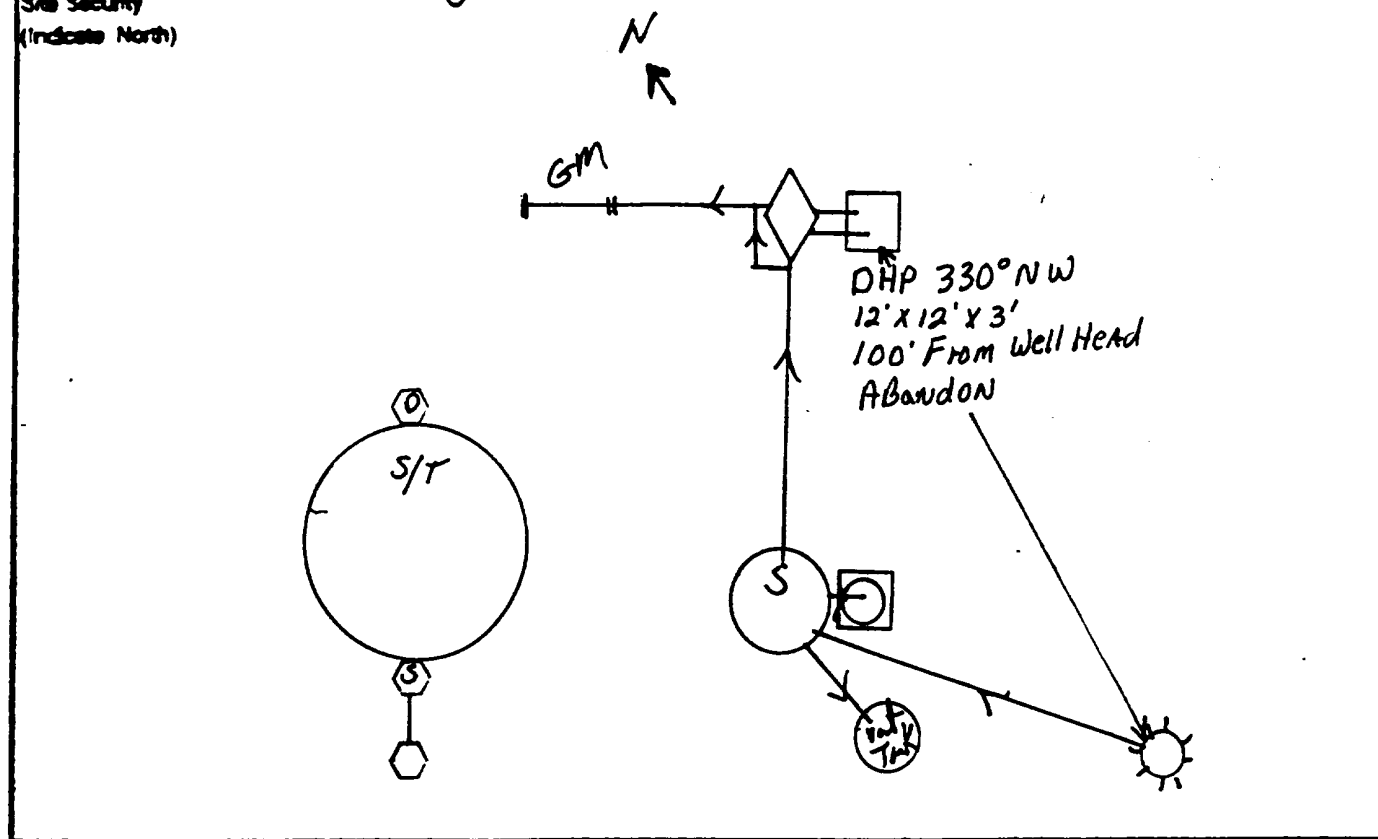
Site Security
(Indicate North)

Load line valves :
Sealed during Production

Drain line valves :
Sealed during Production

Production Line valve:
Sealed during sales

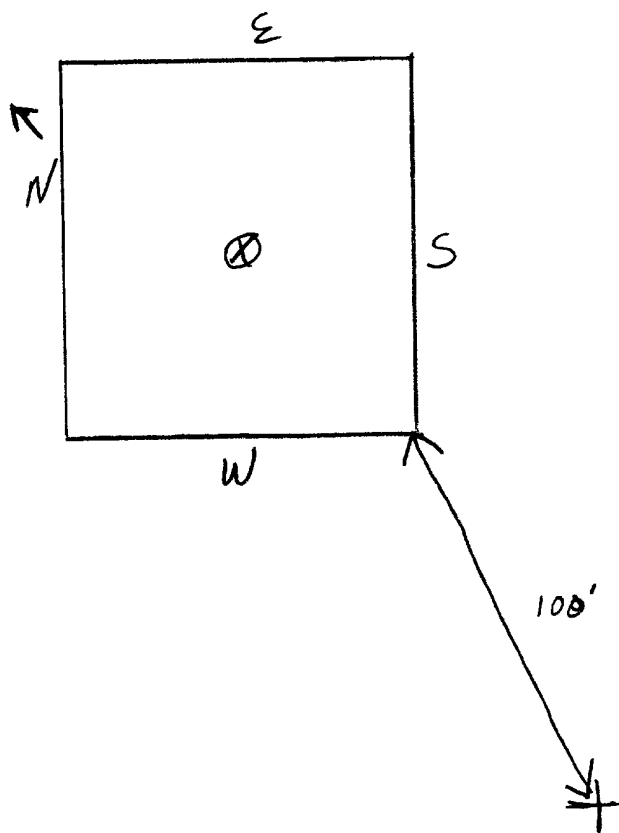
Kate Standage

D.H.P.

100' From W.H. 330° NW.

12' x 12' x 3'

CENTER of PIT

Time : 1502
P.P.M. : 3

⊗ Sample
