PIT REMEDIATION AND CLOSURE REPORT

Facility or Well Name: East #22

Location: Unit H Sec 26 T 31 N R 12 W County San Juan

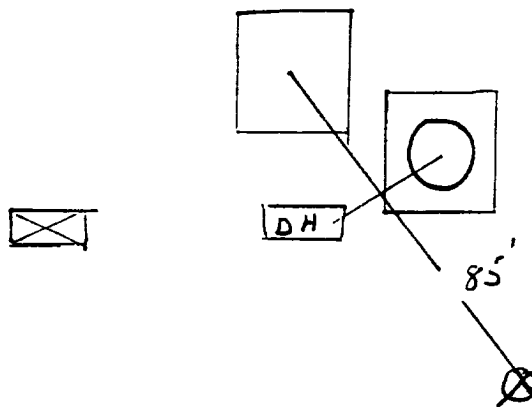
Site diagram:

East # 22
Burlington
Sec. 26, 31N, 12W, H

Field Headspace: 0 ppm (walls)

not to scale

Excavated contaminated soil to a pit size of 25' X 28' X 20' and landfirmed soil onsite within a bermed area at a depth of 6" to 12". Soil was aerated by disking/plowing until soil met regulatory levels.
