PIT REMEDIATION AND CLOSURE REPORT

Operator: PNM Gas Services (Kimbark)		Telephone: 324-3764	
Address: 603 W. Elm Street Farmington, NM 87401			
Facility or Well Name: Horton #1A			
Location:	Unit <u>G</u>	Sec <u>7</u>	T <u>31 N</u> R <u>11 W</u> County <u>San Juan</u>
Pit Type:	Separator <input type="checkbox"/>	Dehydrator <input checked="" type="checkbox"/>	Other _____
Land Type:	BLM <input checked="" type="checkbox"/>	State <input type="checkbox"/>	Fee <input type="checkbox"/> Other _____
Pit Location:	Pit dimensions: length <u>15</u> ' width <u>15</u> ' depth <u>2</u> '		
(Attach diagram)	Reference: wellhead <input checked="" type="checkbox"/> other _____		
	Footage from reference: <u>81</u> '		
	Direction from reference: <u>45</u> Degrees <input type="checkbox"/> East <input type="checkbox"/> North <input type="checkbox"/> of <input checked="" type="checkbox"/> West <input checked="" type="checkbox"/> South		
Depth to Ground Water:	Less than 50 feet (20 points) 50 feet to 99 feet (10 points) Greater than 100 feet (0 points) <u>0</u>

Horton #1A

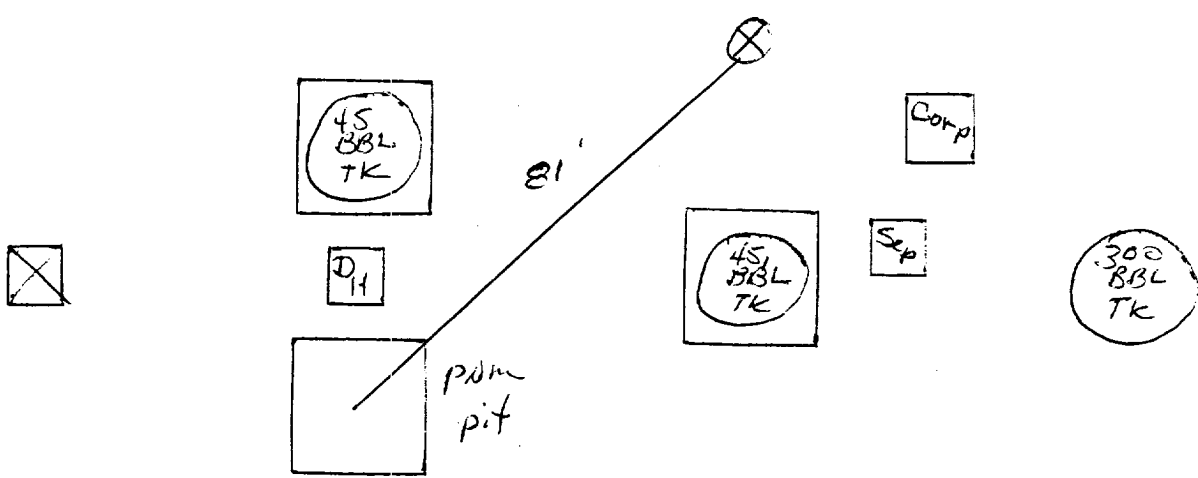
Site Drawing

Sec. 7 T31N R11W Unit G
Kimbank
