Culpepper Martin #15A

General Description of Remedial Action:

Culpepper Martin #15A  
Burlington  
Sec. 21, 32N, 12W, I

# LAND FARM DRAWING

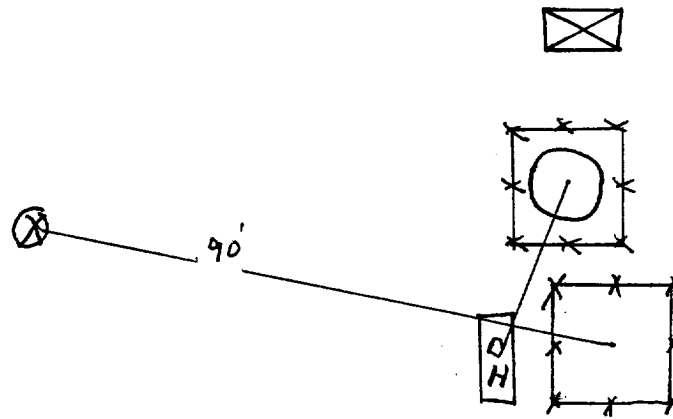
Site diagram:

Excavated contaminated soil to a pit size of 20' X 21' X 20' and landfarmed soil onsite within a bermed area at a depth of 6" to 12". Soil was aerated by disking/plowing until soil met regulatory levels.

3 pt. composite - bottom.

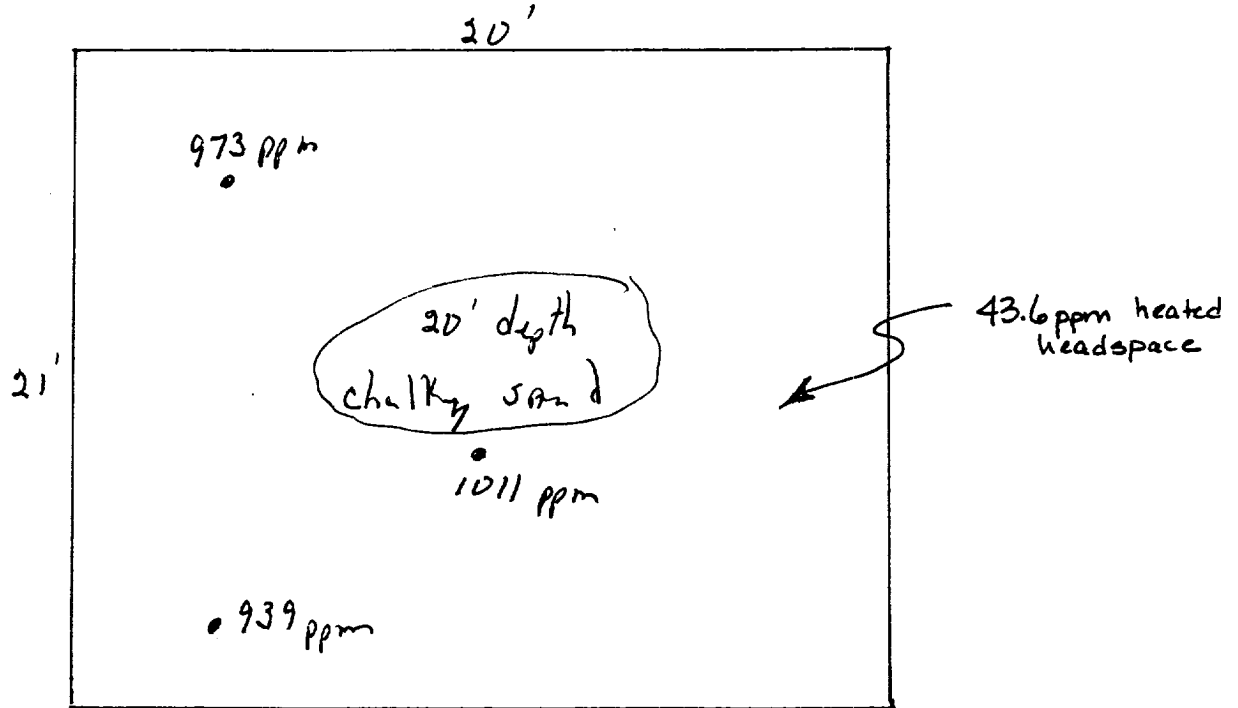
End of excavation:

not to scale
