**Clay Cooper #11 Closure Report  
Duke Energy Field Services  
Lea County, New Mexico**

**CLAY COOPER #11 (CC#11)**

**T20S, R36 E, SECTION 25, UNIT D**

Re: Removal of Hydrocarbon-Impacted Soils from the CC #11 site  
Township 20 South, Range 36 East, Section 25, Unit D

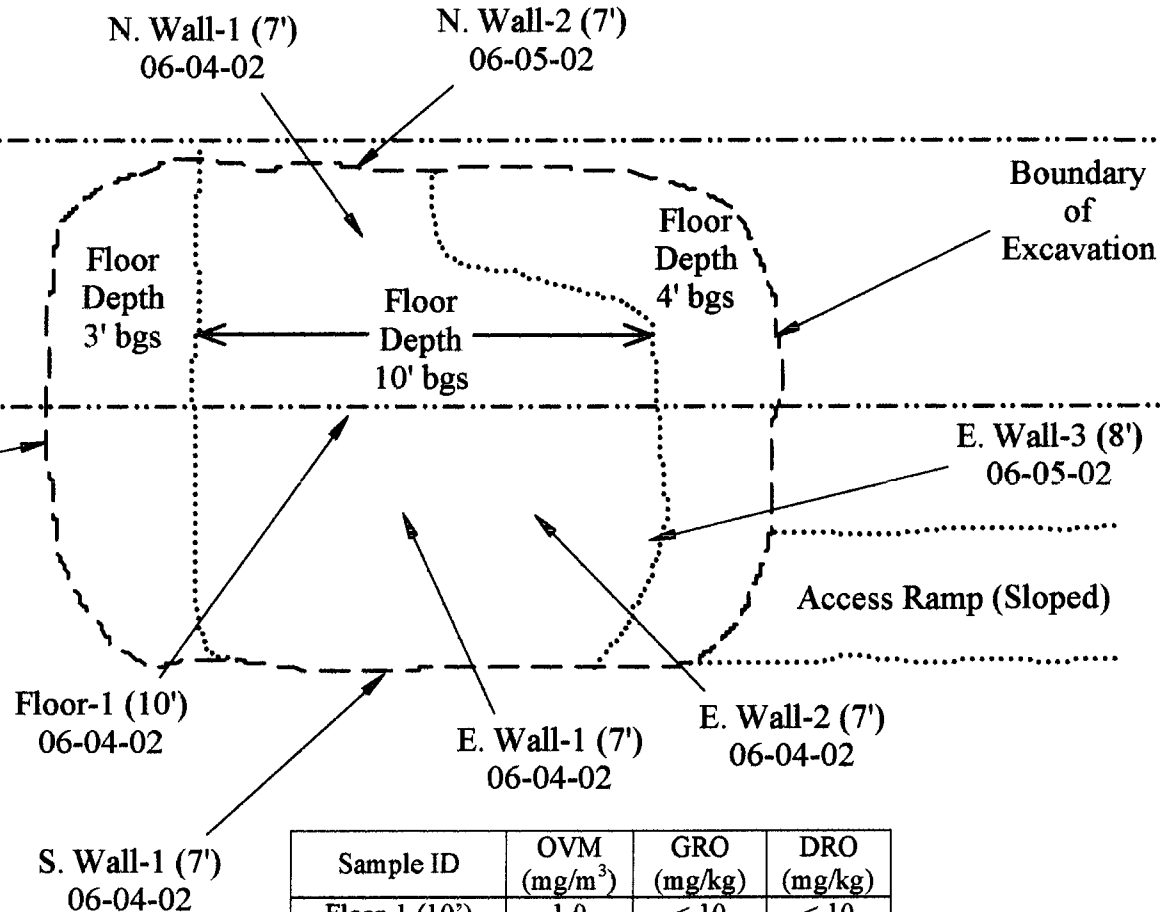
SITE MAP

At the completion of excavation activities all areas had petroleum hydrocarbon concentrations below the OCD standards listed above. Soil sample locations are depicted on the Site Map in Attachment A. A summary of the analytical results and photo documentation are also provided in Attachment A. Laboratory analytical reports, and chain-of-custody documentation for the samples collected are provided in Attachment B. Copies of the field logbook are in Attachment C.

Sample ID	OVM (mg/m <sup>3</sup> )	GRO (mg/kg)	DRO (mg/kg)
Floor-1 (10')	1.0	< 10	< 10
E. Wall-1 (7')	121	460	1370
E. Wall-2 (7')	8.0	29.4	111
E. Wall-3 (7')	0.0	< 10	< 10
N. Wall-1 (7')	2.0	51.4	164
N. Wall-2 (7')	0.0	< 10	< 10
W. Wall-1 (8')	2.0	< 10	< 10
S. Wall-1 (7')	1.0	< 10	< 10

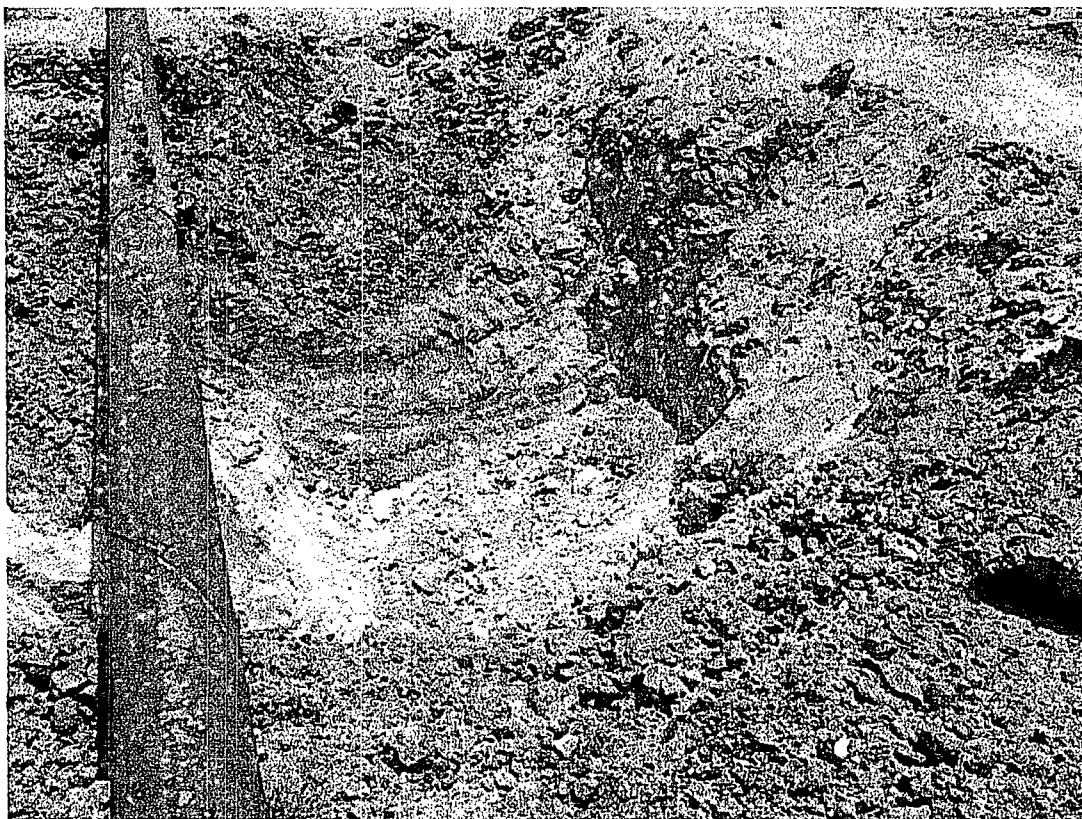
1 View facing east showing area beneath the 12-inch out of service pipeline at completion of excavation activities (06-05-02).

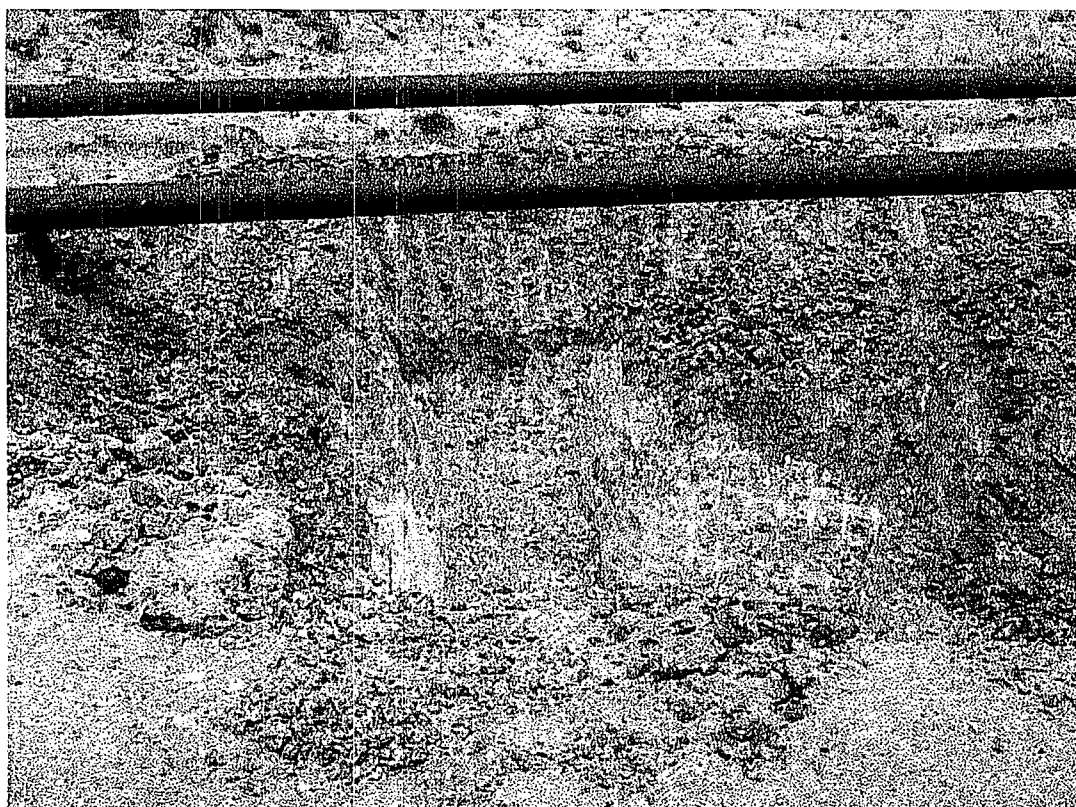
2 View facing north showing area beneath the 12-inch out of service pipeline at completion of excavation activities (06-05-02).

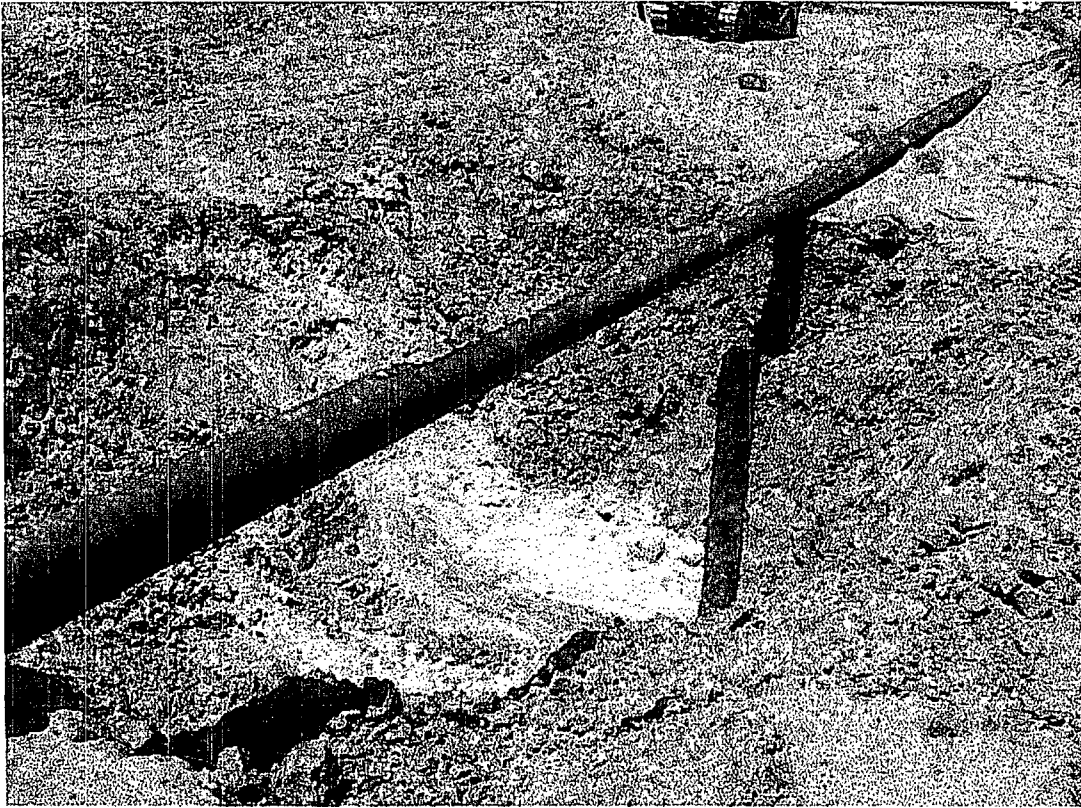
3 View facing southwest showing area beneath the out of service pipeline at completion of excavation activities (06-05-02).

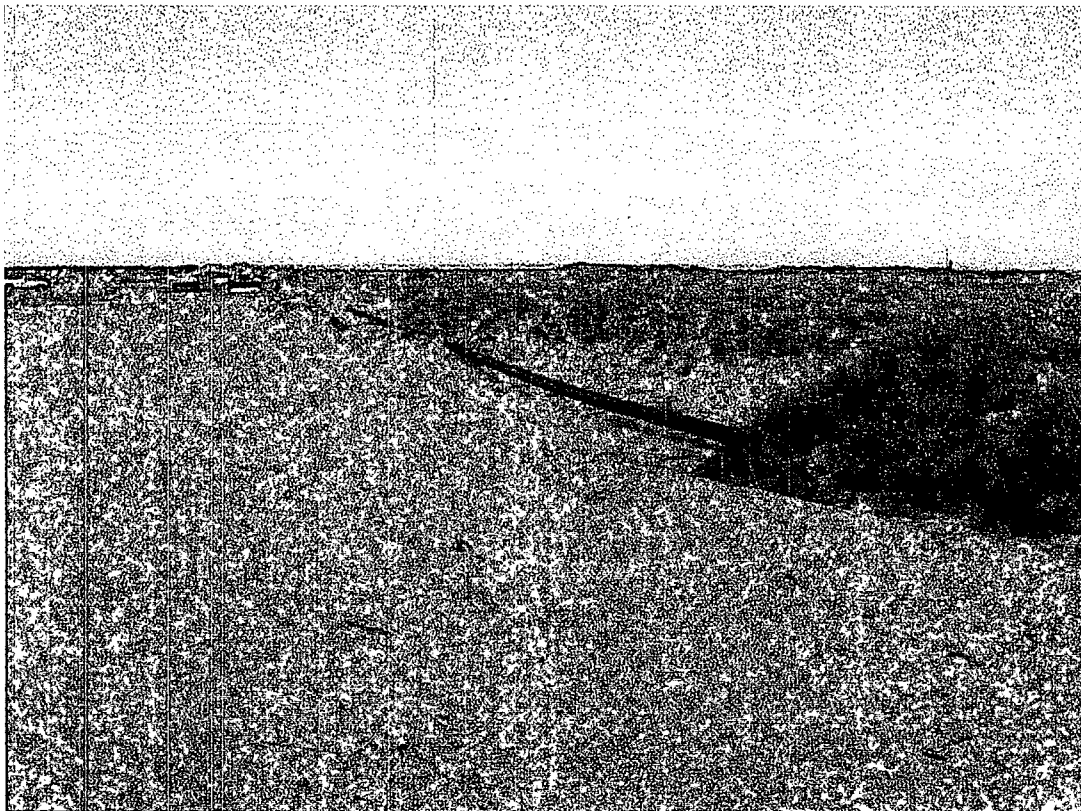
4 View facing west showing CC # 11 site after backfilling (06-13-02)

Excavated soils below the remediation action levels and as agreed upon by Mr. Cooper were returned to the excavation after sampling and analysis verification. Also, native soil from adjacent sand dunes in the area was provided by Mr. Cooper and used as additional backfill in the excavation to restore the excavation to a level grade.

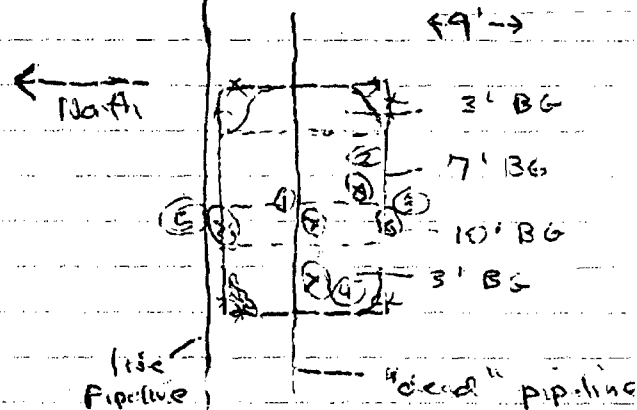
- 1) - Floor 1 (10')
- 2) - E. Wall - 1 (7')
- 3) - S. Wall - 1 (7')
- 4) - W. Wall - 1 (8')
- 5) - N. Wall - 1 (7')

West  
stockpile  
(contaminated)

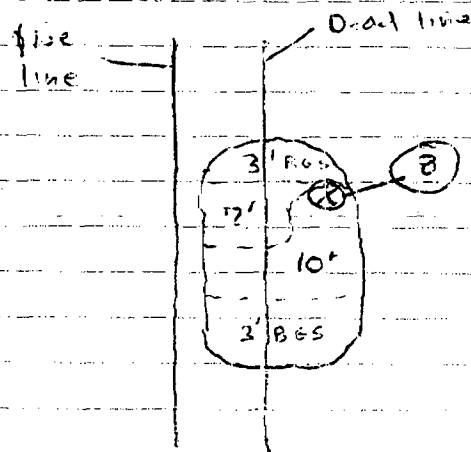
Final Pit Size as of 1400 CT

8) E. Well - 2 (7') 8 ppm PID

1344 Had Mike excavate the  
SE corner a few more  
feet to remove the soil  
assoc. with sample # 2  
above.
