SITE INVESTIGATION, REMEDIATION, AND FINAL C-141 CLOSURE DOCUMENTATION

D-2-1 RELEASE SITE

DEFS REF: D-2-1 091702

Subject: Duke Energy Field Services – D-2-1 091702 Final C-141 and Closure Documentation

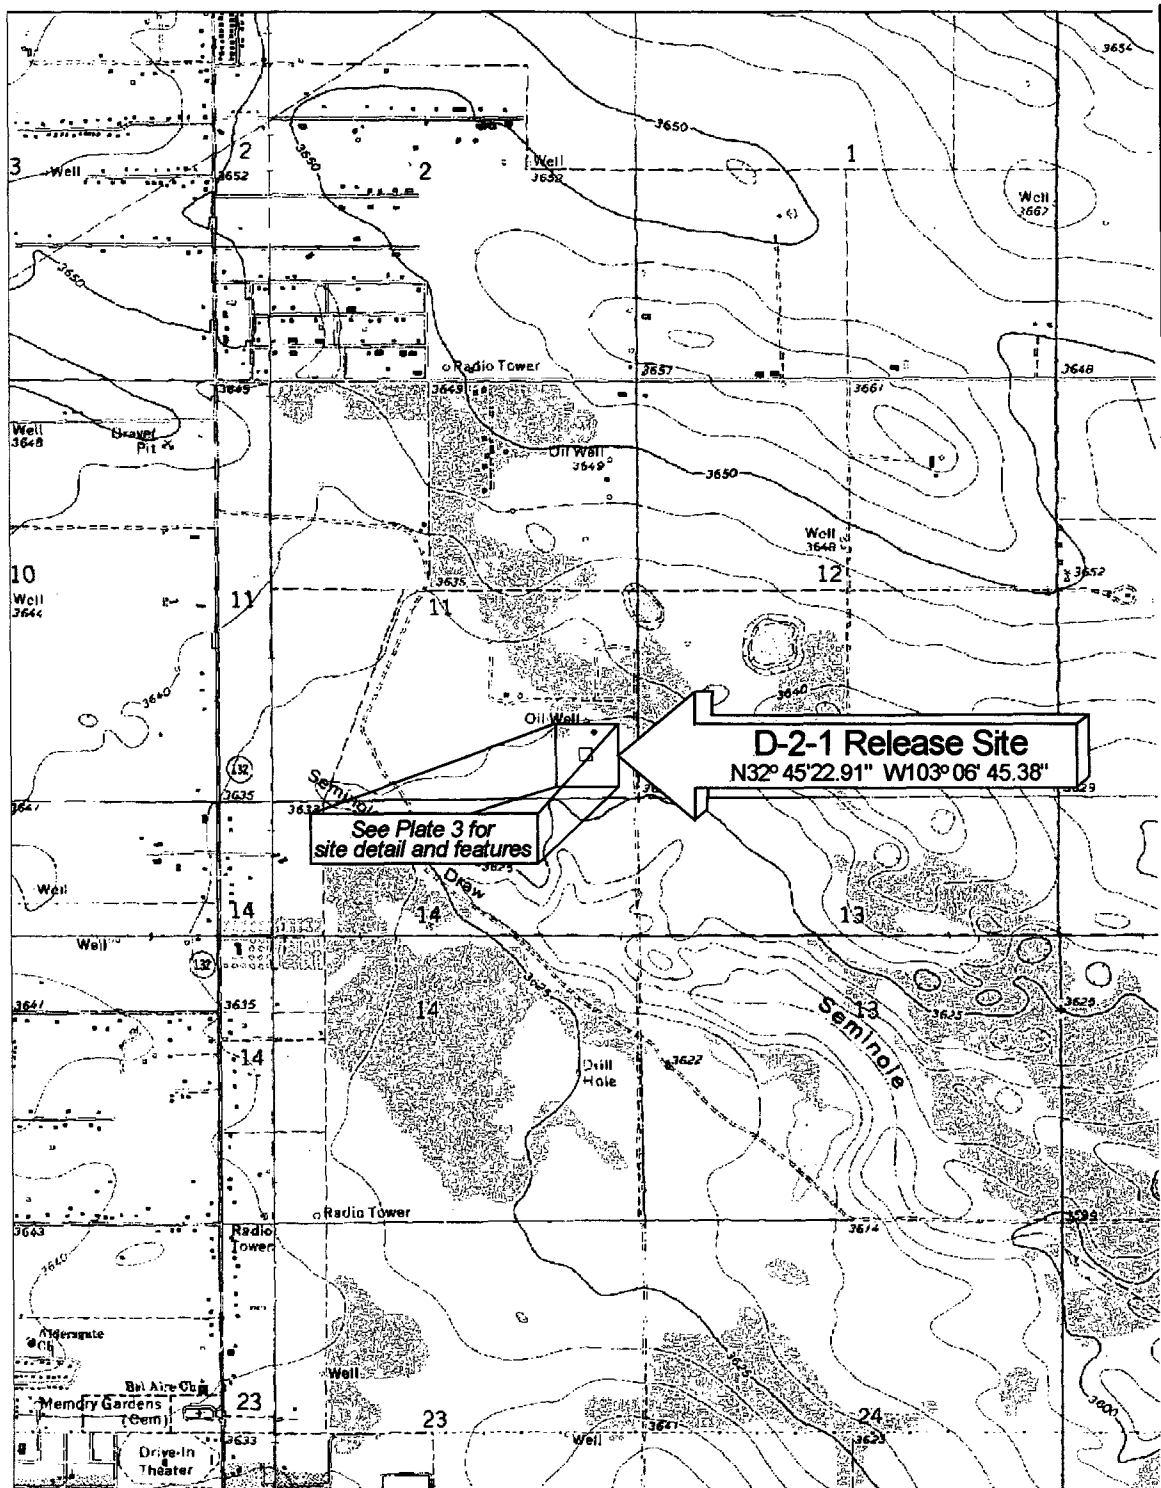
Plate 2: Site Topography Map

Plate 2: Site Topography and Release Location

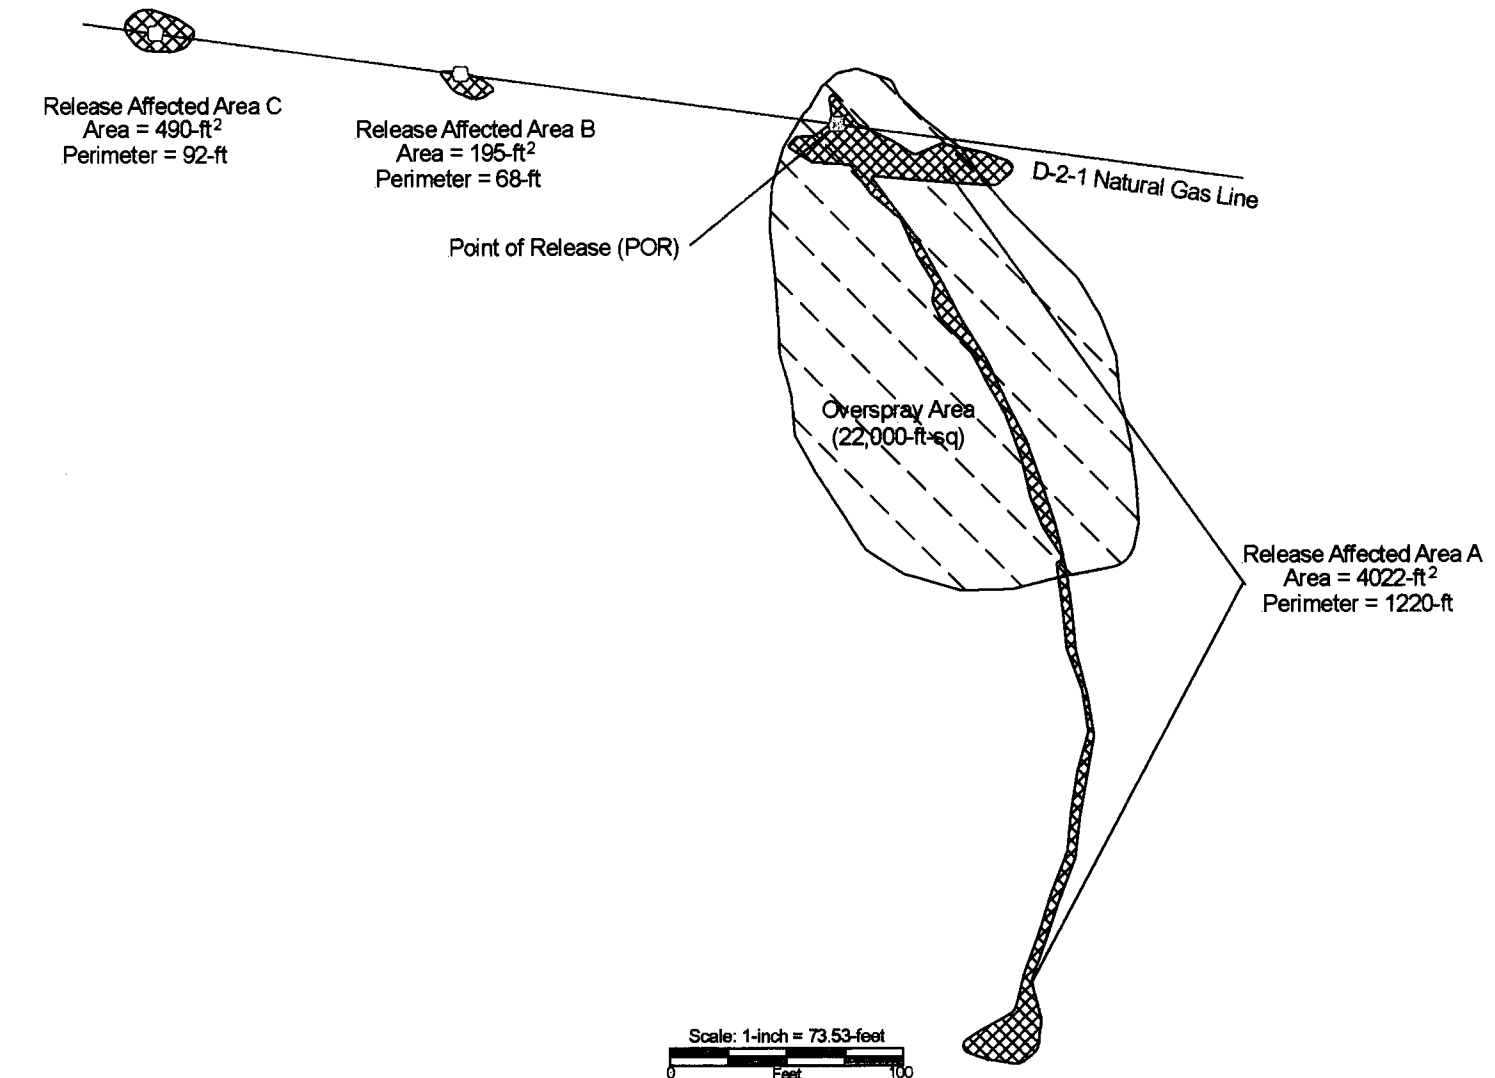
Plate 3: Initial GPS Demarcation with Site Features

Plate 3: Release Site Initial GPS Demarcation
 Duke Energy Field Services - D-2-1 Line 091702
 Lea County, NM; UL-P Section 11 T18S R38E
 Drawn By: JCG Date: Sept-02 Revised: Oct-02

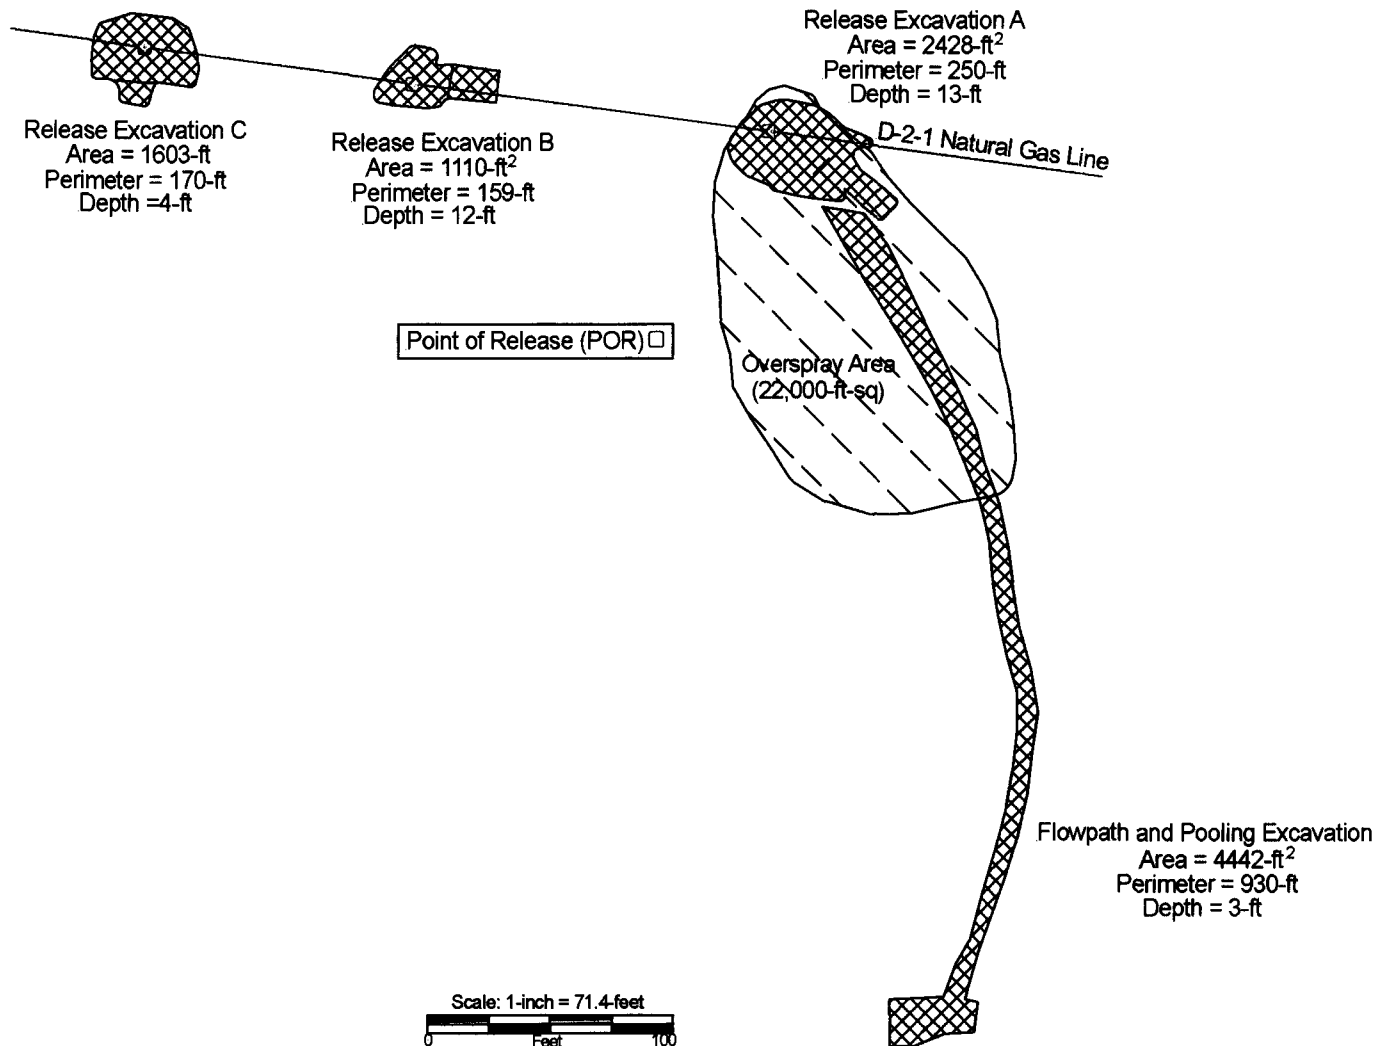
Plate 4: Excavation(s) Final GPS Demarcation
Duke Energy Field Services - D-2-1 Line 091702
Lea County, NM; UL-P Section 11 T18S R38E

Excavation-A was further excavated down to 13-ft bgs to achieve chloride levels < 250 ppm.

Excavation-B was further excavated down to 12-ft bgs, and all sidewalls were extended 3-ft to achieve chloride levels < 250 ppm and sulfate levels < 600 ppm.

Excavation-C was not excavated beyond the 4-ft depth; all sidewalls were extended 4-ft to achieve TPH levels < 1000 ppm and sulfate levels < 600 ppm.

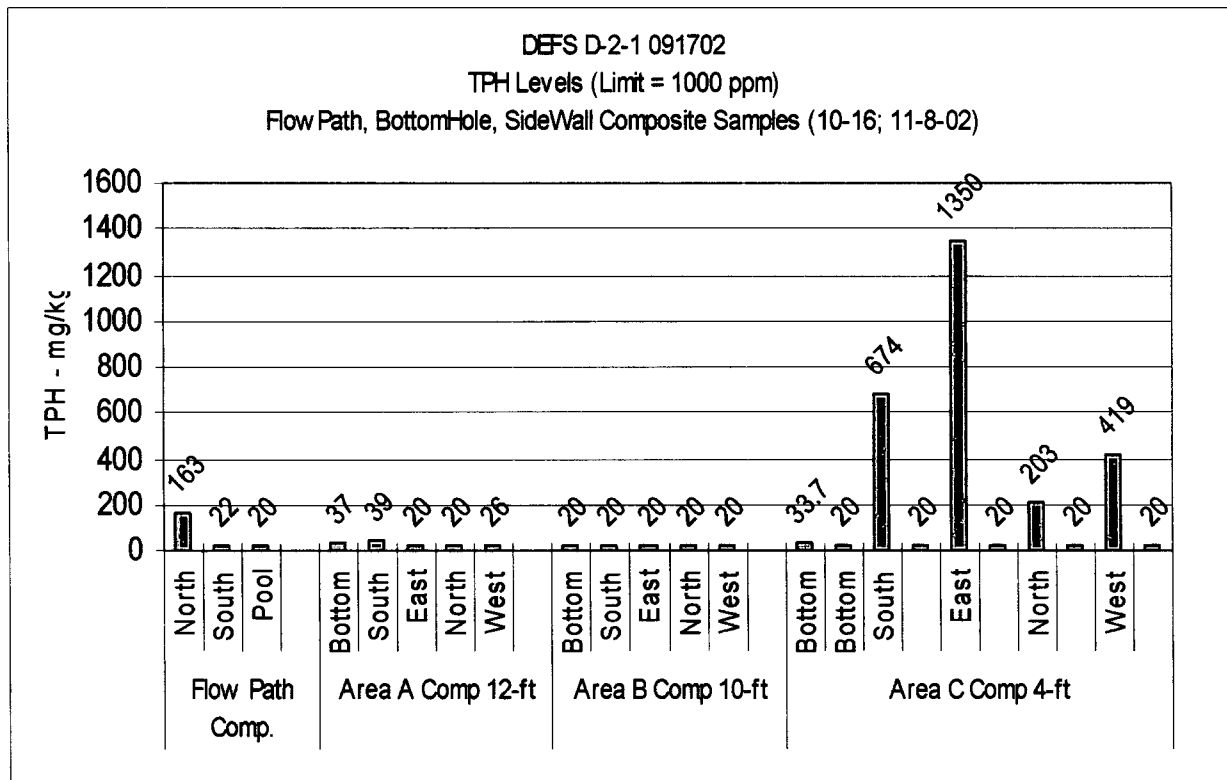
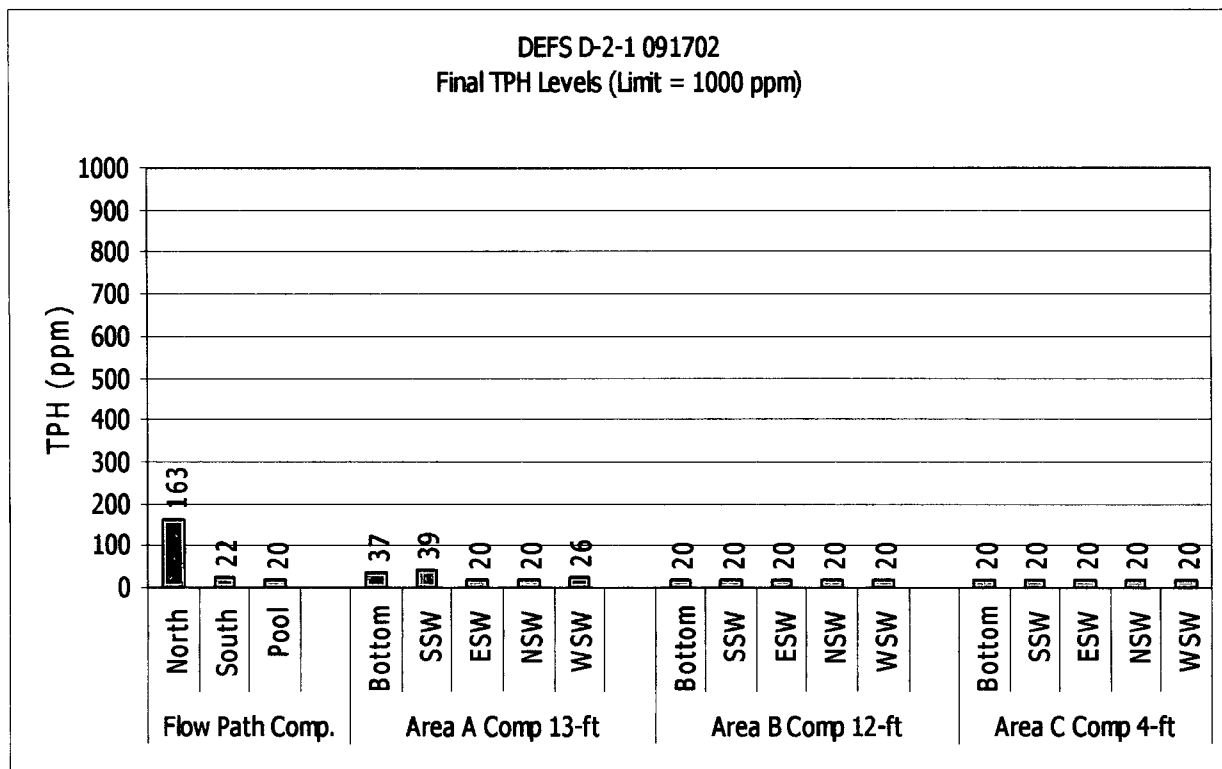
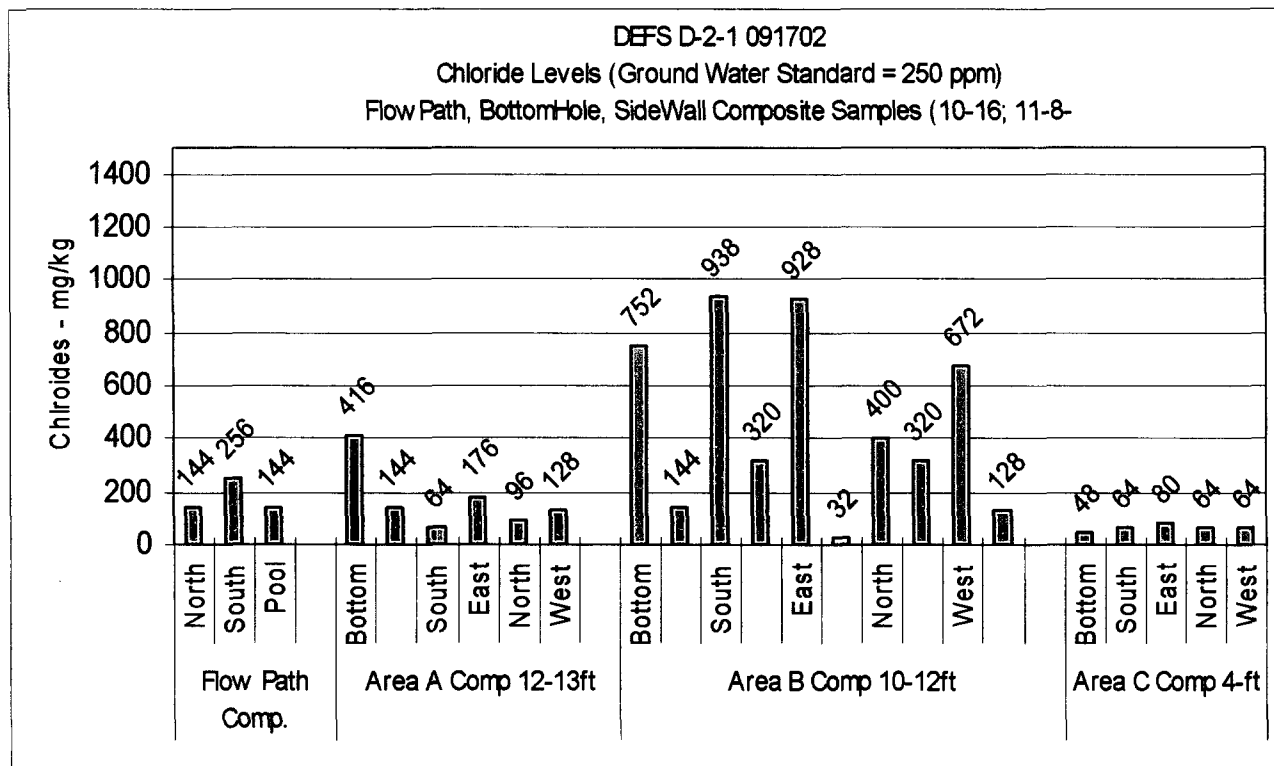
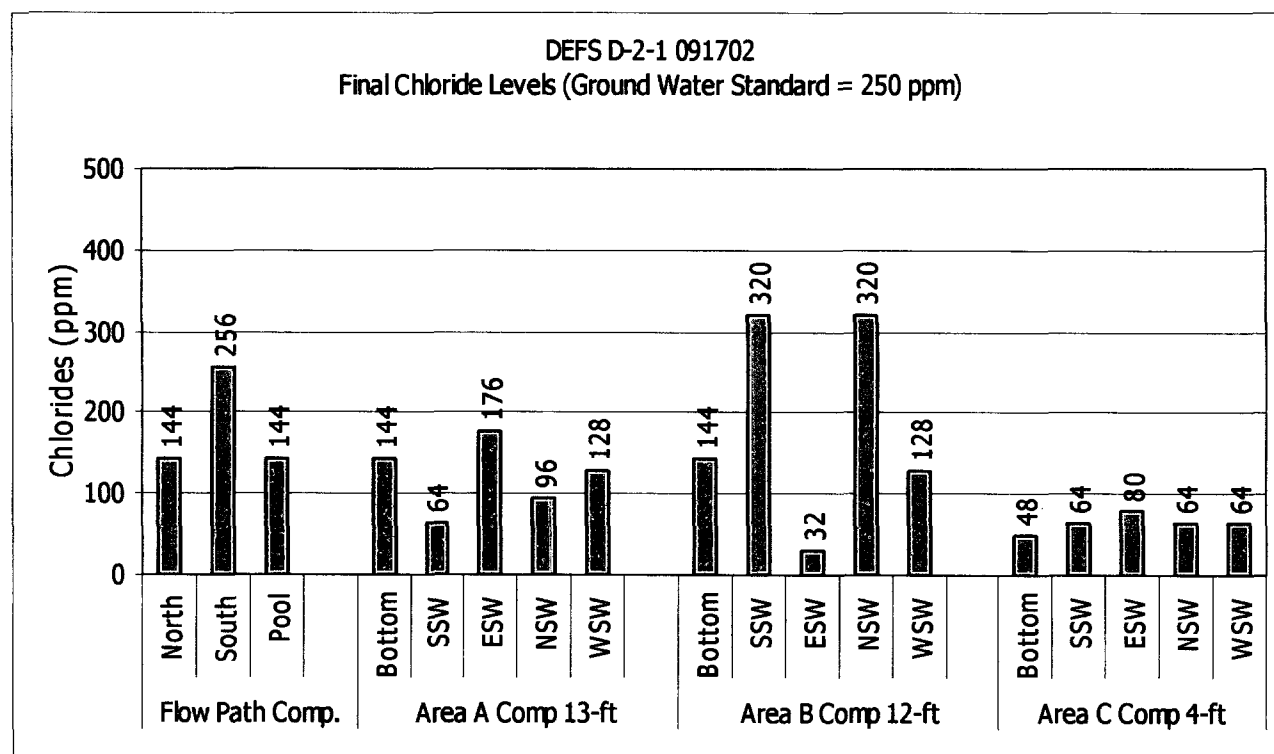
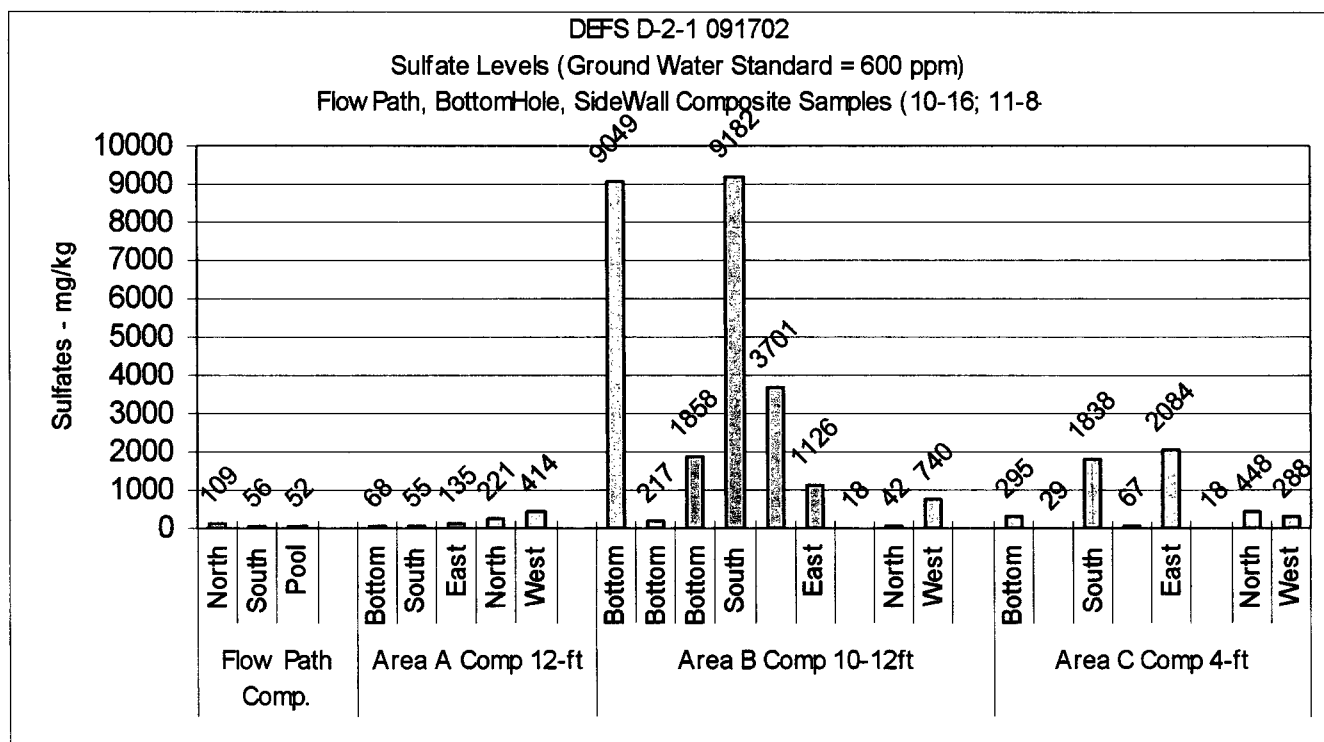
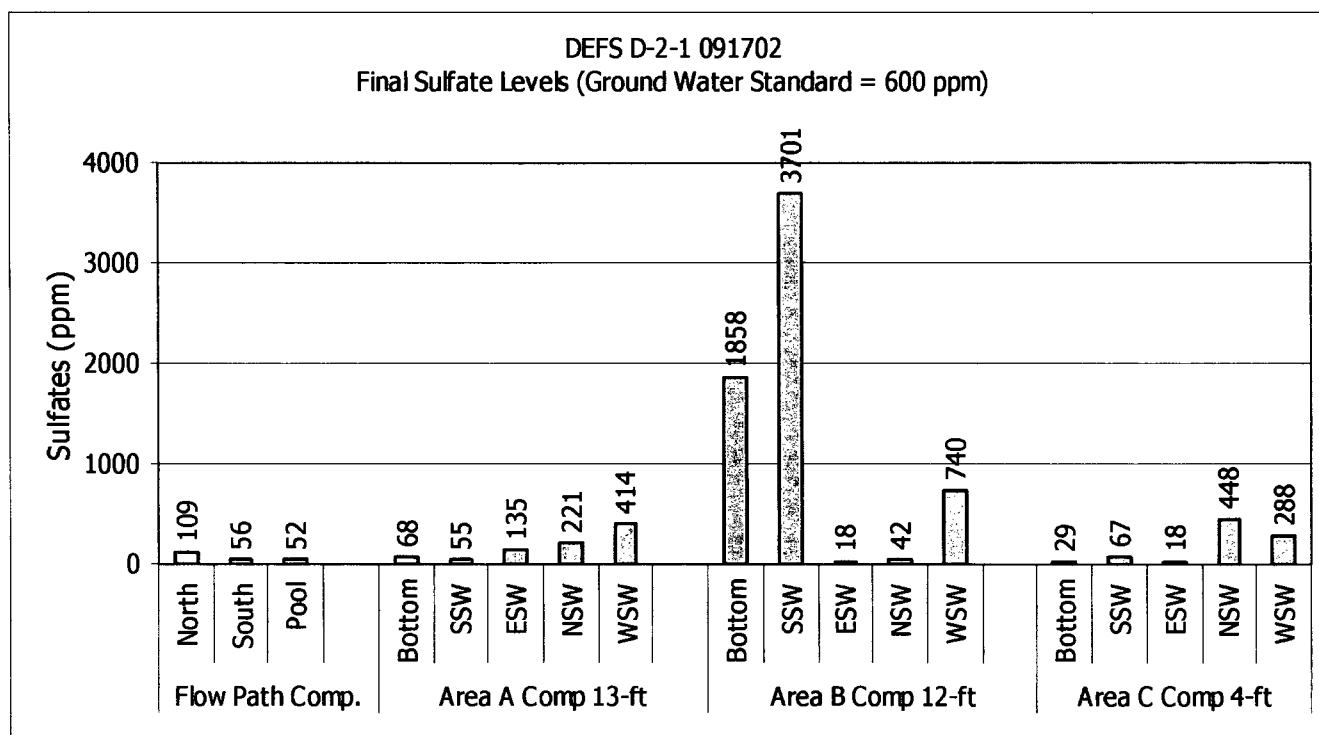
Bar Charts: Composite TPH, Chloride and Sulfate Analyses

Laboratory analytical reports, a summary table of all analytical results and graphical representations of the analytical data are provided in the Attachments.
