RE: Closure Request  
C-Line Header and J-4-2-7-4 Line  
Dates of Occurrence: June 28, 2004 and June 21, 2004 respectively

SITE INVESTIGATION,  
REMEDICATION AND FINAL C-141  
CLOSURE DOCUMENTATION

C-LINE HEADER RELEASE SITE  
DEFS REF: 130005

UL-B (NW¼ OF THE NE¼) OF SECTION 32 T17S R33E  
~6.25 MILES SOUTHEAST OF MALJAMAR,  
LEA COUNTY, NEW MEXICO  
LATITUDE: N 32° 47' 44.42" LONGITUDE: W 103° 40' 56.35"

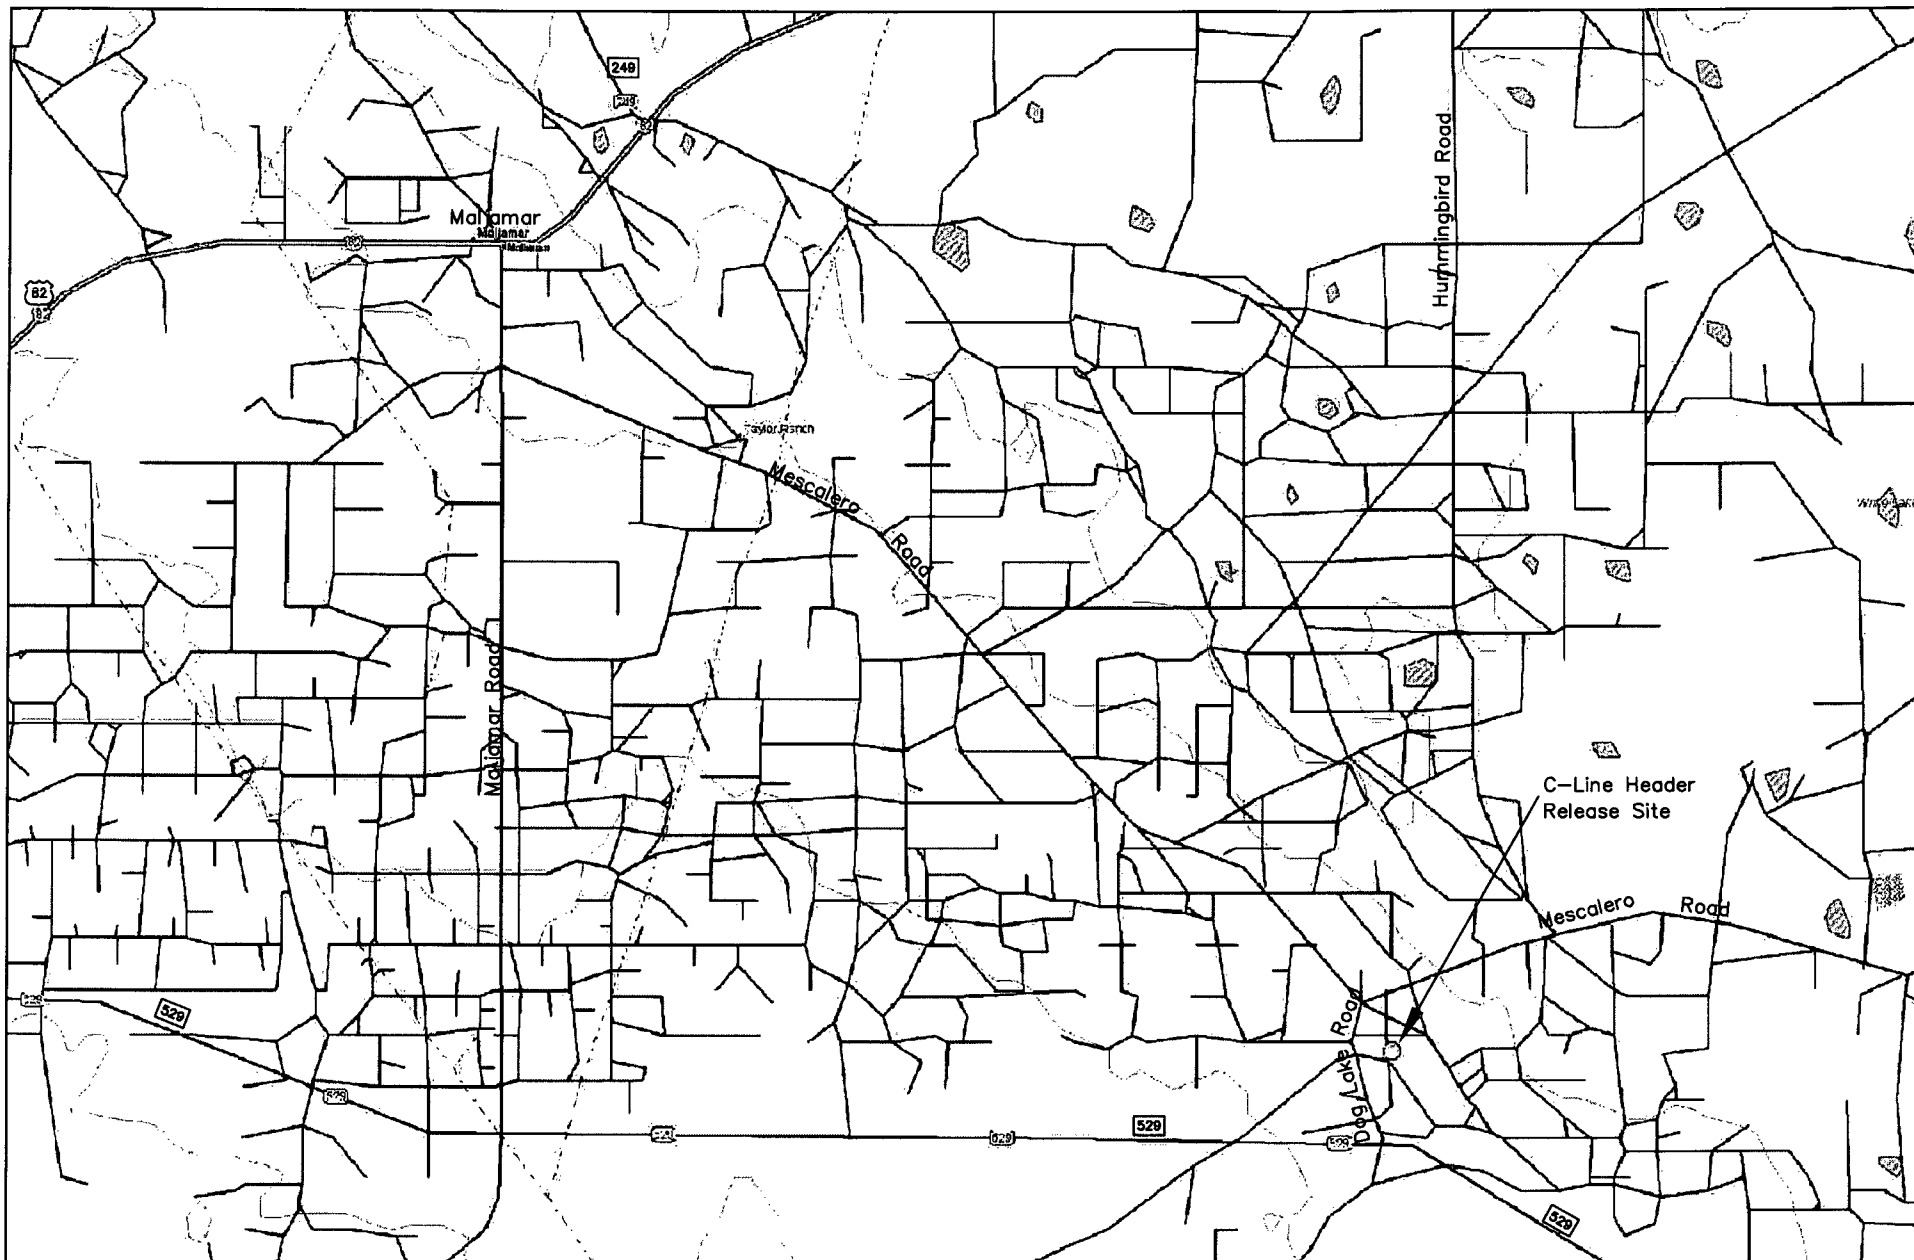
Figure 1  
Area Map  
Duke Energy Field Services  
C-Line Header

Lea County, New Mexico  
NW 1/4 of the NE 1/4, Sec. 32, T17S, R33E  
N 32° 47' 44.4" W 103° 40' 56.3"  
Elevation: 4,055 feet amsl

This release site is located in Unit Letter B (NW<sup>1</sup>/<sub>4</sub> of the NE<sup>1</sup>/<sub>4</sub>), Section 32, T17S, R33E, at a latitude of N32° 47' 44.42" and a longitude of W103° 40' 56.35". The site is approximately 6.25-miles southeast of Maljamar, New Mexico. The property is owned by Snyder Ranches (*reference Figures 1 through 3*).

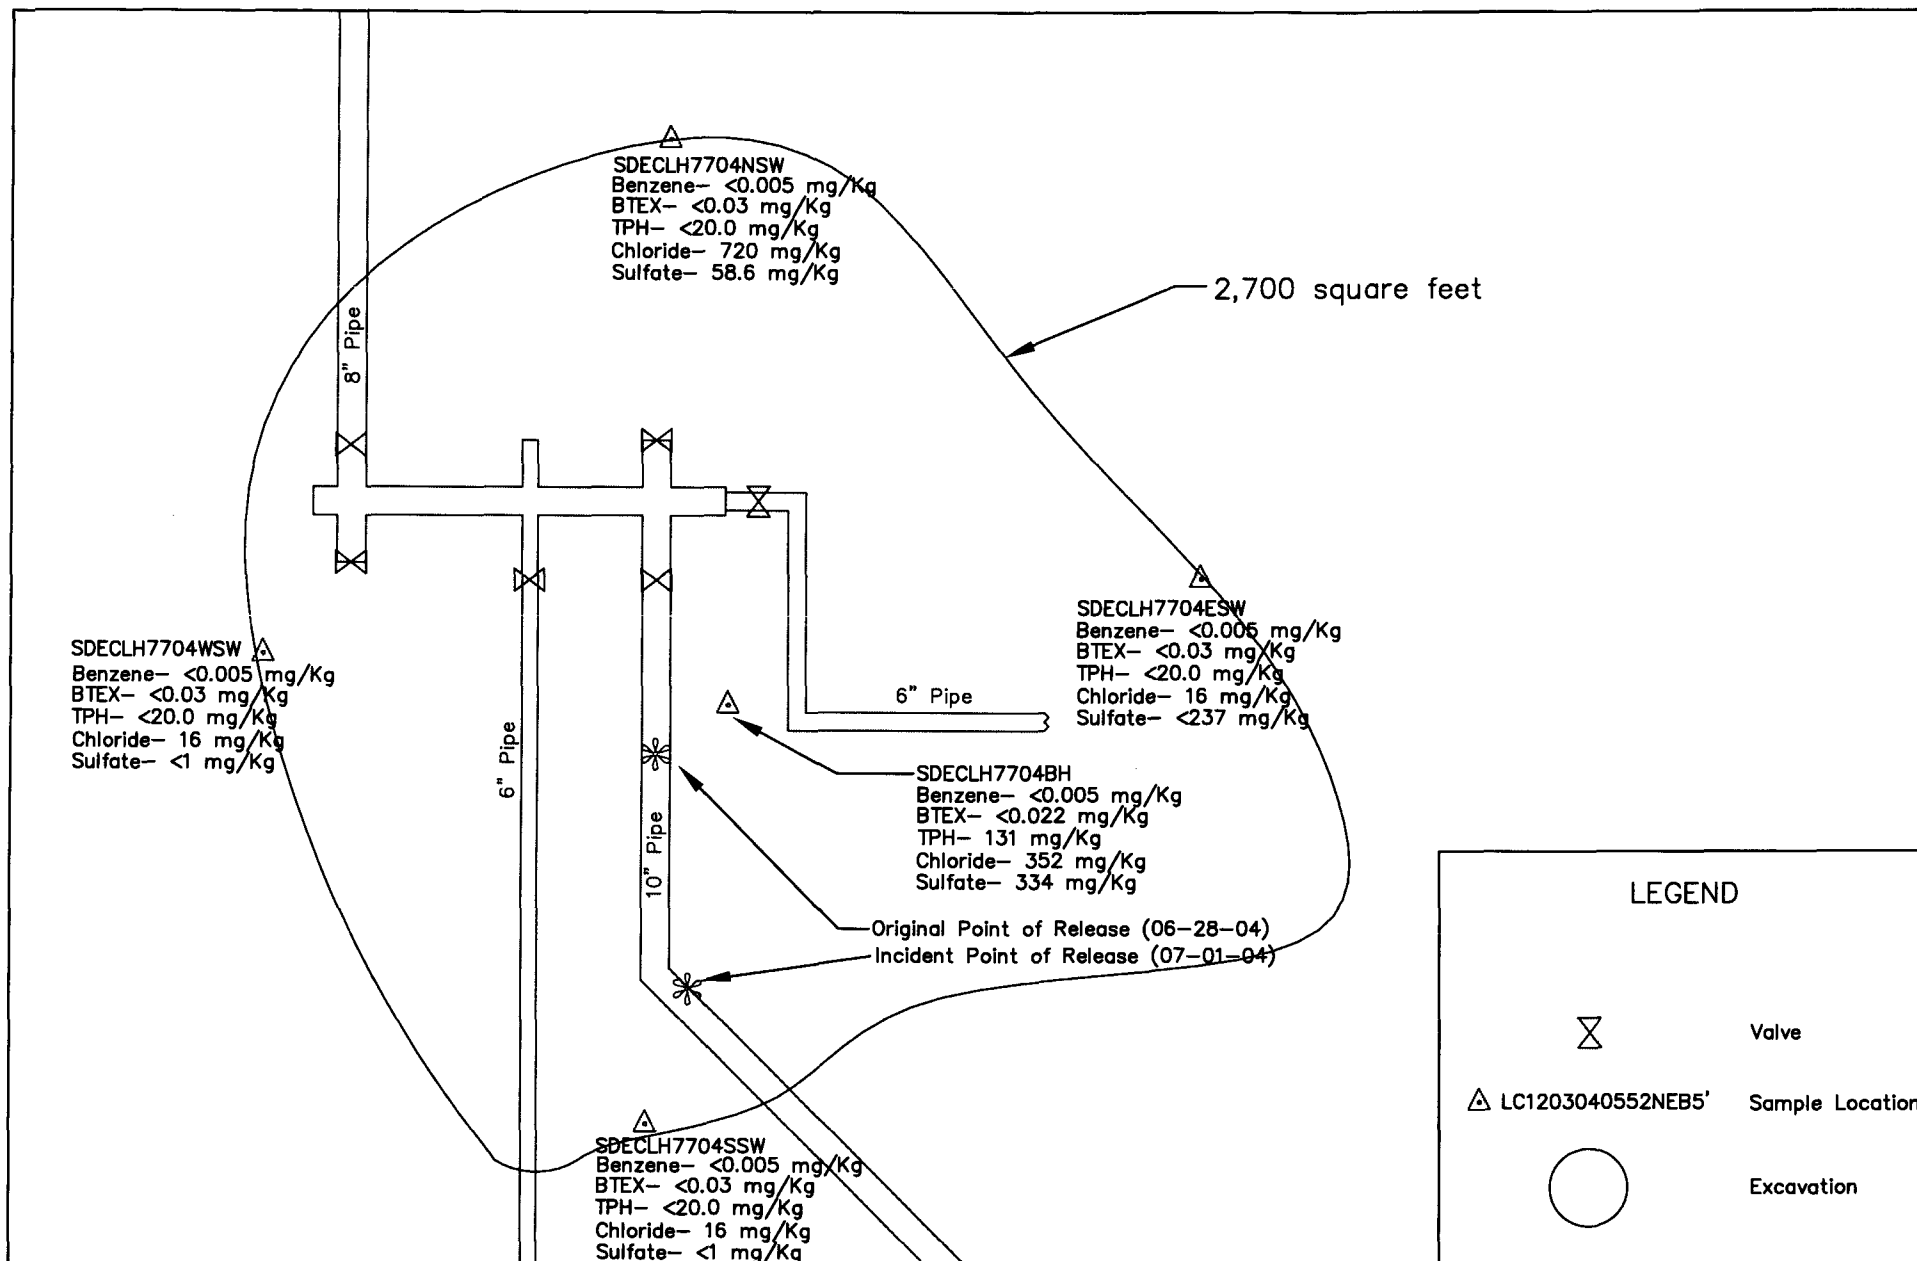
**LEGEND**

△ LC1203040552NEB5' Sample Location

○ Excavation

The vertical and lateral extents of contamination at the header and POR were determined with measurements of organic vapor concentrations as the excavation progressed outwardly from the POR. To verify removal of NGL contaminated soil, soil samples were collected on July 7, 2004 from the excavation sidewalls at 14-foot bgs, as well as from the bottom hole at 18-foot bgs (*reference Figure 4*). A portion of each sample was field analyzed for organic vapor concentrations

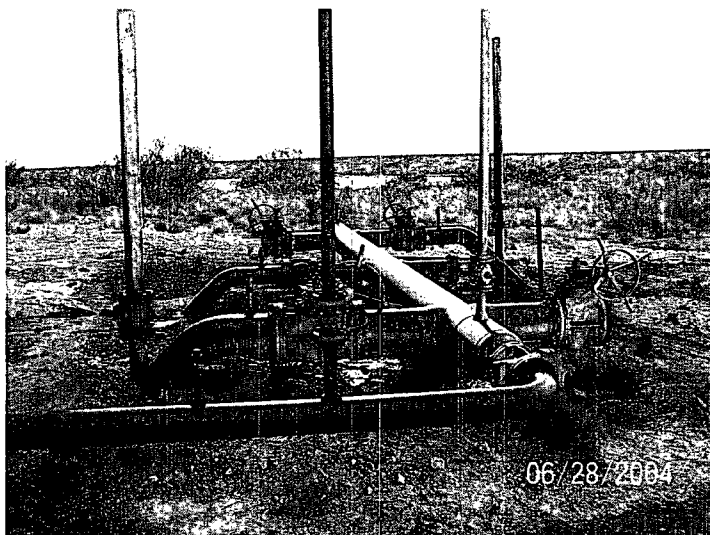
Photo #1: Release area, looking westerly at header.  
Dark soil indicates contamination.

Remediation of the site commenced on June 30, 2004 and continued through July 13, 2004. Remedial activities at the site consisted of the excavation of approximately 1,400 yd<sup>3</sup> of NGL contaminated soil from the site. Approximately 332 yd<sup>3</sup> of NGL impacted soil was transported to the Artesia Aeration landfarm for treatment. The remaining contaminated soil was blended with clean soil purchased from the property owner and obtained from the right-of-way. After laboratory analyses of the excavation sidewalls, floor, soil boring and blending cell sample indicated TPH and BTEX constituent concentrations were below NMOCD remedial thresholds the excavation was backfilled with the blended soil. (*reference Table 1 and Appendix 1*). The backfilling and contouring of the site was completed on July 13, 2004.

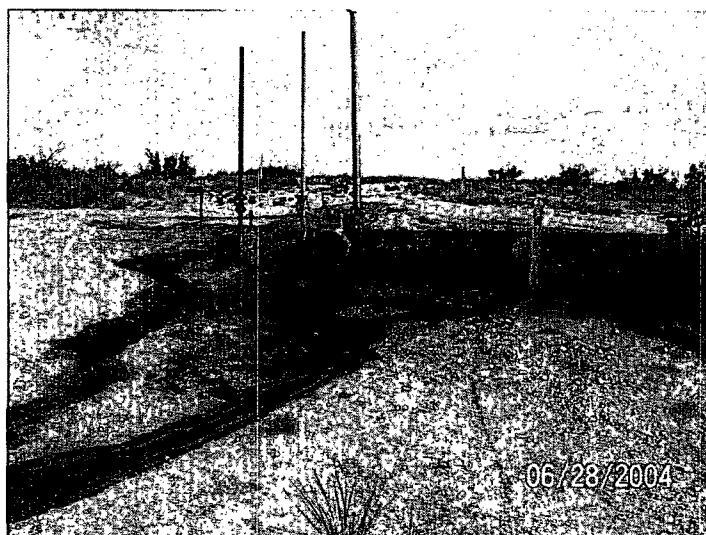
Photo #2: Release area, looking westerly at header. Dark  
soil indicates contamination

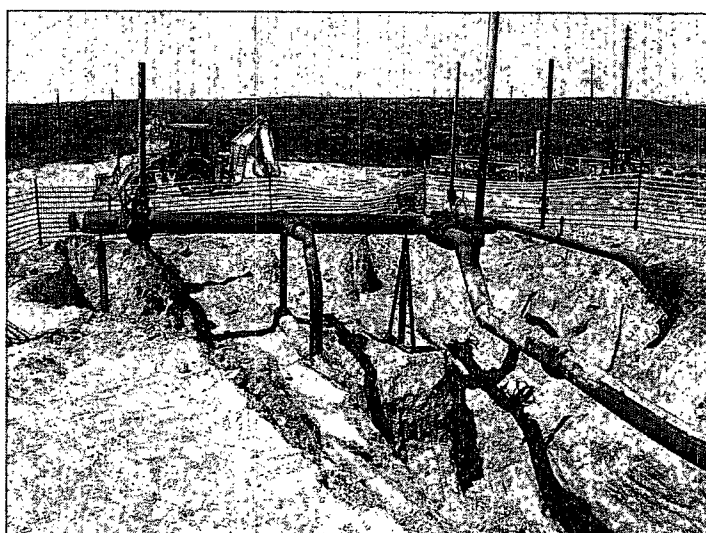
Photo #4: Excavation at header, looking northerly.

Remediation of this site continued at the header area with the excavation of approximately 1,400 cubic yards (yds<sup>3</sup>) of NGL impacted soil from what was ultimately a 2,700-ft<sup>2</sup> excavation, to a maximum depth of 14-feet below ground surface (bgs). Approximately 332 yds<sup>3</sup> of contaminated soil was transported to the Artesia Aeration landfarm for treatment. The remaining NGL impacted soil was blended on site with clean soil purchased from Caviness Family Trust and obtained from the right-of-way. On July 1, 2004, during excavation activities, the header was punctured approximately eight-feet south of the original point of release. The line was repaired and excavation activities resumed. On July 7, 2004, samples were collected from the excavation sidewalls and from a soil boring advanced into the floor of the excavation. A portion of each sample was analyzed in the field for the presence of organic vapors utilizing an UltraRae PID equipped with a 9.8 eV lamp, the remaining portion of each sample was submitted for laboratory quantification of benzene, toluene, ethylbenzene, and total xylenes (BTEX), total petroleum hydrocarbons (TPH), chloride and sulfate. Analytical results indicated that hydrocarbon concentrations were below the NMOCD remedial thresholds (*reference Table 1*). On July 12, 2004, a soil sample was collected from the blended soil with a portion of the sample field analyzed and the remainder of the sample submitted for laboratory analyses. Reported TPH and BTEX constituent concentrations were below NMOCD remedial goals, as stated in the Project Summary above and outlined in Section 3.0. Analytical results indicated chloride and sulfate concentrations in the majority of the soil samples were below remedial goals (*reference Table 1*). The excavation phase of the site remediation commenced on June 30, 2004 and was completed with backfilling and contouring on July 13, 2004.

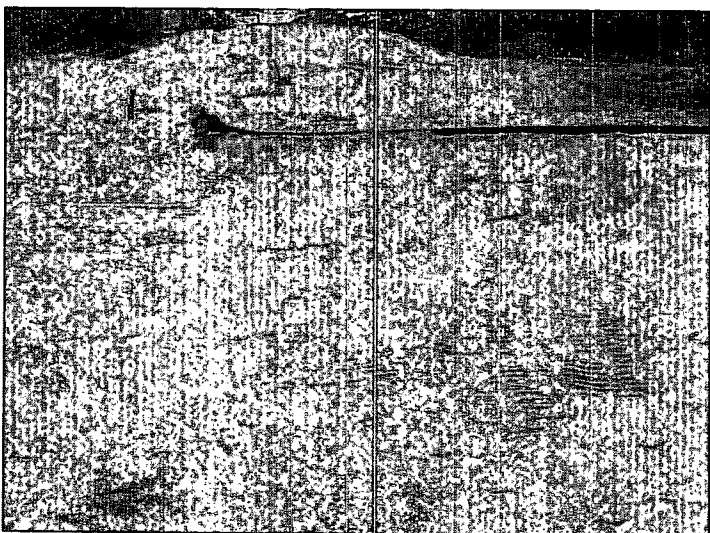
Photo #5: Site graded and contoured, looking northerly.

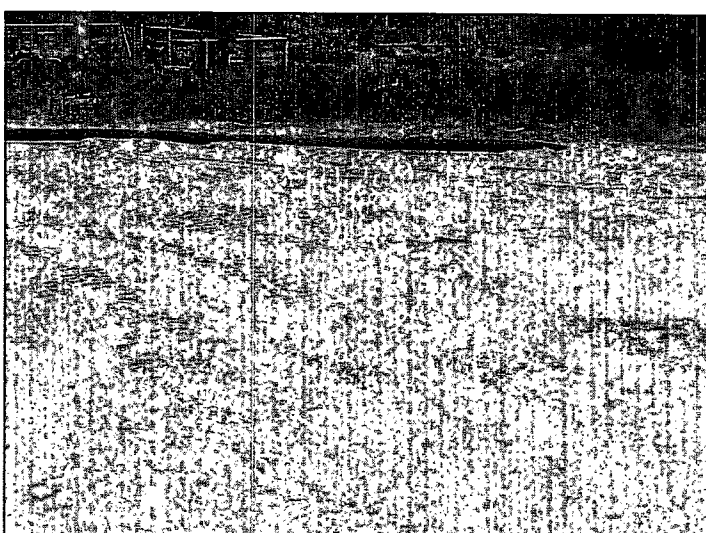
Photo #6: Site graded and contoured, looking northerly.
