SITE INVESTIGATION, REMEDICATION AND FINAL C-141 CLOSURE DOCUMENTATION

J-4-2-7-4 RELEASE SITE

DEFS REF: 130004

LEA COUNTY, NEW MEXICO

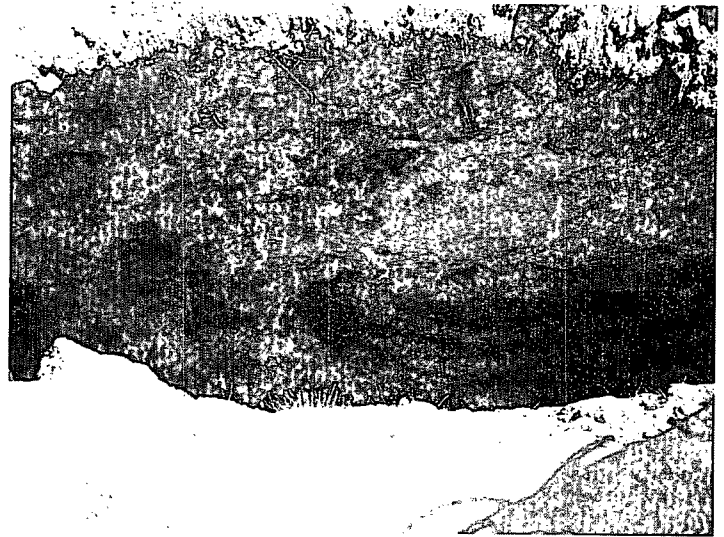
Photo #2: Looking down on north test trench.

Initial activities at the site consisted of delineating the extent of contamination via test trenches. One trench was excavated in the north/south direction and two in the east/west direction. Samples were collected from the trenches and analyzed in the field for the presence of organic vapors utilizing an UltraRae photoionization detector (PID) equipped with a 9.8 electron-volt (eV) lamp. In addition, samples were submitted for laboratory confirmation to ensure the extents of contamination had been delineated.

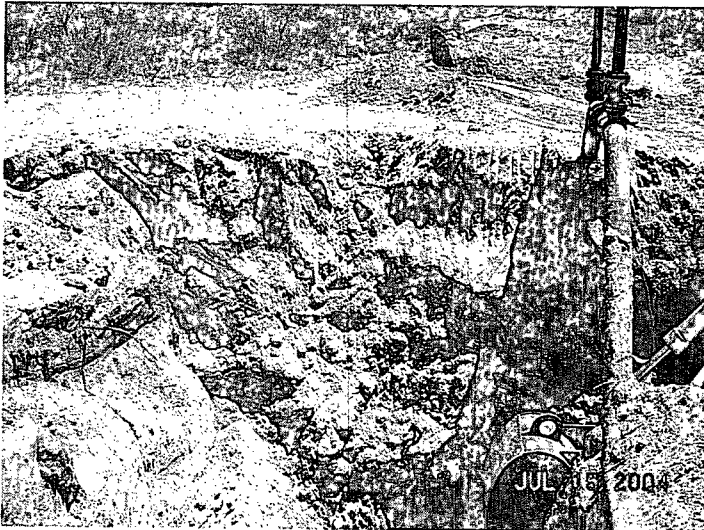
Photo #3: Excavation activities, looking easterly.

Once the extents of contamination had been delineated, remediation activities commenced. Remediation of this site consisted of the excavation of approximately 1,700 cubic yards (yds³) of contaminated soil from what was ultimately a 3,600-ft² excavation, to a maximum depth of 22-feet below ground surface (bgs). Approximately 182 yds³ of contaminated soil was transported to the South Monument landfarm for treatment. The remaining contaminated soil was blended on site with clean soil purchased from Snyder Ranches and obtained from the pipeline right-of-way. The excavation bottom(s) and sidewalls were sampled on July 15-16, 2004 and analyzed in the field for the presence of organic vapors utilizing an UltraRae photoionization detector (PID) equipped with a 9.8 electron volt (eV) lamp and chlorides using LaMotte Chloride Reactant #2. Once field results indicated remedial goals had been achieved, samples were submitted for laboratory quantification of total petroleum hydrocarbons (TPH), benzenes, toluene, ethylbenzene and total xylenes (BTEX constituents), chlorides and sulfates. Analytical results indicated total petroleum hydrocarbon (TPH) concentrations in sample SDEJ427471604NSBH12 obtained from the North Side Bottomhole were above the NMOCD remedial threshold of 100 parts per million (ppm). Excavation activities resumed and another sample (SDEJ427472204NBH13) was collected from approximately one-foot below the impacted sample. Analytical results for this sample indicated all hydrocarbon concentrations were less than the NMOCD remedial thresholds. Chloride concentrations were still in excess of 250 mg/Kg. Excavation resumed until field analyses indicated that chloride concentrations were below 250 mg/Kg. On August 9, 2004, confirmatory composite samples were collected from the excavation bottom and sidewalls and submitted for laboratory analyses. Reported BTEX, TPH, Chloride and Sulfate concentrations were below remedial goals. The excavation phase of the site remediation commenced on July 14, 2004 and was completed with backfilling and contouring on August 23, 2004.

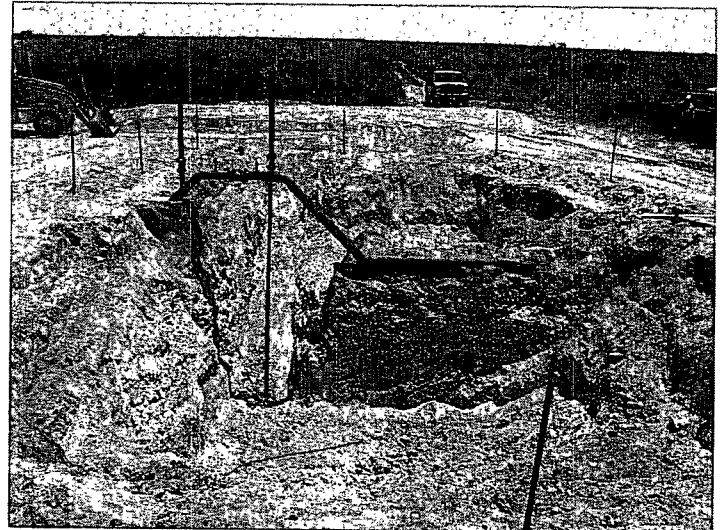
Photo #4: Excavation, looking southerly.

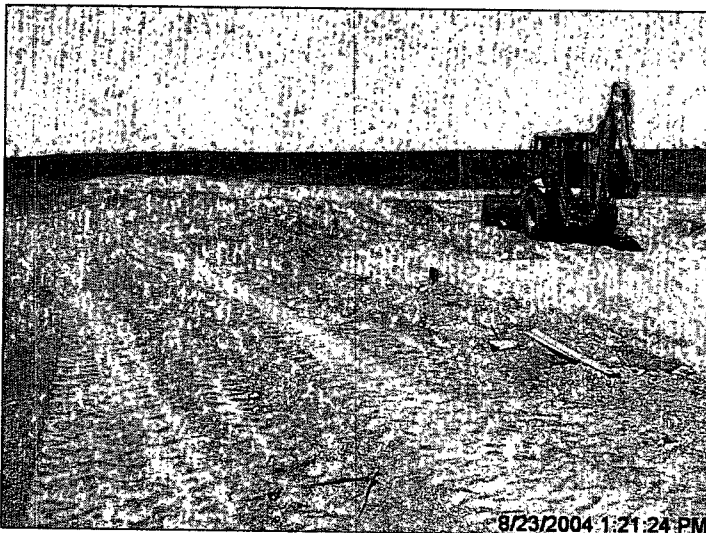
Photo #5: Final grading and contouring, looking northerly.

Remediation of the site commenced on July 14, 2004 and continued through August 23, 2004. Remedial activities at the site consisted of excavation of approximately 1,700 yd³ of NGL contaminated soil from the site. Approximately 182 yd³ of NGL impacted soil was transported to the South Monument landfarm for treatment. The remaining contaminated soil was blended with clean soil obtained from the right-of-way. Laboratory analysis of the blending cell five-point composite sample (BC COMP) indicated analytes were below NMOCD remedial thresholds (reference Table 1 and Appendix I). After laboratory analyses of soil samples collected from the sidewalls and base of the excavation indicated remedial goals had been achieved, the excavation was backfilled with the blended soil. The backfilling and contouring of the site was completed on August 23, 2004.

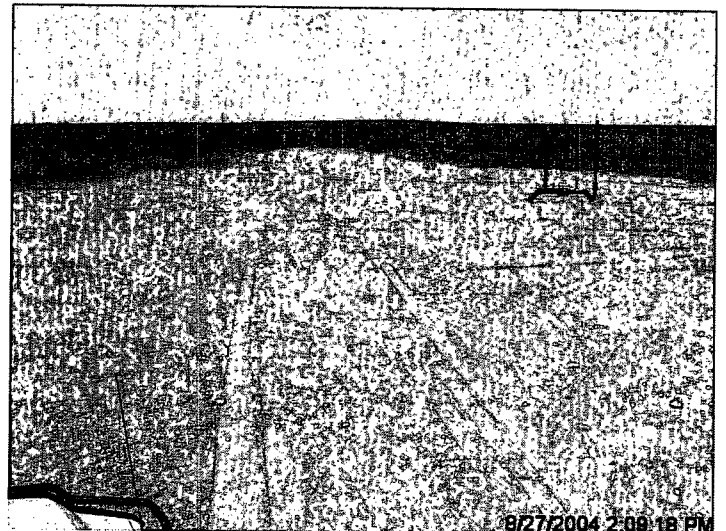
Photo #6: Site graded and contoured, looking northerly.
