**Americo Energy
Denton #1 SWD Mainline
Delineation Report
Unit J, Section 11, Township 15S, Range 37E
Lea County, New Mexico**

September 28, 2004

Safety and Environmental Solutions, Inc. (SESI) was engaged to perform delineation and cleanup services on the Denton #1 SWD Mainline. The site is located in Unit J, Section 11, Township, 15S, Range 37E. The land is owned by Mr. Darr Angell.

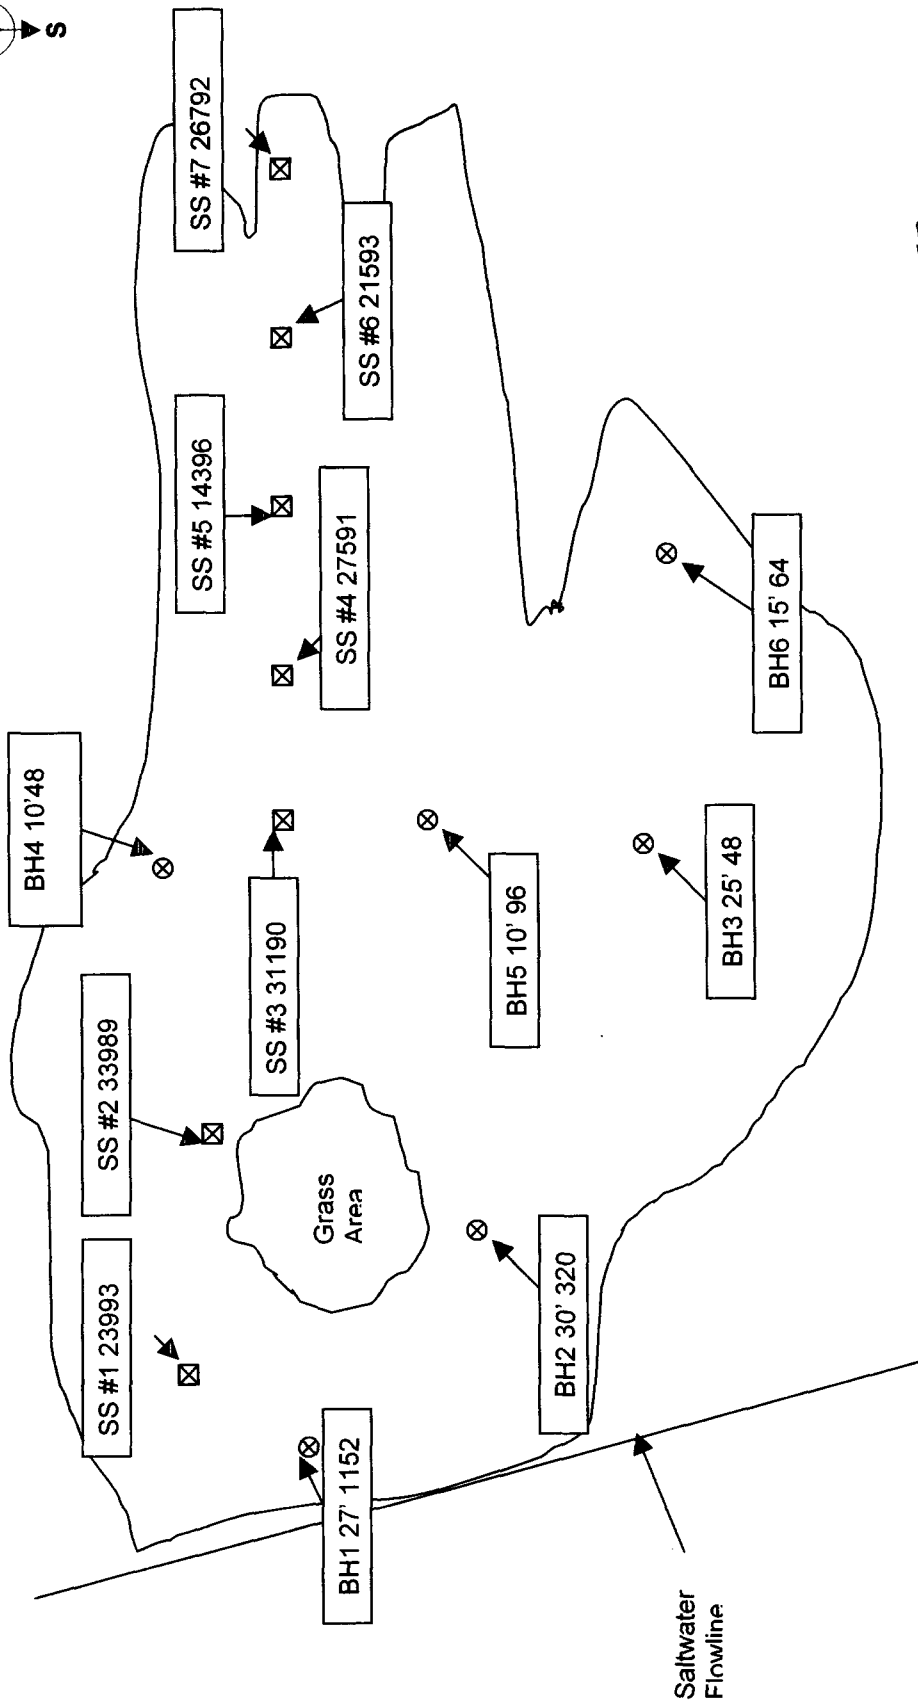
Appendix B
Site Plan

SS- SURFACE SAMPLE

Prod. WTR 53,000

Not to Scale
