**SITE CHARACTERIZATION
AND
PROPOSAL FOR RISK-BASED CLOSURE
G-28-4 (REF. #130002)**

**UL-P (SE¼ OF THE SE¼) OF SECTION 21 T22S R36E
~7.7 MILES SOUTHWEST (BEARING 227°) OF EUNICE
LEA COUNTY, NEW MEXICO**

OCTOBER 2005

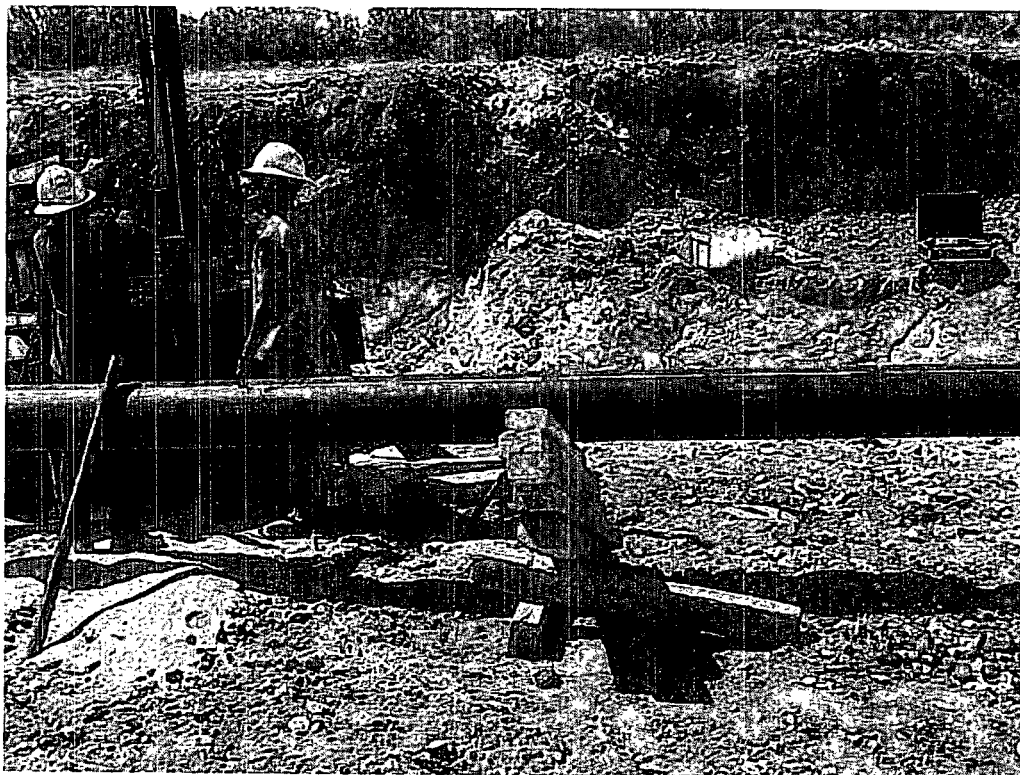
Photograph #6: Advancement of original soil boring, looking southerly.
