HESS CORPORATION

TEXACO JW COOPER BATTERY No. 43 LEA COUNTY, NEW MEXICO

SITE CLOSURE REPORT

May 10, 2007

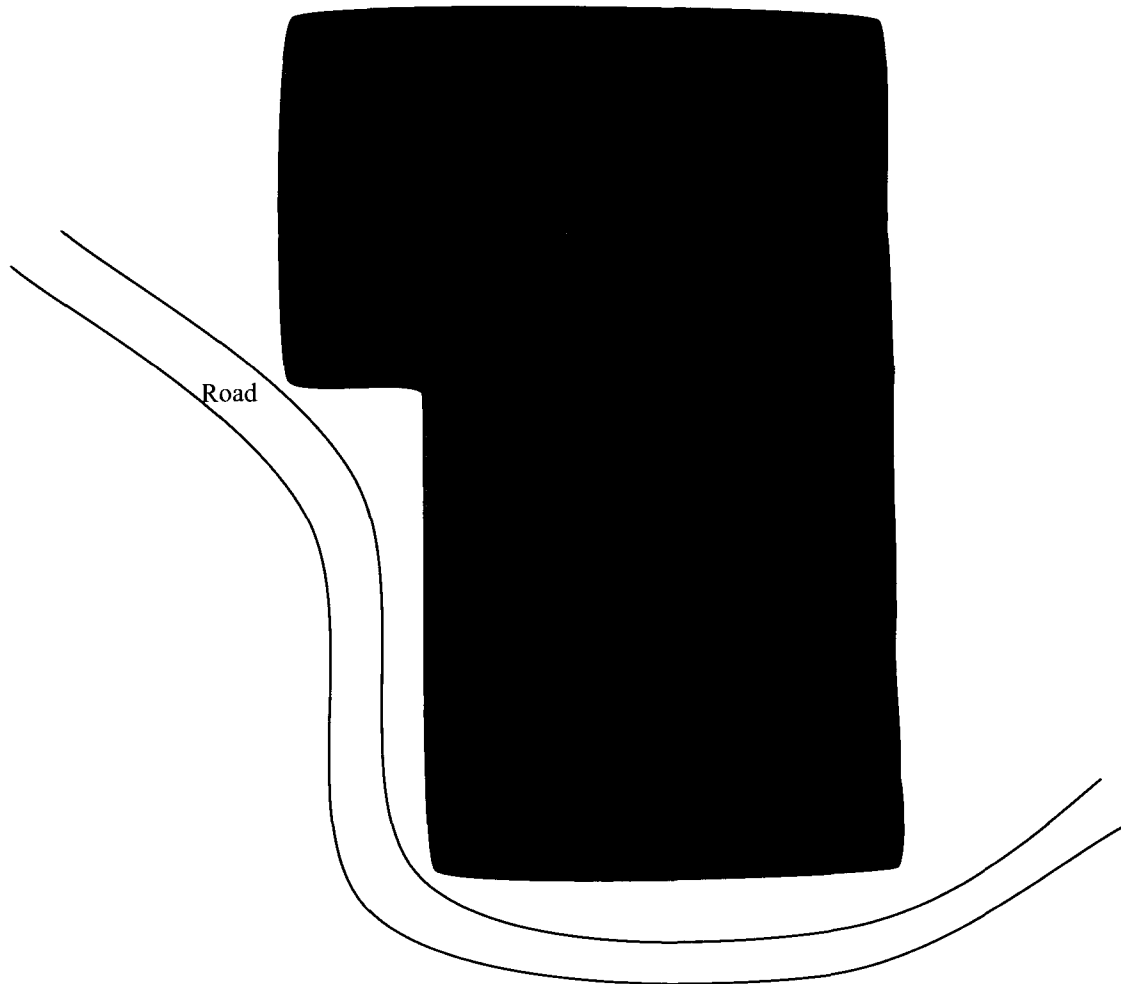
Drilling and Sampling Event – January 24, 2007

On January 24, 2007, three (3) soil borings were advanced at the site and BBC collected soil samples for laboratory analysis. The samples were sent to a laboratory and analyzed for total petroleum hydrocarbons (TPH) – gasoline range organics (GRO)/diesel range organics (DRO), chloride, and benzene-toluene-ethylbenzene-xylene (BTEX).

The first soil boring, SB1, was placed in the center of the associated pit located at the north end of the site. All site diagrams depicting sample points can be found in **Appendix I**. Five (5) samples were collected from SB1. The samples nearest the surface, labeled SB1-4' and SB1-6', were non-detect for GRO/DRO and BTEX. Chloride was at or less than 16 parts per million (ppm). SB1-8.5' contained 193 ppm GRO, 6,520 ppm DRO, less than 16 ppm chloride, 0.127 ppm benzene, 0.303 ppm toluene, 0.309 ppm ethylbenzene, and 1.21 ppm total xylenes. Laboratory analyticals can be found in **Appendix II**, site photographs can be viewed in **Appendix III**, and drilling logs can be found in **Appendix V**. SB1-15' and SB1-20' were non-detect for GRO and BTEX. SB1-15' contained

175 ppm DRO and 64 ppm chloride. SB1-20' contained 65.5 ppm DRO and 304 ppm chloride.

SB2 was placed in the center of the tank pad at the south end of the site. Four (4) samples were collected from SB2 from seven (7) feet below ground surface (bgs) to twenty (20) feet bgs. All four (4) samples were non-detect for GRO/DRO, chloride, and BTEX.

SB3 was placed in the northeast corner of the site, east and just north of SB1. Two (2) samples were collected from SB3 at seven (7) and ten (10) feet bgs. Both samples were non-detect for GRO/DRO, chloride, and BTEX.

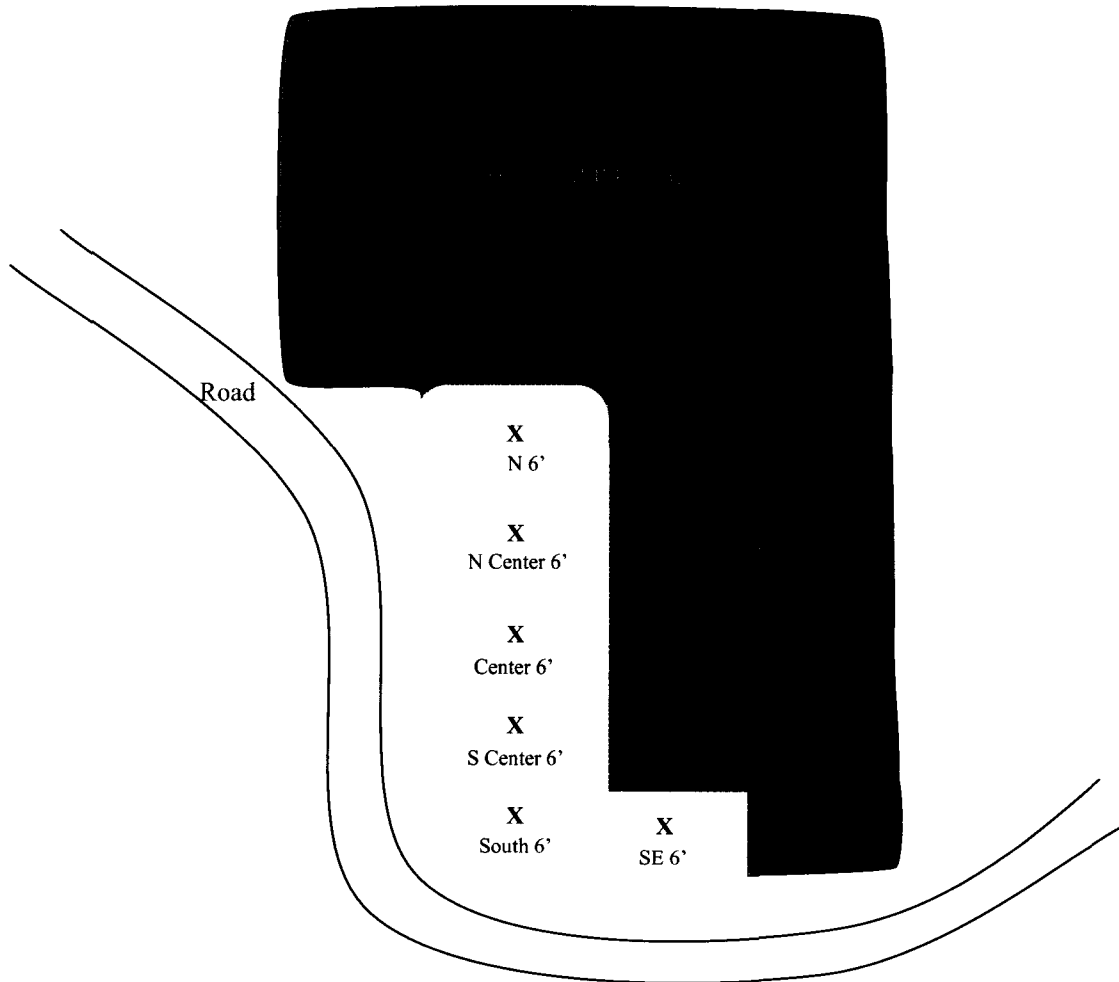
Sampling Event – February 8, 2007

Excavation began at the south end of the site along the west edge. On February 8, 2007, BBC collected six (6) soil samples from the floor of the excavation at six (6) feet bgs. The samples were within guidelines with the exception of the northernmost sample, labeled N 6', and the southernmost sample, labeled SE 6'. The sample N 6' was non-detect for GRO and chloride, DRO was 554 ppm, benzene was 0.004 ppm, toluene was 0.006 ppm, ethylbenzene was 0.012 ppm, and total xylenes were 0.107 ppm. The sample SE 6' was non-detect for GRO, chloride, and BTEX, however DRO was 212 ppm.

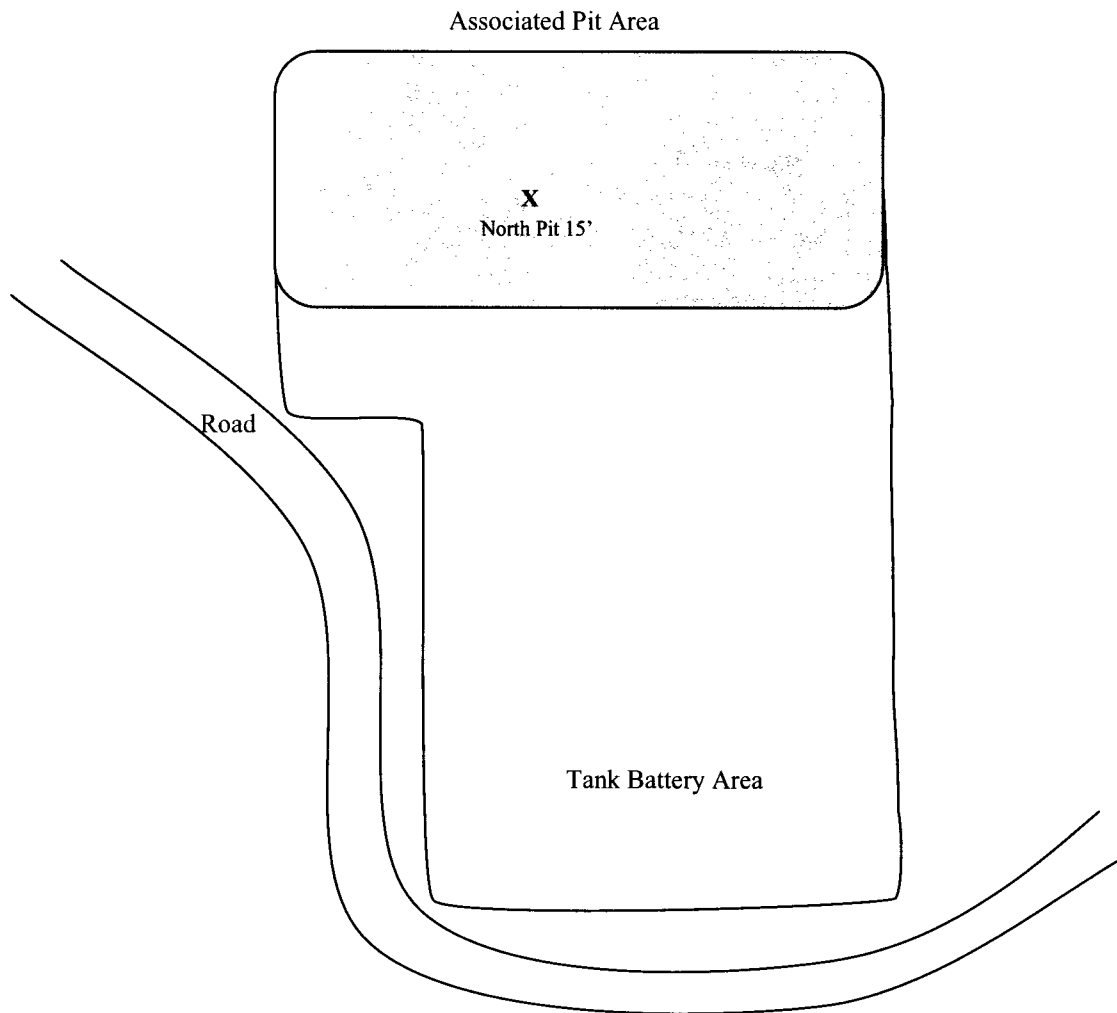
Sampling Event – March 9, 2007

The remaining southeast quarter of the site was excavated to six (6) feet bgs as well. The associated pit on the north side of the site was excavated to fifteen (15) feet bgs. On March 9, 2007, BBC collected a sample from the floor of the associated pit. This sample, labeled North Pit 15', contained 404 ppm GRO, 3,330 ppm DRO, 16 ppm chloride, 0.116 ppm ethylbenzene, and 0.664 ppm total xylenes.

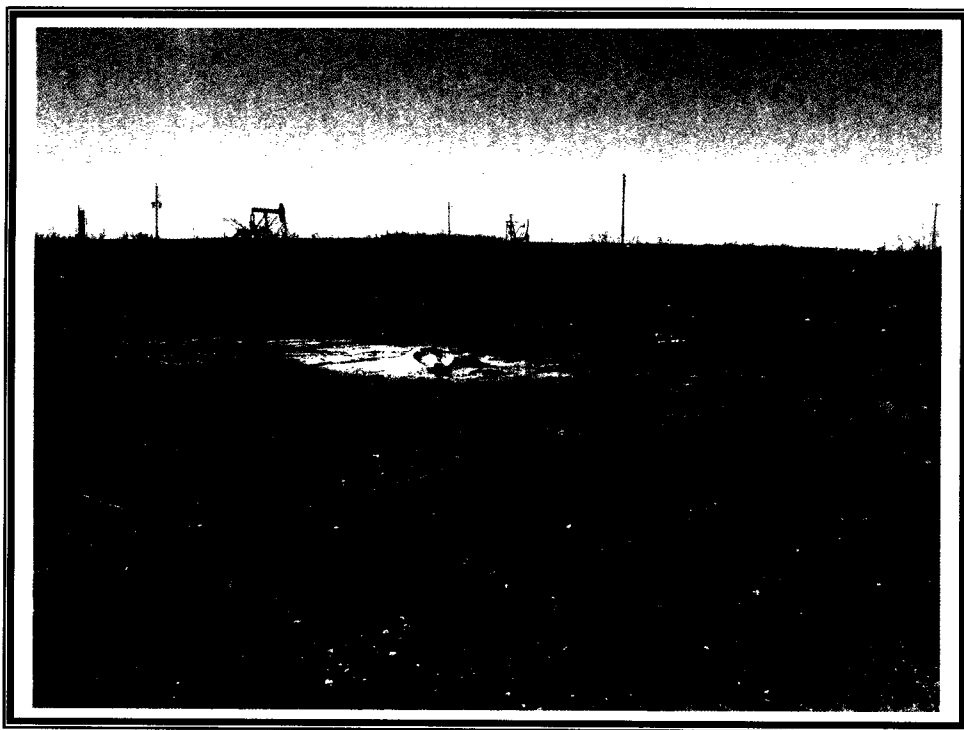
Location of SB1 at north end of Texaco JW Cooper Battery #83

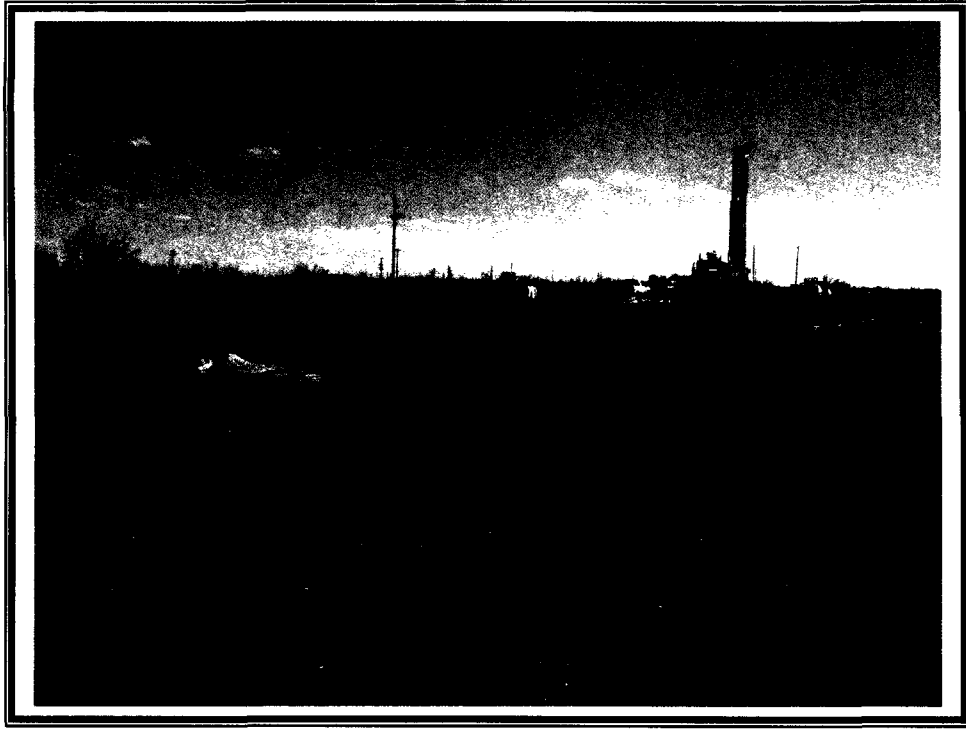
SB1 in foreground. Drilling rig in location of SB2 at south end of
Texaco JW Cooper Battery #83

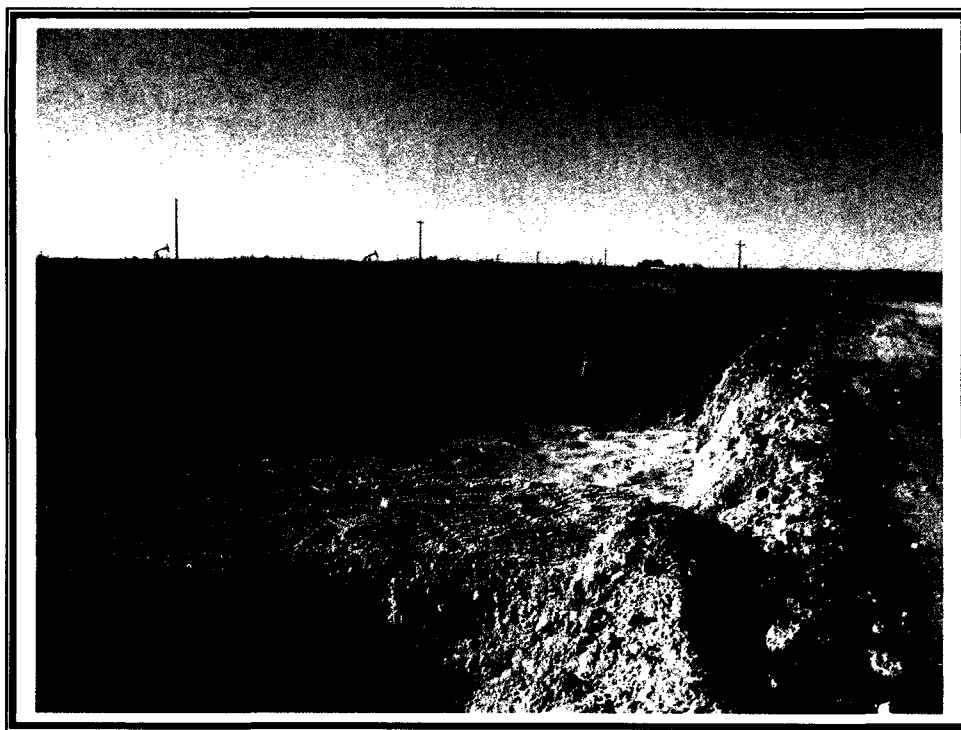
15' associated pit on north end of tank battery excavation

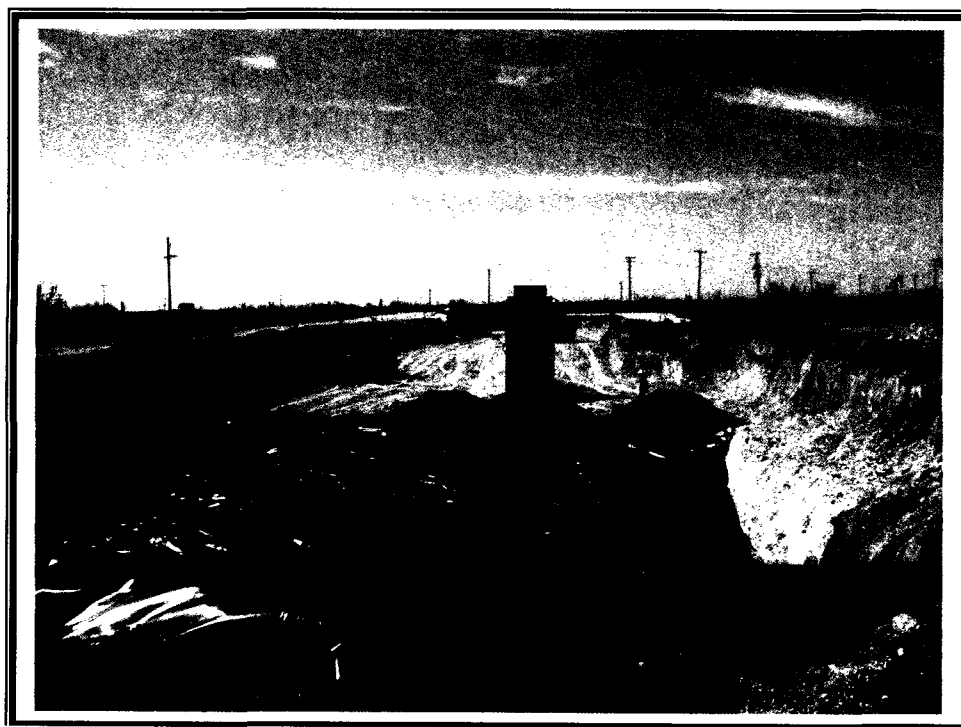
Installation of plastic liner in associated pit at north end of tank battery excavation

Backfilling and contouring of the site was completed on May 1, 2007 with a total of 25,452 cubic yards of clean soil. The north excavation and associated pit were lined with topsoil before and after installation of the plastic to prevent rupture of the liners by caliche rock in the floor of the excavations. The excavation was backfilled with caliche to three (3) feet bgs. The remaining volume to the surface was completed with topsoil and contoured to grade. The site will be reseeded.

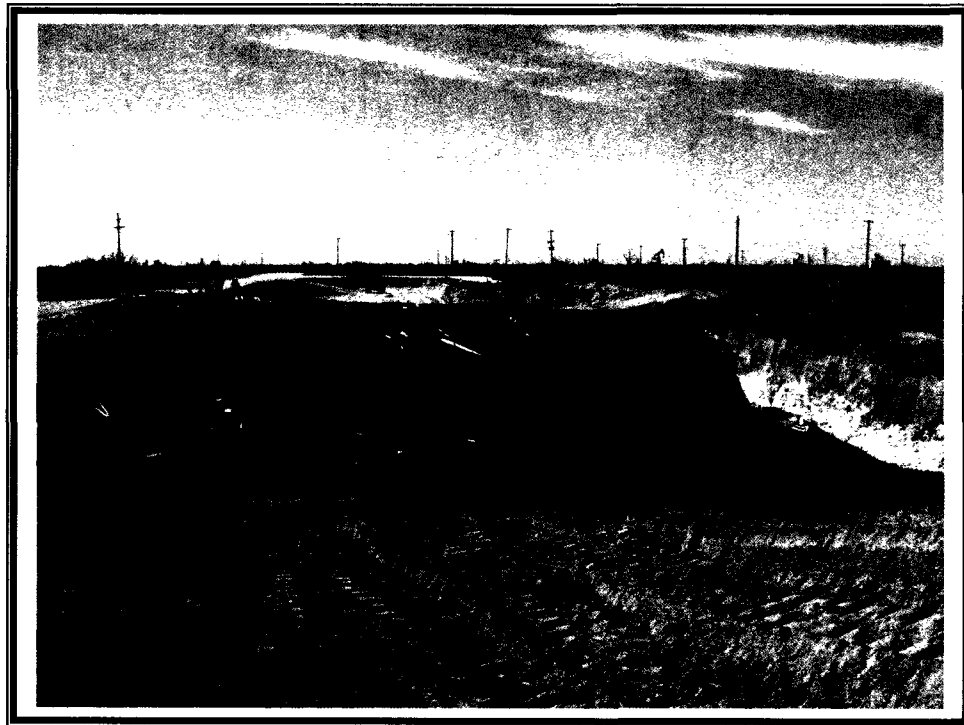
Plastic liners installed in both the tank battery excavation (background)
and the north excavation (foreground)

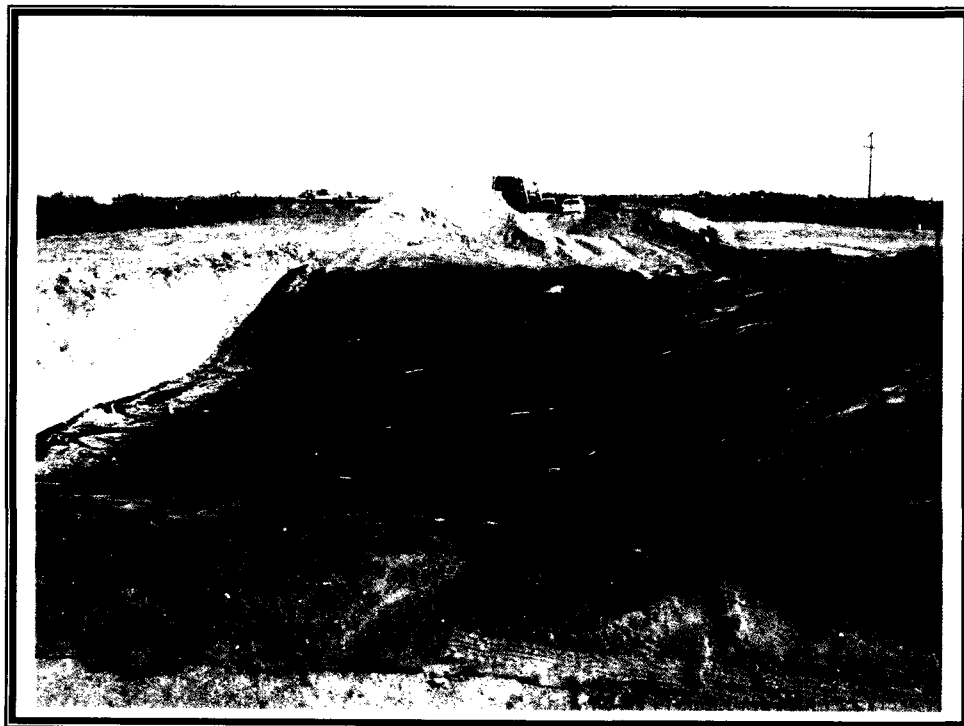
North excavation of Texaco JW Cooper Battery #83
