HESS CORPORATION

TEXACO KEOHANE "A" BATTERY No. 6 LEA COUNTY, NEW MEXICO

SITE CLOSURE REPORT

May 4, 2007

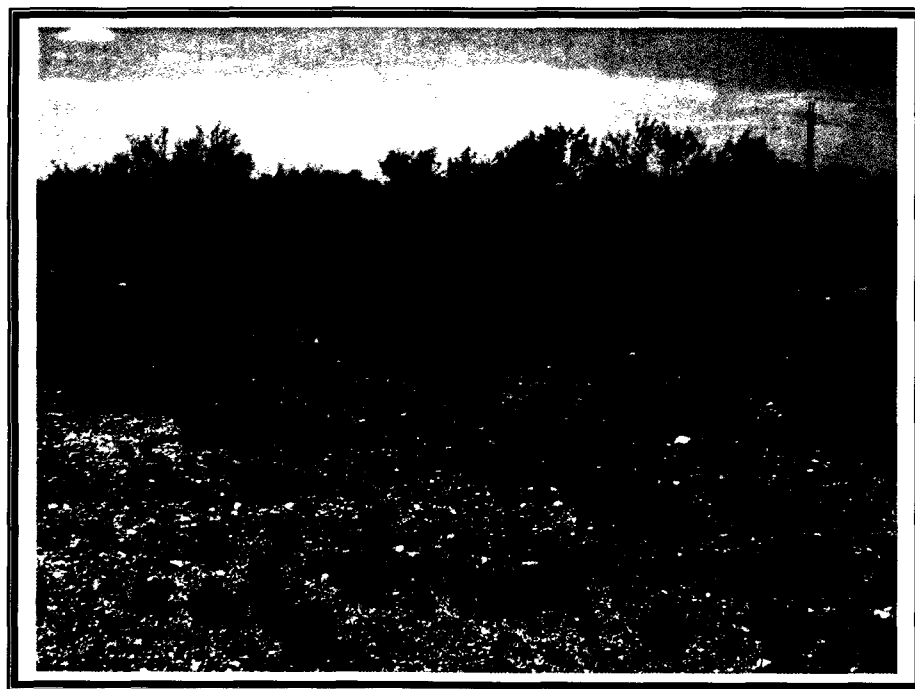
Texaco Keohane "A" Battery 6

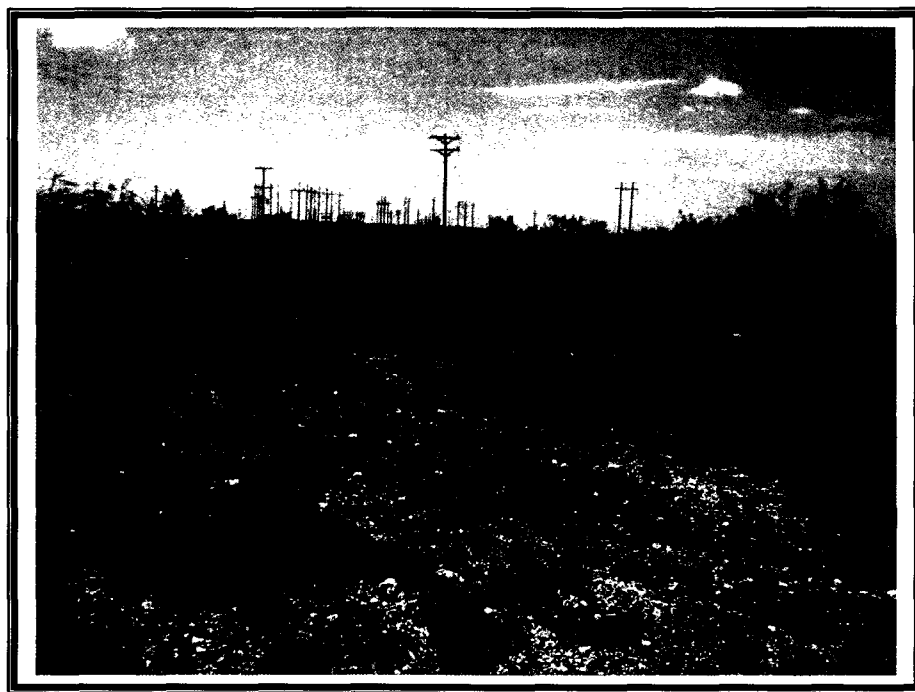
West end of Texaco Keohane "A" Battery 6

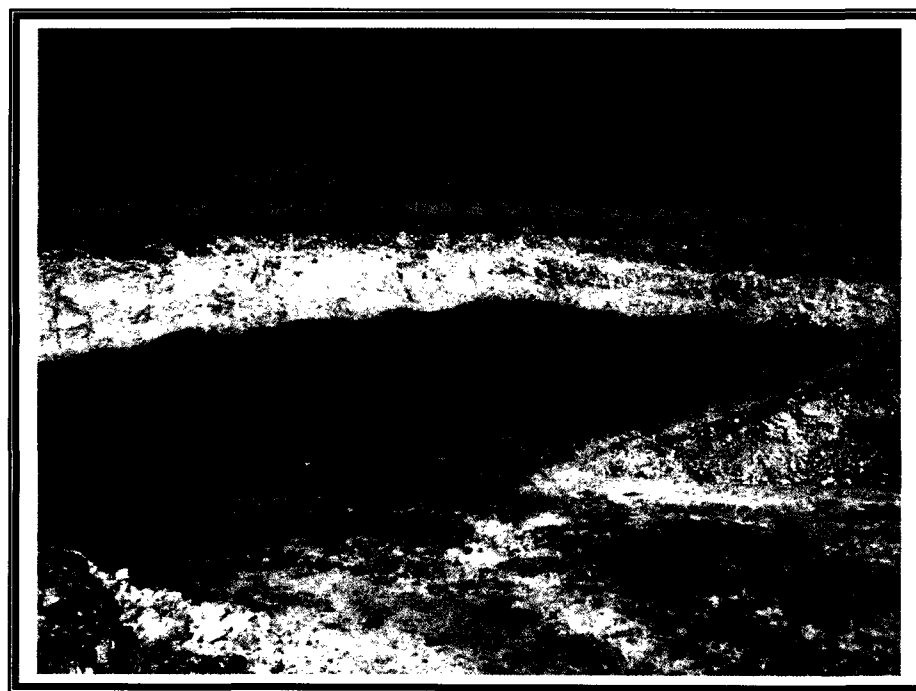
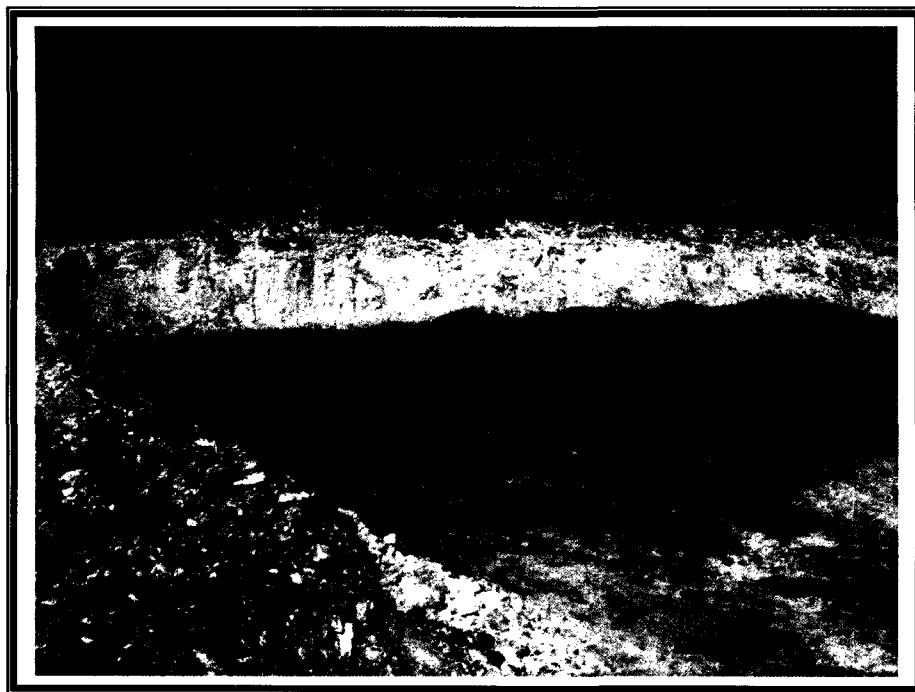
Clay liner inside associated pit excavation

Backfilling and contouring of the site was completed on March 30, 2007 with a total of 21,116 cubic yards of clean soil. The clay liner in the associated pit totaled 480 cubic yards. Both the associated pit and tank battery excavations were backfilled with 10,796 cubic yards of caliche to three (3) feet bgs. The remaining volume was completed with 9,840 cubic yards of topsoil and contoured to grade. The site will be reseeded.
