HESS CORPORATION

CHEVRON WILLIAMS BATTERY No.43 LEA COUNTY, NEW MEXICO

SITE CLOSURE REPORT

Chevron Williams Battery No.43

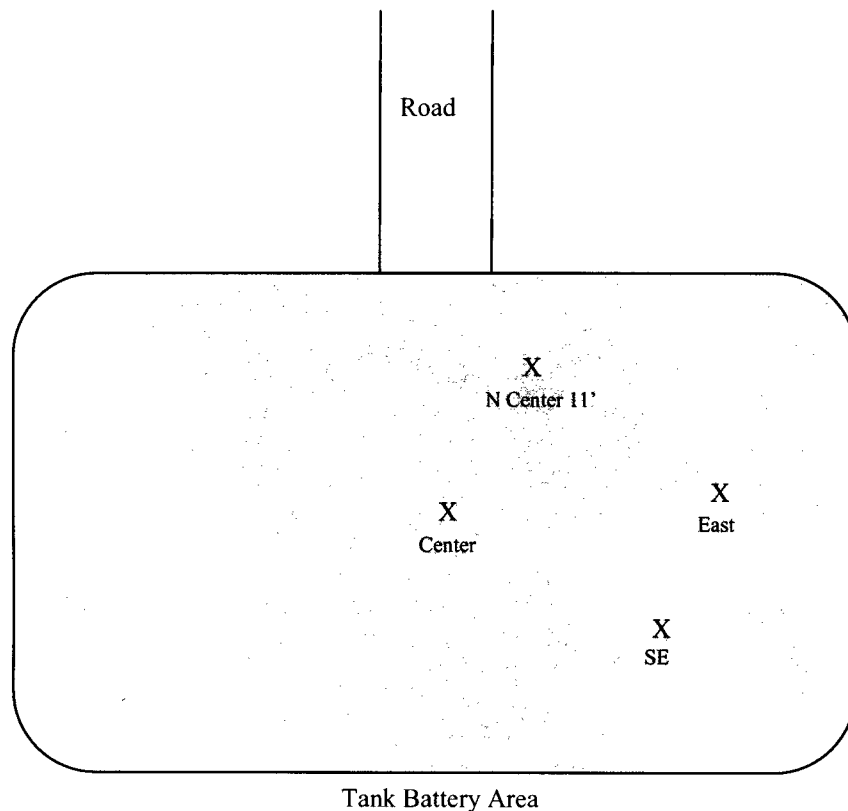
Chloride Field Screen and Sampling Event – March 15, 2007

On March 15, 2007, BBC personnel performed chloride field screens on the center and east areas of the excavation. One sample in the northeast corner of the excavation showed a field screen of less than 200 ppm. This sample, labeled N Center 11', contained 96 ppm after laboratory analysis. Further field screens in the remaining area revealed that the soil contained chloride from 600 ppm to 1,400 ppm.

Excavated 5 to 11 feet below ground surface

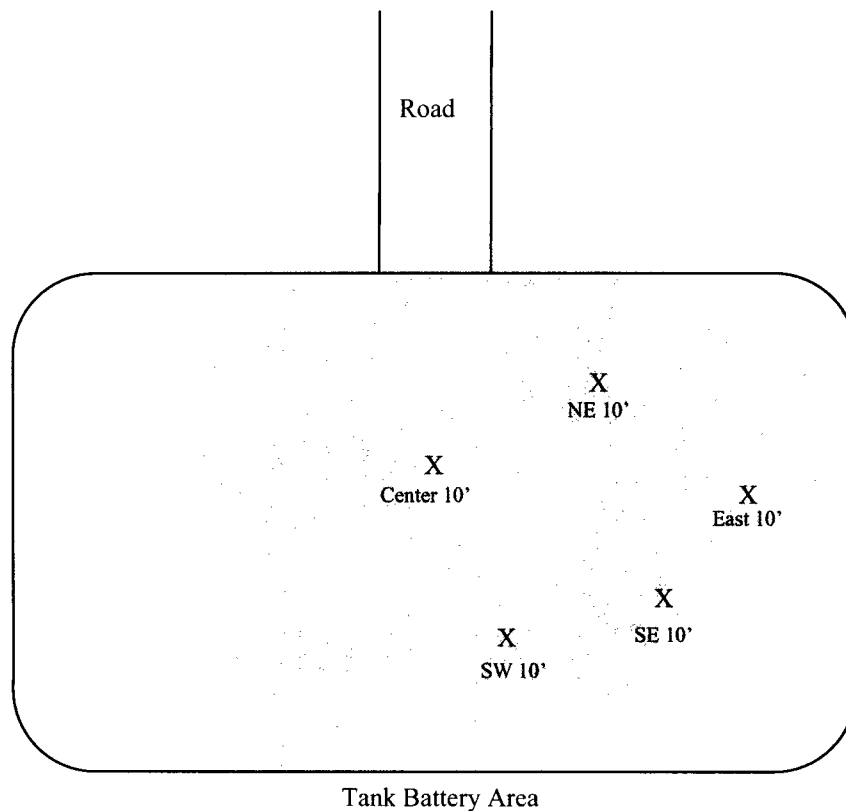
Sampling Event – April 5, 2007

The center and east areas were excavated to ten (10) feet bgs. Five (5) samples were collected from the floor of the ten (10) foot excavation on April 5, 2007 and submitted to a laboratory for chloride analysis only. Chloride ranged from 128 ppm to 336 ppm.

Excavated 5 to 11 feet below ground surface

On April 12, 2007 after reviewing soil sample analytical results, NMOCD verbally approved backfill of the site with the condition that Hess would install a one foot thick clay liner in the center and east areas of the excavation before backfilling.

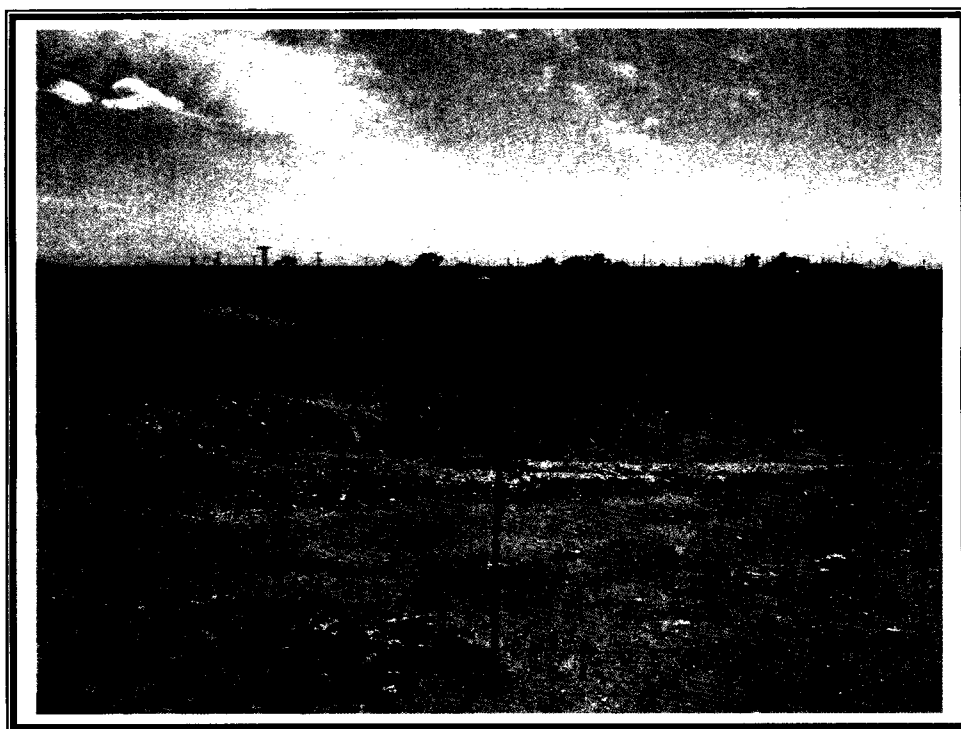
East end of Chevron Williams battery #43 excavation

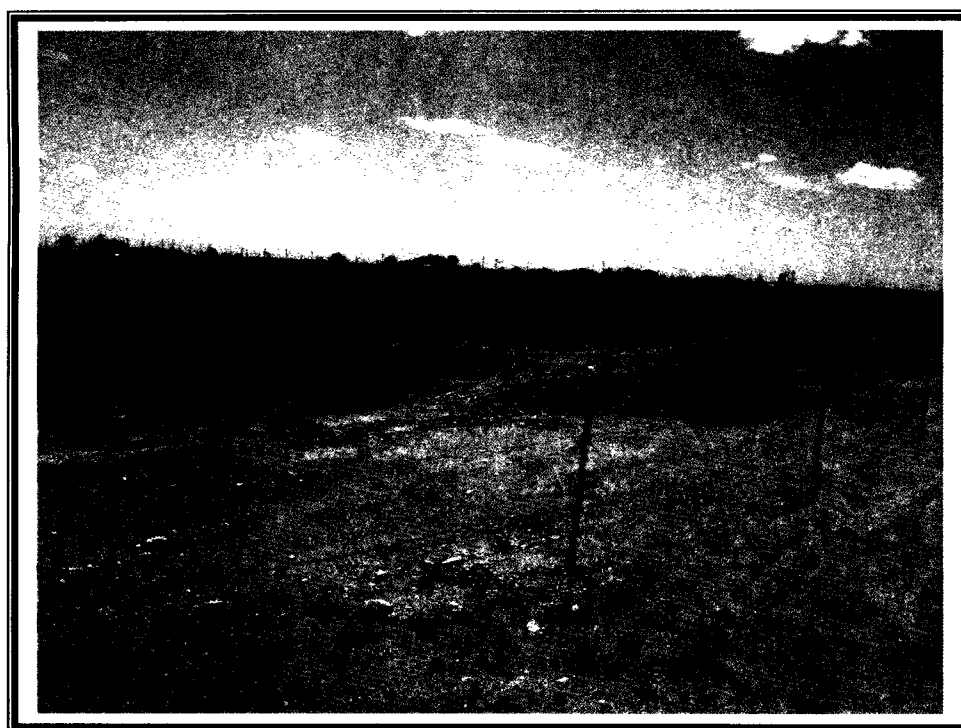
Central and west areas of Chevron Williams battery #43 excavation
