SITE CLOSURE REPORT

**QUAIL QUEEN SWD No. 001
(QUAIL STATE SWD)**

**EPI REF: #160030
NMOCD REF: 1RP #748**

MARCH 2007

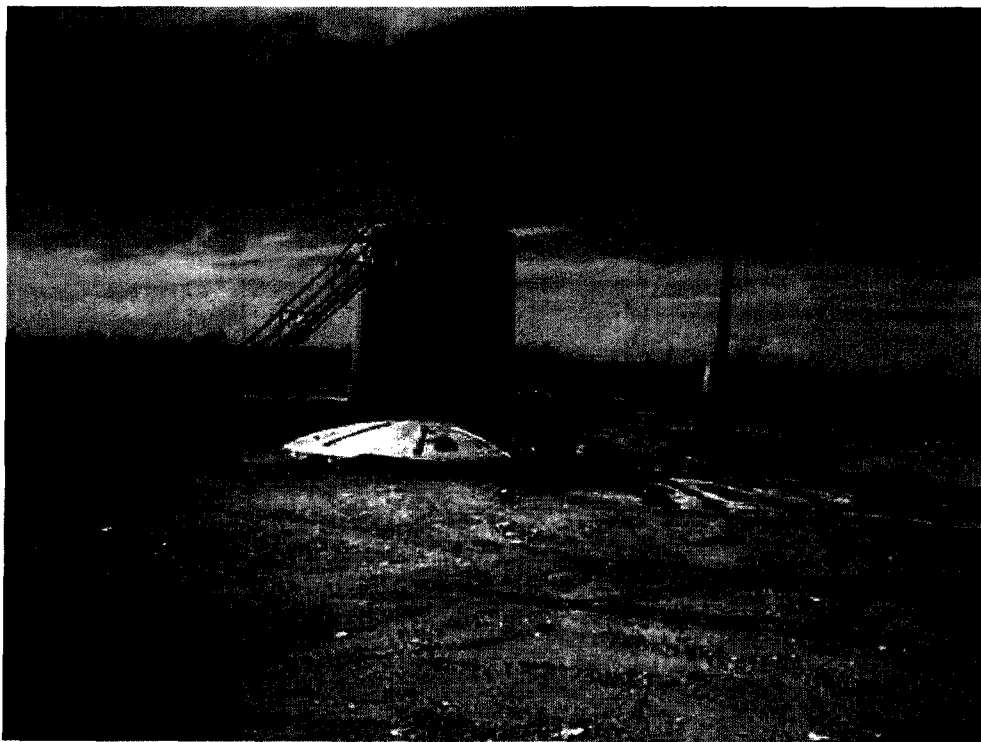
Photograph #2- Looking westerly at fiberglass tank with top in foreground. Fluid and dark stained soil indicate contamination.

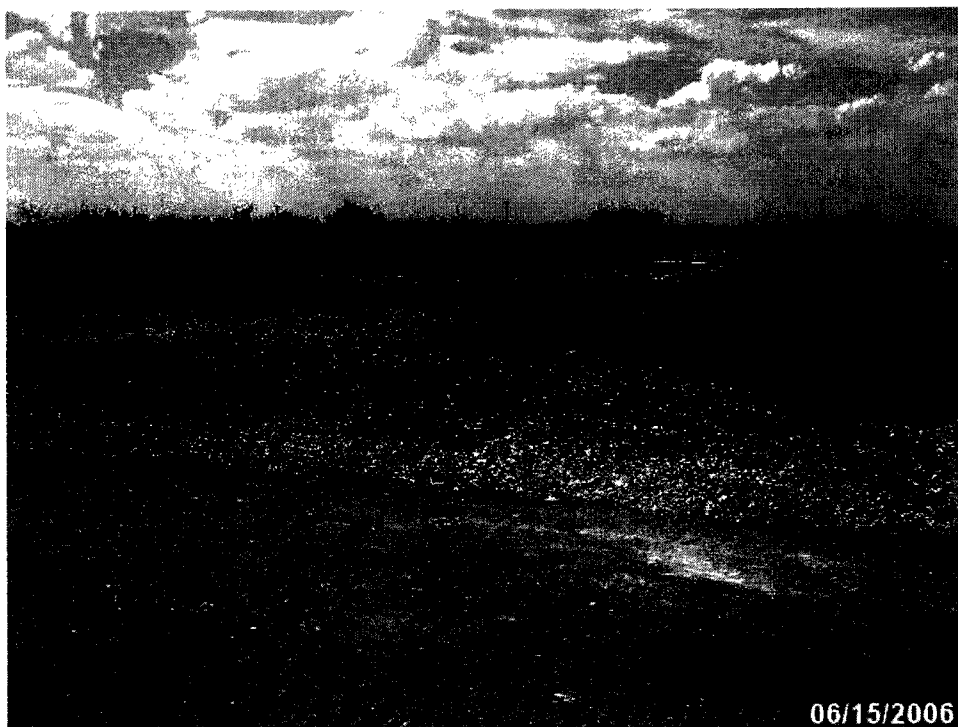
06/15/2006

Photograph #5 – Looking easterly at excavation and stockpile.

EPI removed impacted soil from the release area from June 14 through July 31, 2006 and December 19, 2006 through December 21, 2006. Approximately 2,234 yds³ of impacted soil were excavated from the release area with disposal at Lea Landfill, Inc. Due to existing tank battery facilities (tankage, heater treaters, flow lines, SWD well head, road, etc.), the release area was divided into three (3) separate areas (reference *Figures 5, 7, 8*). After extracting impacted soil to a depth of approximately one (1) foot within the perimeter of the north release area, six (6) each soil samples were collected on June 15, 2006 and June 16, 2006 from the sidewalls of the excavation and analyzed in the field for organic vapor and chloride concentrations utilizing methods outlined in Section 4, *Subsurface Soil Investigation*. All twelve (12) soil samples indicated concentrations of organic vapors were below 100 ppm, but exceeded site remedial threshold goals for chloride concentrations of 250 mg/Kg. The bottom and sidewalls of the excavation were over-excavated due to high chloride concentrations. Thirteen (13) soil samples were collected from the bottom of the north area excavation on June 28, 2006 with ten (10) soil samples transported to an independent laboratory for analyses of chlorides. Field analyses of the thirteen (13) soil samples indicated organic vapors were below 100 ppm, but chloride concentrations exceeded site threshold goals of 250 mg/Kg. Laboratory analytical results of the ten (10) soil samples exceeded site threshold goals for chloride concentrations of 250 mg/Kg. Excavation of the north release site sidewalls continued from June 28 to July 5, 2006 as field analyses indicated elevated chloride concentrations. On July 6, 2006 four (4) Test Trenches were excavated to varying depths within the northern area release confines to delineate the vertical extent of chloride impacted soil (reference *Figure 6*). Soil samples collected from the four (4) Test Trenches were transported to an independent laboratory for analyses of chloride concentrations. Laboratory analytical data for Test Trench No.1 indicated four (4) samples collected at various depths (4-, 7-, 11- and 16-feet bgs) were above site remedial threshold goals of 250 mg/Kg. Soil samples collected from four (4) feet bgs

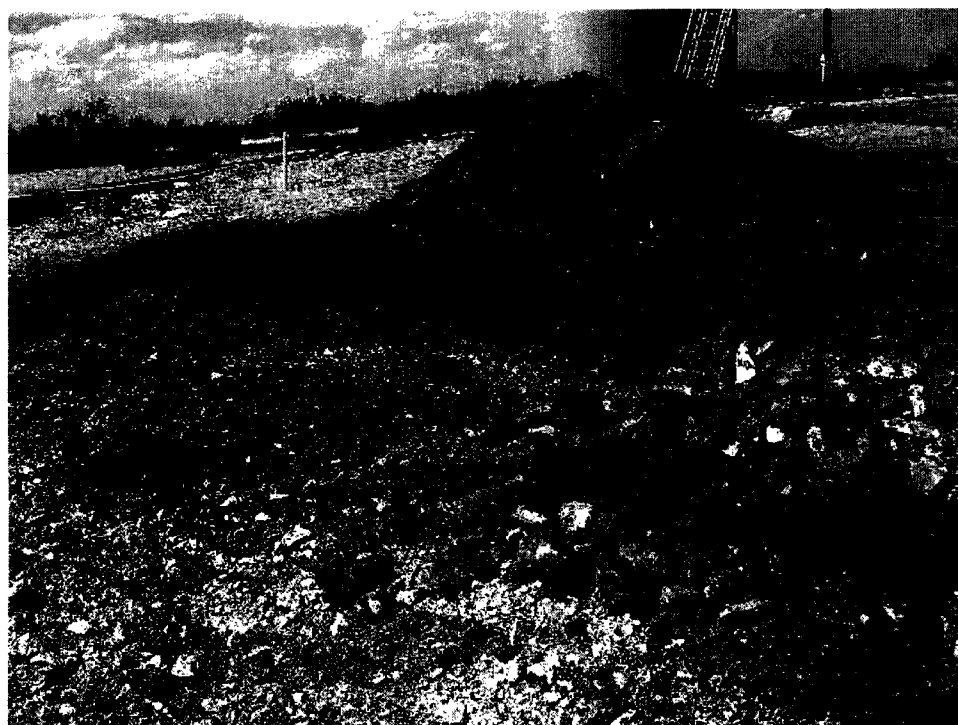
Photograph #6 – Looking northeasterly at excavation and stockpile.

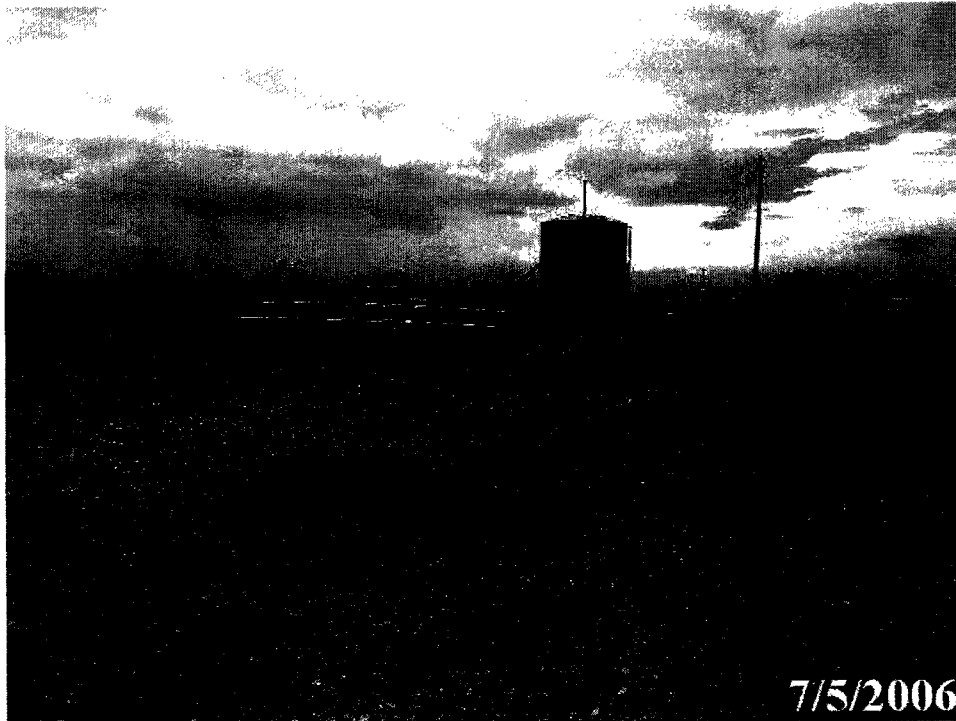
Photograph #7 – Looking northwesterly at excavation and tank battery.

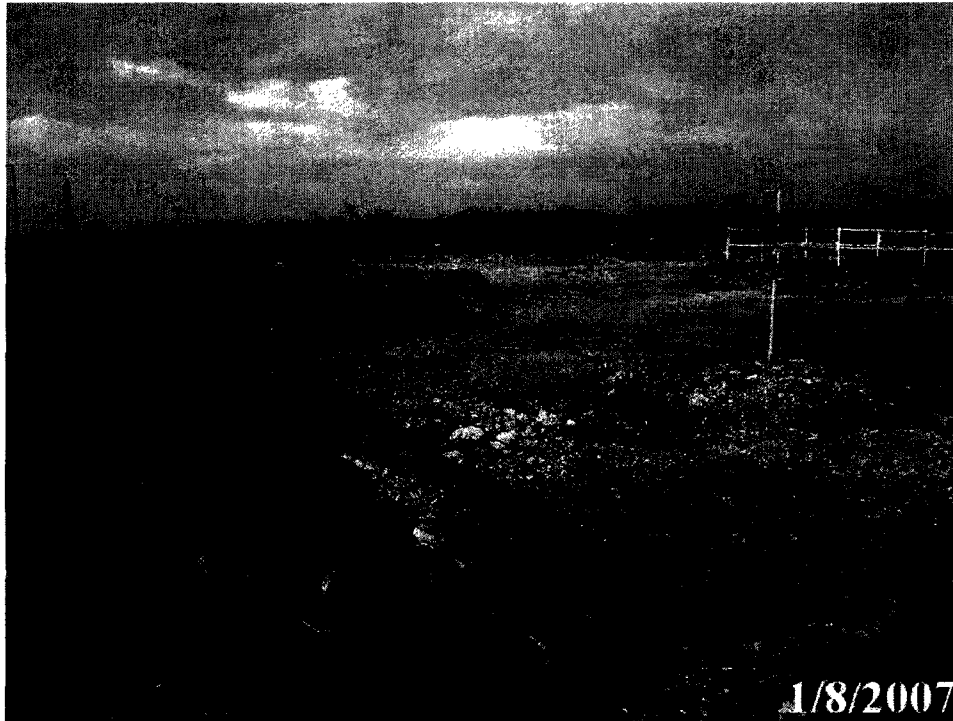
Photograph #9 - Looking northwesterly at northern excavation.

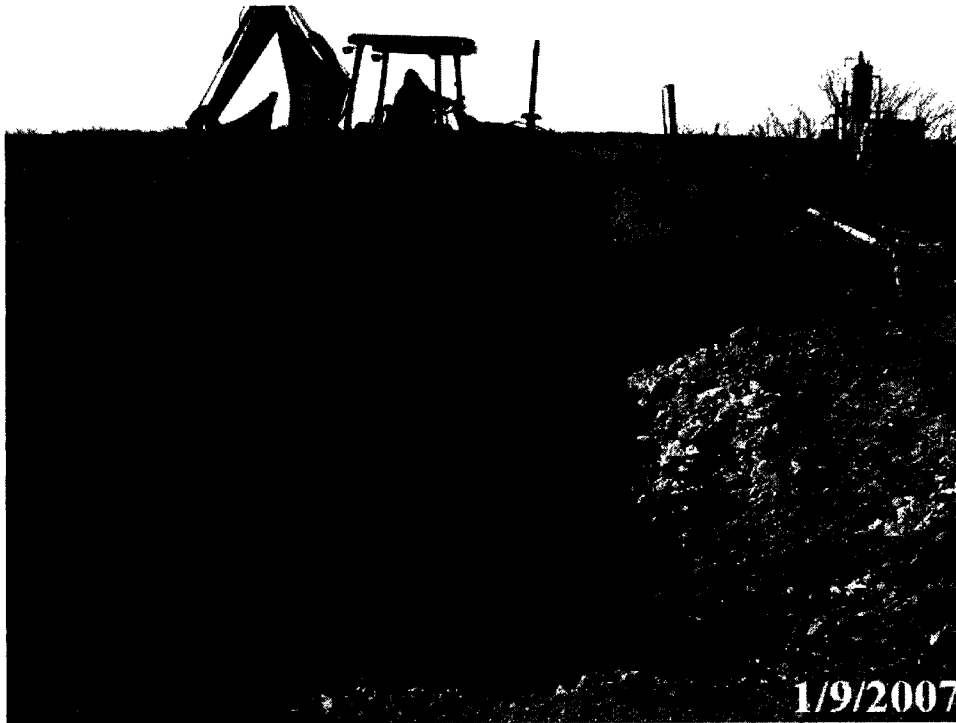
Photograph #11 – Looking westerly at backfilling of southern excavation.
