**XTO Energy
EMSU-B Injection Line #2
Unit B, Section 14, Township 20S, Range36E
Lea County, New Mexico
Delineation Report and Work Plan**

April 22, 2014

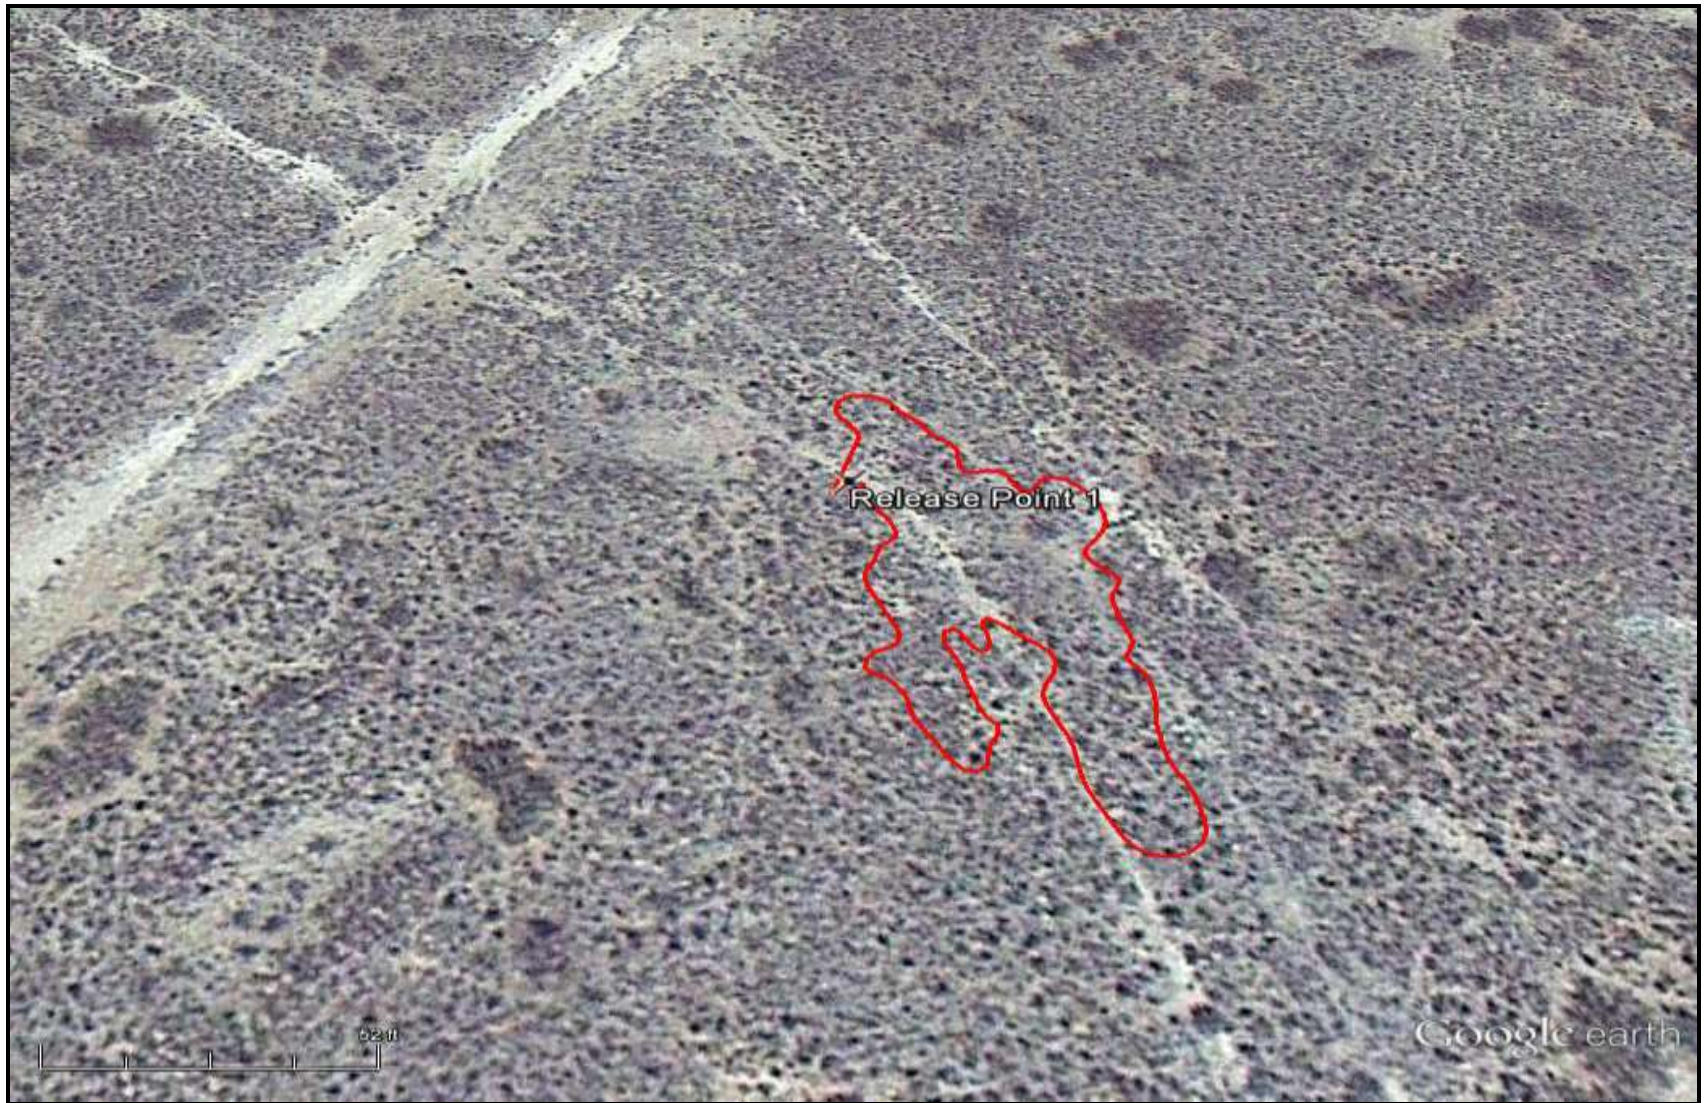
Figure 2
Site Plan Showing Extent of Release

Safety and Environmental Solutions, Inc. (SESI) was engaged by XTO Energy to perform delineation services at the EMSU-B Injection Line #2 release site (Figures 1 and 2). This release occurred at a location in Unit Letter B, Section 14, T20S, R36E (32.577816N, 103.322627W). An estimated 10 barrels of produced water were released with zero barrels recovered. The affected area from the release is estimated at 4,270 square-feet.

The location of these samples is shown in Figure 5. Some sample points are shown by location and by sample results to be outside the spill release footprint. These include SP 1, 2, and SP 6. SP-9 is located on the periphery of the release. Because the area has been disturbed, the spill footprint outline is not visible. Before excavation, it will need to be located using measurements from the site map (Figure 2).

The spill area will be excavated to a depth of 3 ft. and removed to an NOCD approved facility for disposal. In addition the soil pile from the existing small excavation will also be removed for disposal. Confirmation samples from the side and bottom of the excavation will be taken, these samples will confirm that the horizontal extent of contamination has been reached and document the level of chloride being left in place. A 20 mil

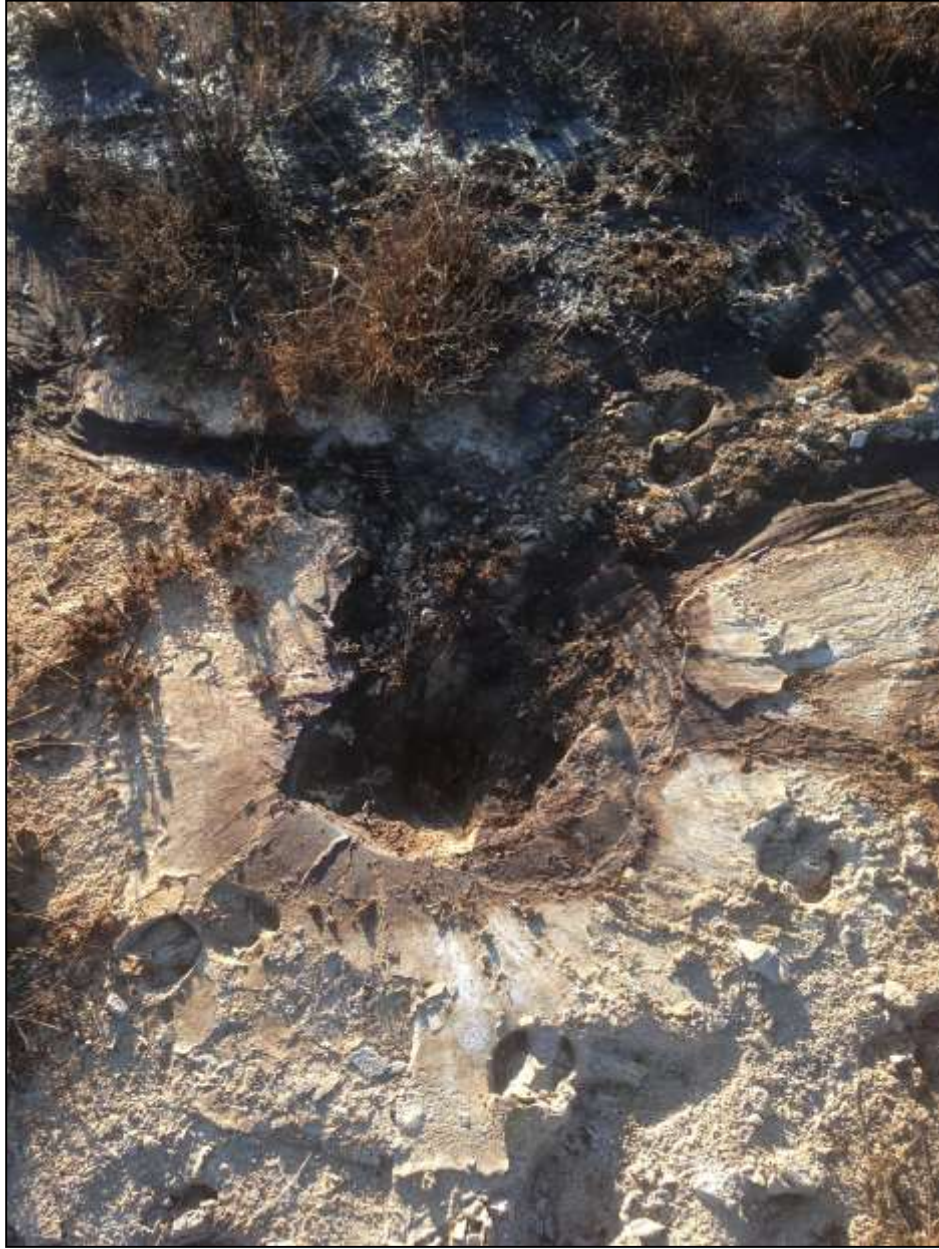
Photo #1 – Release Point

On August 12, 2013 SESI was onsite to delineate the vertical extent of the release. The leak in the injection line was located by excavating the pipeline and soil samples were taken from the excavation using a trackhoe. Four samples were taken at 5 ft. intervals to a depth of 20 ft. below the spill area. The samples were properly preserved and transported under Chain-of-Custody to Cardinal Laboratories for analysis. The samples were analyzed for chlorides (EPA method 300.0), benzene, toluene, ethyl benzene, and xylenes (BTEX) (EPA method 8021B), and Total Petroleum Hydrocarbons (TPH) (EPA method 8015M). The results are shown in the table below.
