Vanguard Permian Grizzell B # 7 Delineation Work Plan

**Section 8, T22S, R37E
Lea County, New Mexico**

November 11, 2013

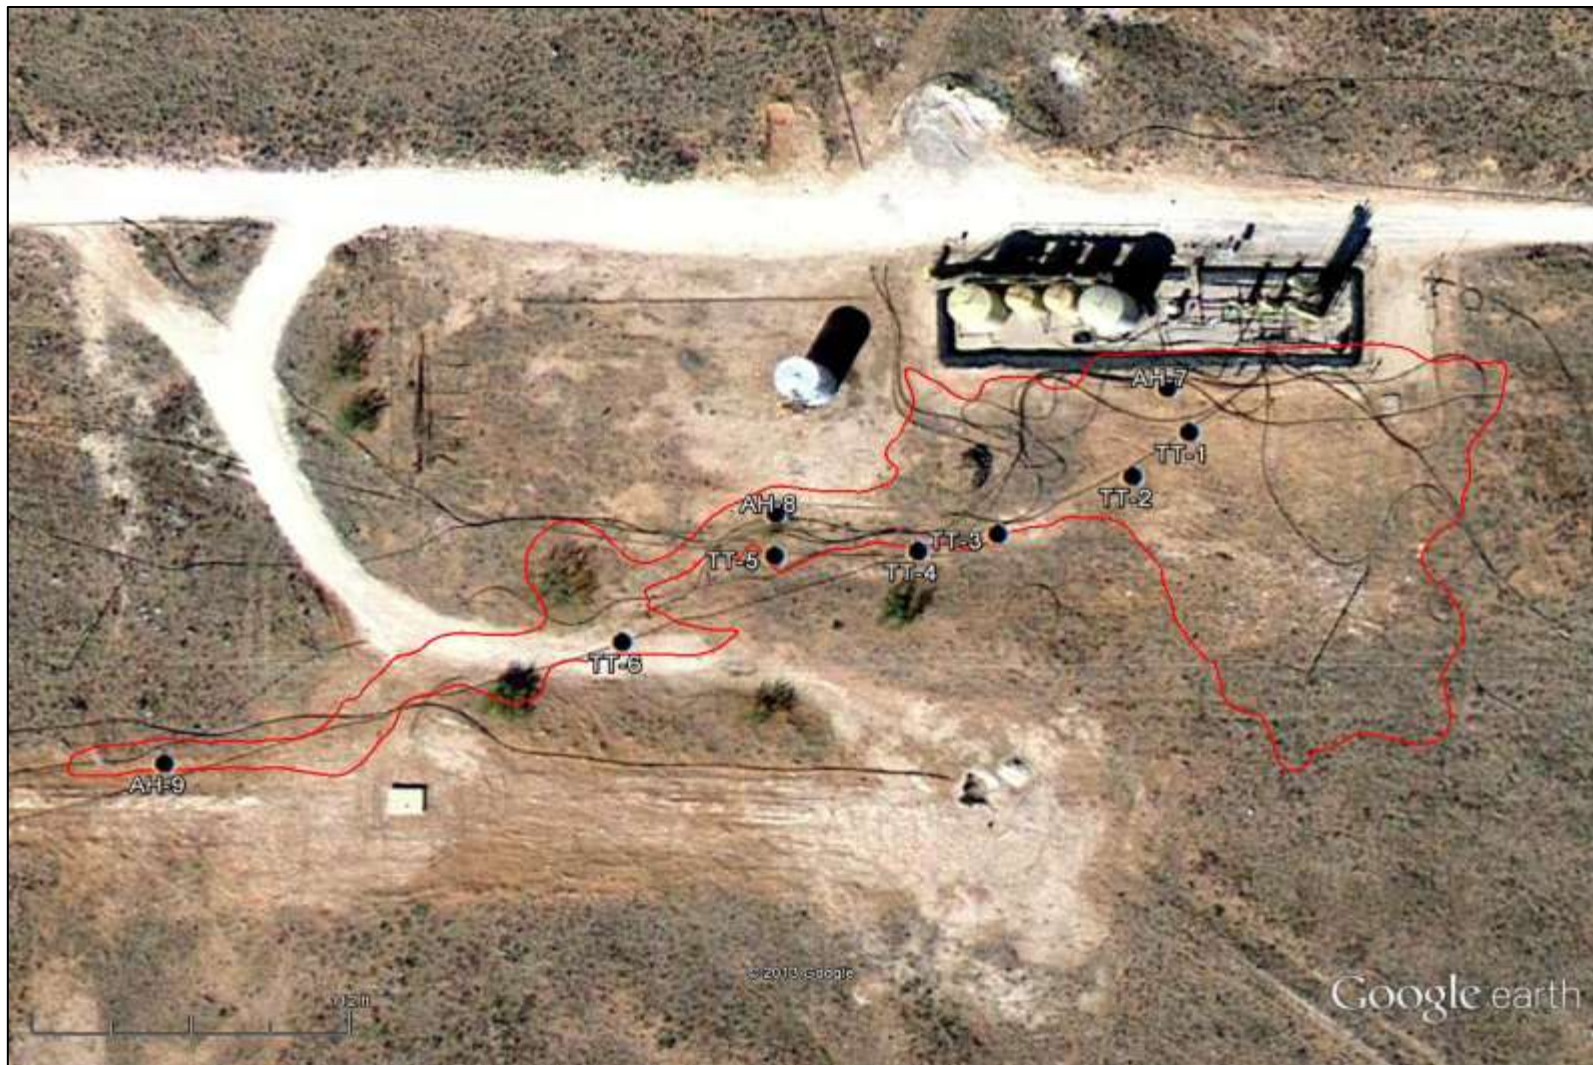
Figure 3

Site Map

Grizzell B #7 Release Area, Auger Holes and Test Trenches

On October 22, 2012, SESI was onsite with Bryan's Oilfield Services and installed 6 test trenches to determine vertical extent of contamination. Samples were retrieved at a depth of 3 feet below ground surface (bgs). Samples were retrieved, properly packaged and transported under chain of custody to Cardinal Laboratories in Hobbs, New Mexico. The results of the analysis are as follows:

On December 30, 2013 SESI was on site along with Mike Stubblefield at his request to sample and install three auger holes to a depth of 1', 2' 6' to determine extent of contamination. Samples obtained were properly packaged, preserved and transported under chain of custody to Cardinal Laboratories. The results of the analysis are as follows:

The Recommended Remediation Action Levels (RRAL) are 10 parts per million (ppm) Benzene, 50 ppm combined benzene, toluene, ethylbenzene, and total xylenes (BTEX), and 1,000 ppm Total Petroleum Hydrocarbons (TPH) for this site. The affected area will be excavated to a depth where the level of contamination is 1,000 ppm TPH and 250 PPM chlorides. The excavated soils will be transported to a New Mexico Oil Conservation Division (NMOCD) approved facility for disposal. Samples will be obtained from the bottom and all sides of the excavation to confirm that the RRALs have been reached. The excavation will then be backfilled with like soils and contoured to match the surrounding area.
