Warn State A/C 2 #19

Closure Report

RE: TERMINATION REQUEST

Apache – Warn State A/C 2 #19 AD

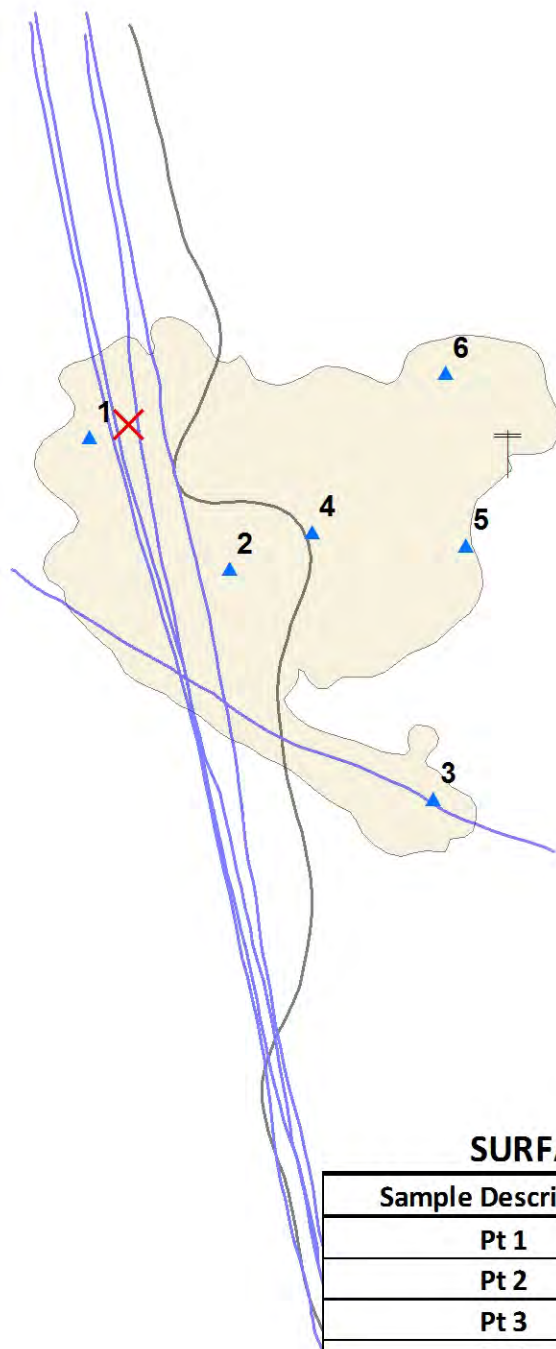
Figure 1

On September 7, 2011, RECS personnel initiated work on the Warn State A/C 2 #19 (Figure 1). Surface soil samples were collected and field tested for chloride. Headspace measurements were also taken in the field using a Photo Ionization Detector (PID). The samples were submitted to a commercial laboratory for chloride and TPH (GRO/DRO) analyses (Appendix C). Chloride ranged from 11,000 ppm (parts per million or mg/kg) to 39,600 ppm. GRO ranged from <250 ppm to 7,670 ppm and DRO ranged from <250 ppm to 79,500 ppm.

Sample Description	Cl-	GRO	DRO
Pt 1	11,000	7,670	79,500
Pt 2	26,800	<5000	41,900
Pt 3	22,400	<250	<250
Pt 4	27,200	4,530	32,700
Pt 5	26,000	<1250	10,200
Pt 6	39,600	<250	<250

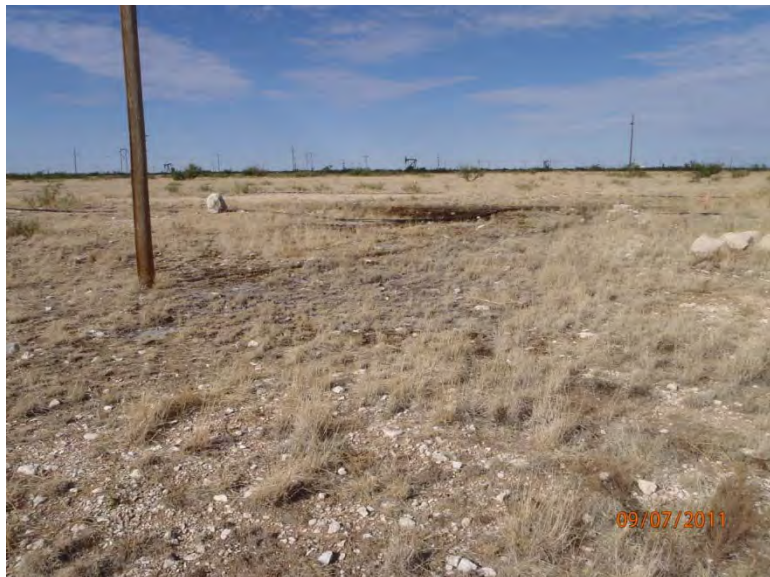
Initial release, facing north

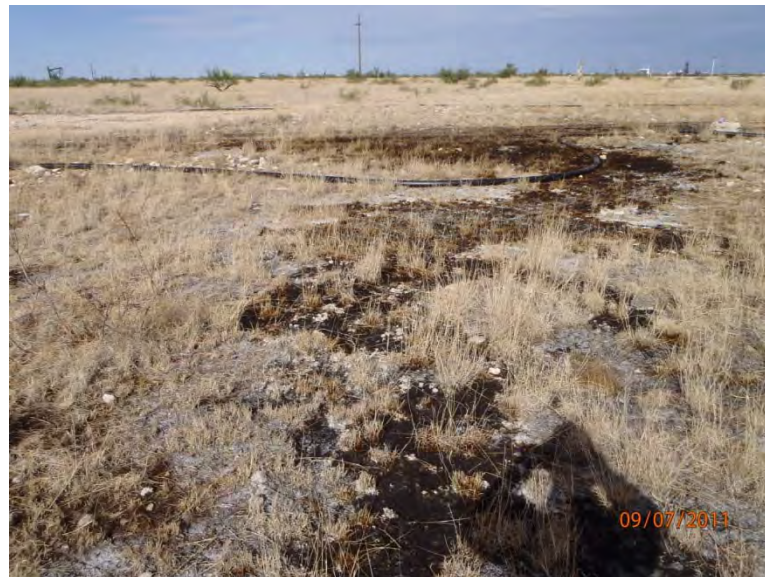
Initial release, facing west

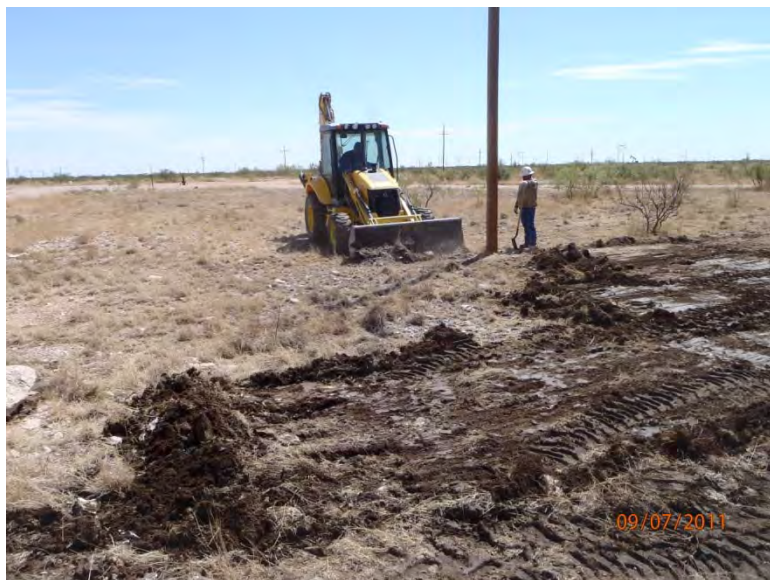
Excavating leak, facing east

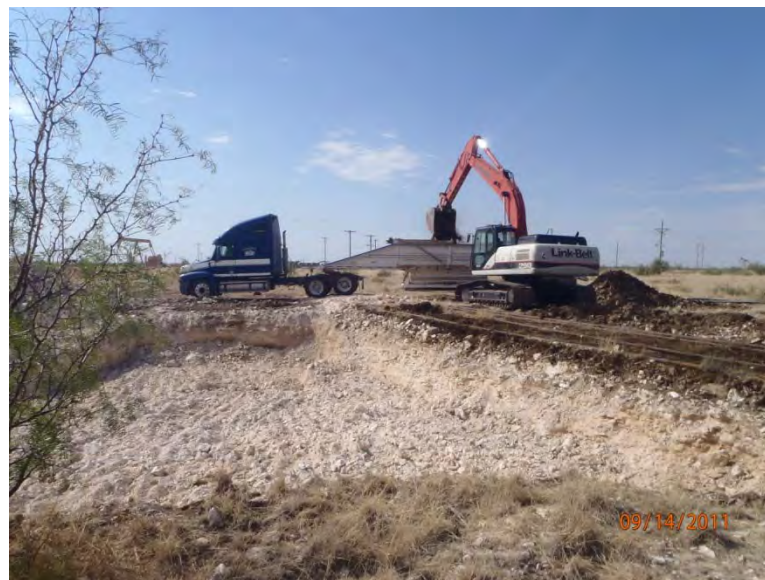
Exporting soil, facing south

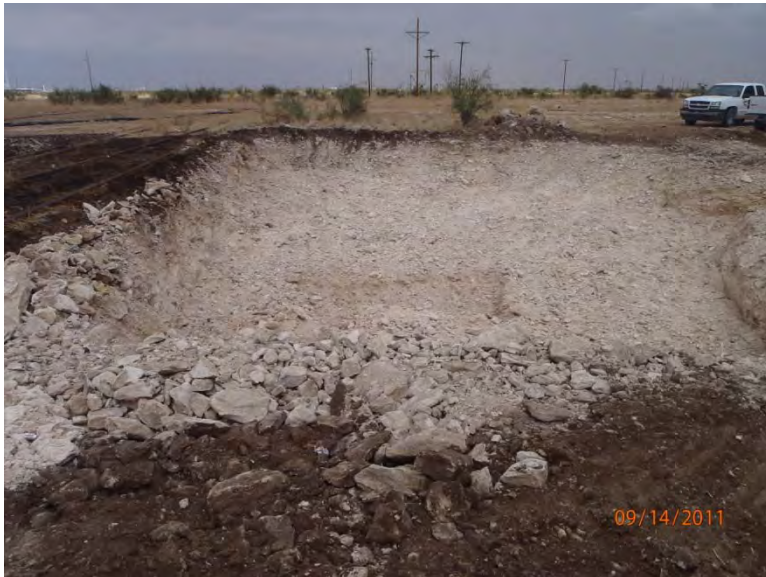
Final excavation, facing north

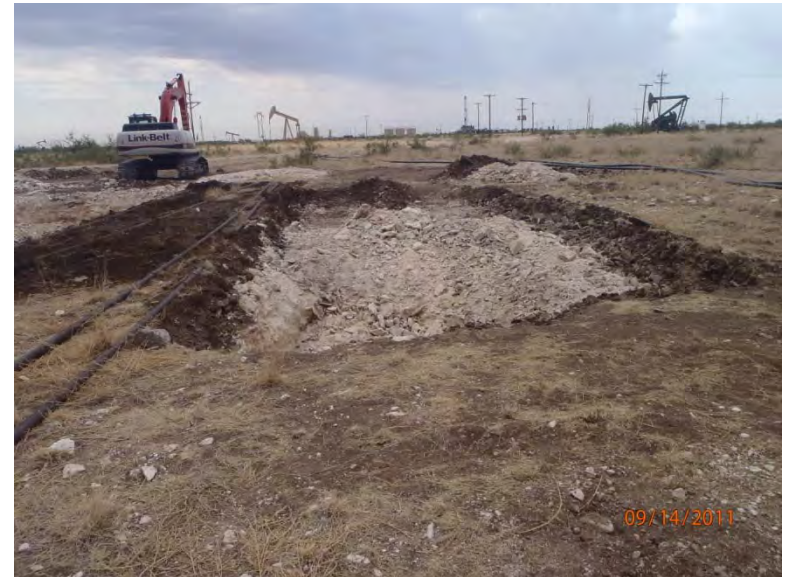
Final excavation, facing south

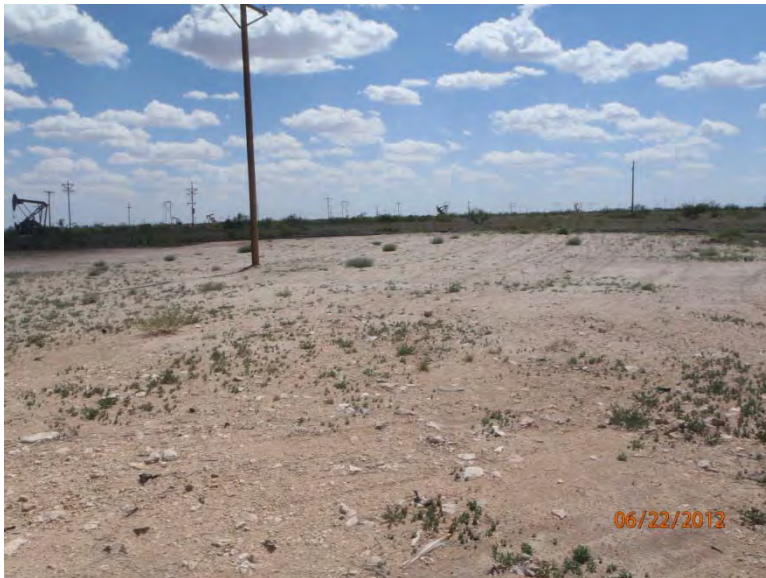
Site backfilled, facing west

the inability of equipment to safely access the space between steel lines. The excavation was backfilled with clean soil and contoured to the surrounding area. See Appendix B for photographs of field activities.

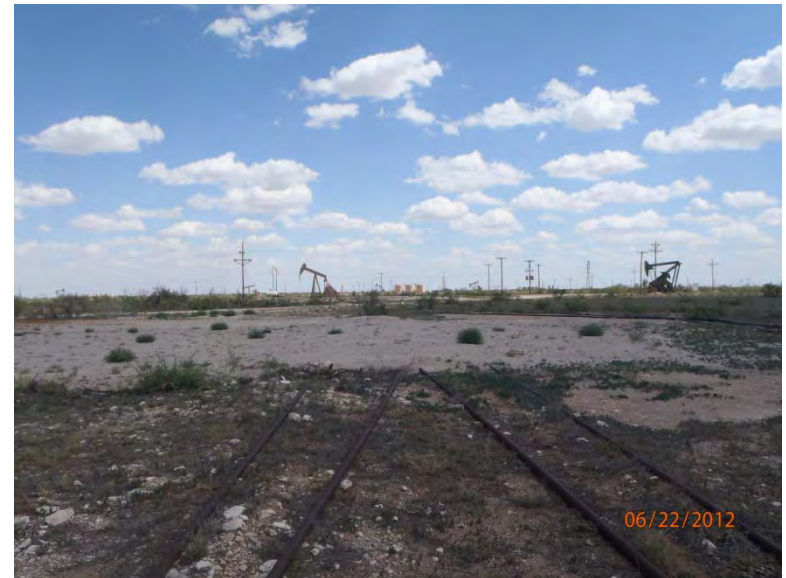
Site backfilled, facing south
