REMEDIATION SUMMARY & SITE CLOSURE REQUEST

SOUTHERN UNION GAS SERVICES

WOOLWORTH 12" (1RP-1875)

HISTORICAL RELEASE SITE

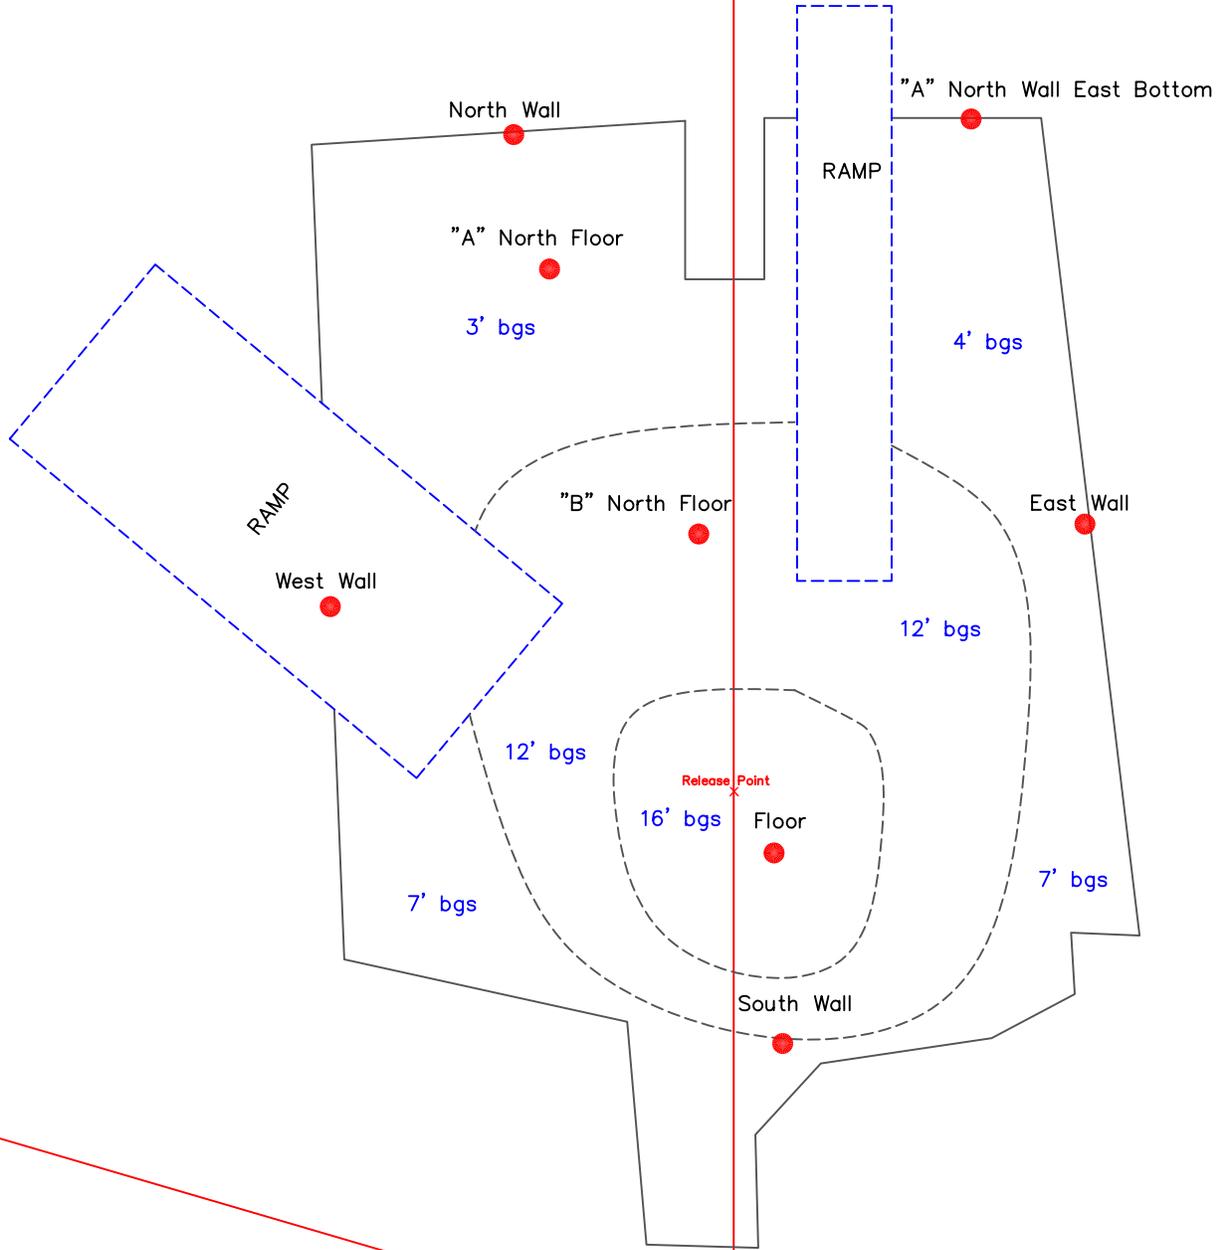
Figure 2
 Site & Sample Location Map
 Southern Union Gas Services
 Woolworth 12" (RP-1875)
 Lea County, NM

On June 13, 2008, eight (8) confirmation soil samples (“A” North Floor, “A” North Wall East Bottom, Floor, “B” North Floor, North Wall, East Wall, South Wall and West Wall) were collected from the floor and sidewalls of the excavation and submitted to Xenco Laboratories, of Odessa, Texas, for analysis of TPH concentrations in accordance with EPA Method SW 846-8015M. Laboratory analytical results indicated TPH concentrations ranged from less than the appropriate laboratory method detection limit (MDL) for soil samples “B” North Floor, North Wall and West Wall to 39.0 mg/Kg for soil sample East Wall.

On June 19, 2008, Basin began backfilling the excavation with treated material from Southern Union Gas Services’ Landfarm. Excavation backfill was compacted and contoured to fit the surrounding topography. Prior to backfilling the excavation, the final dimensions were approximately one hundred feet (100’) in length, eighty feet (80’) in width, and ranged in depth from approximately three feet (3’) to sixteen feet (16’) bgs.

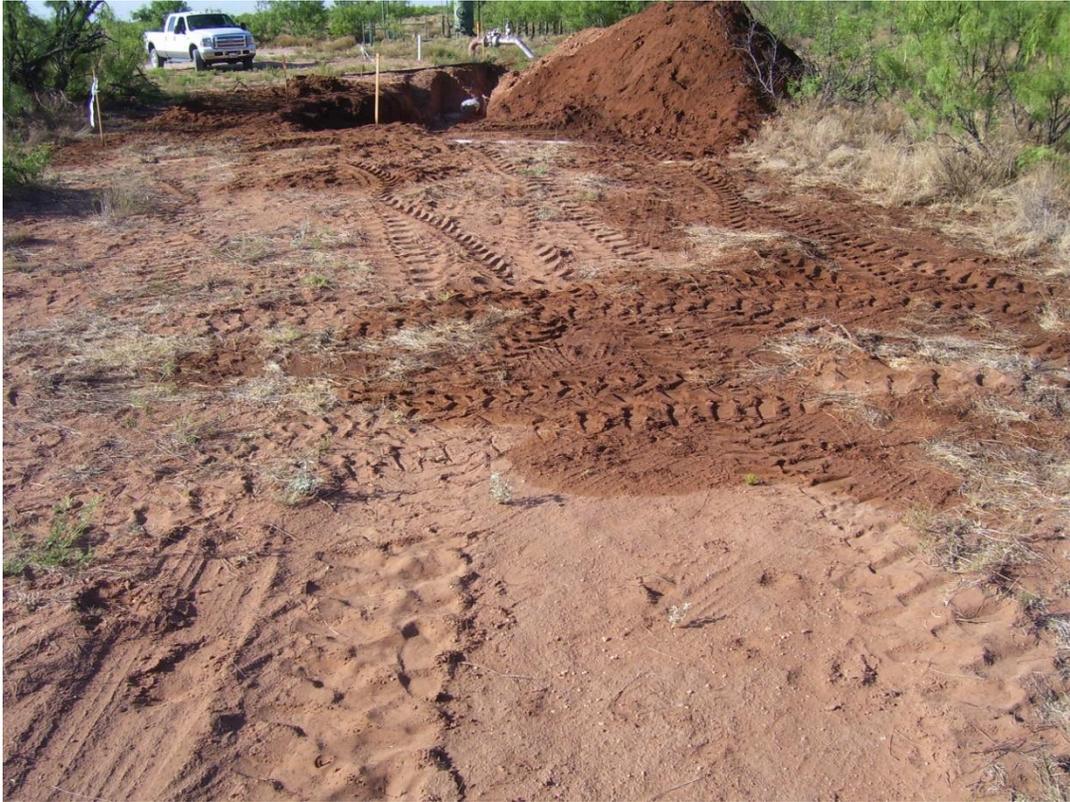
On March 1, 2008, Southern Union discovered a release had occurred on the Woolworth 12” Pipeline. The "Release Notification and Corrective Action" (Form C-141) indicated failure of a section of twelve-inch (12”) low-pressure pipeline resulted in the release of approximately twelve barrels (12 bbls) of crude oil and seventeen (17) Mcf of natural gas. The pipeline has since been repaired. Approximately one thousand, five hundred and eighty square feet (1,580 ft²) of pasture land was affected by the release. The release was reported to the New Mexico Oil Conservation Division (NMOCD) Hobbs District Office on June 8, 2008. General photographs of the release site are provided as Appendix A. The Form C-141 is provided as Appendix D.

Photograph of the initial release at the Woolworth 12" Historical Release Site.

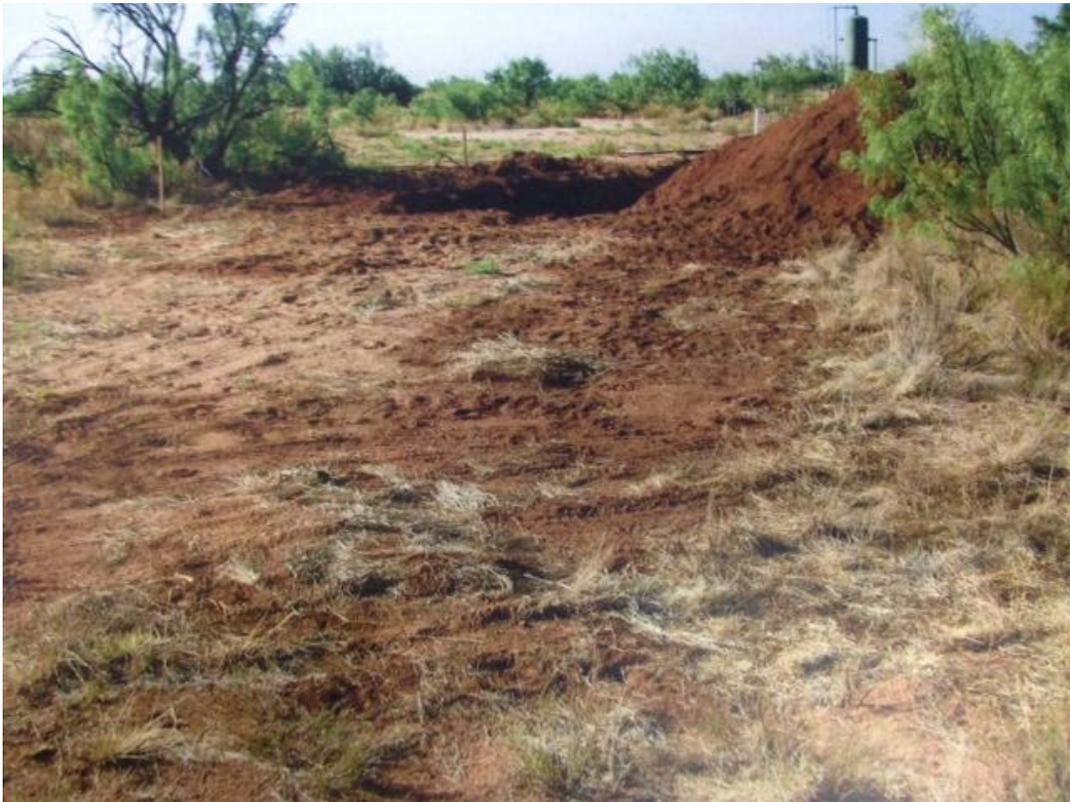
Photograph of the initial release at the Woolworth 12" Historical Release Site.

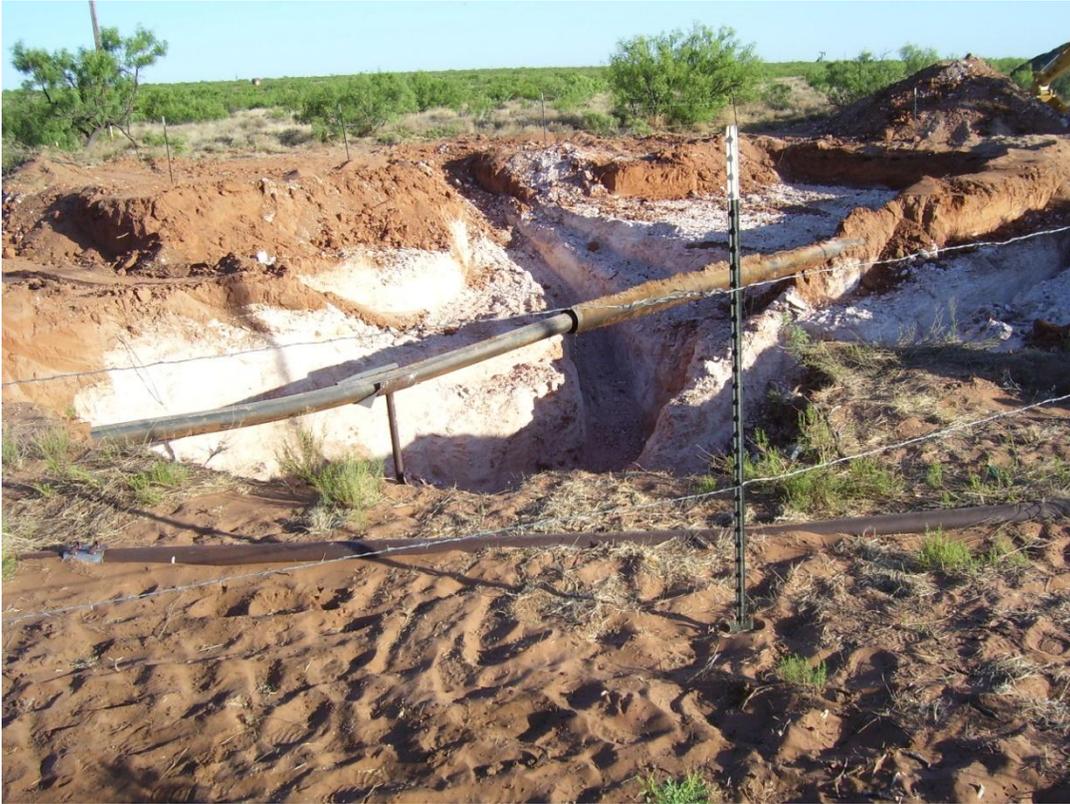
Photograph of excavation activities at the Woolworth 12" Historical Release Site.

On June 10, 2008, Basin began remediation activities at the release site. Heavily impacted soil was excavated and stockpiled on-site pending final disposition. A photo-ionization detector (PID) and chloride field test strips were used to field screen soil samples and help guide the excavation. The excavation floor and sidewalls were advanced until field measurements indicated benzene, toluene, ethylbenzene and xylene (BTEX), total petroleum hydrocarbons (TPH) and chloride concentrations were below NMOCD regulatory remediation action levels.

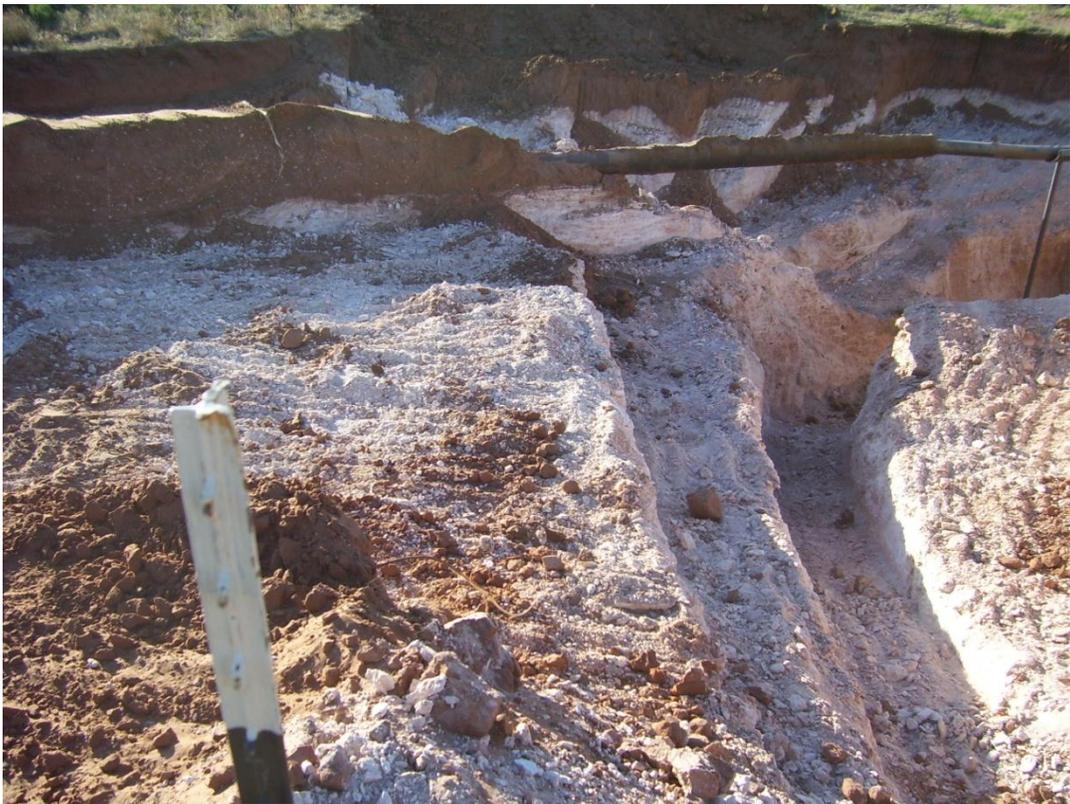
Photograph of excavation activities at the Woolworth 12" Historical Release Site.

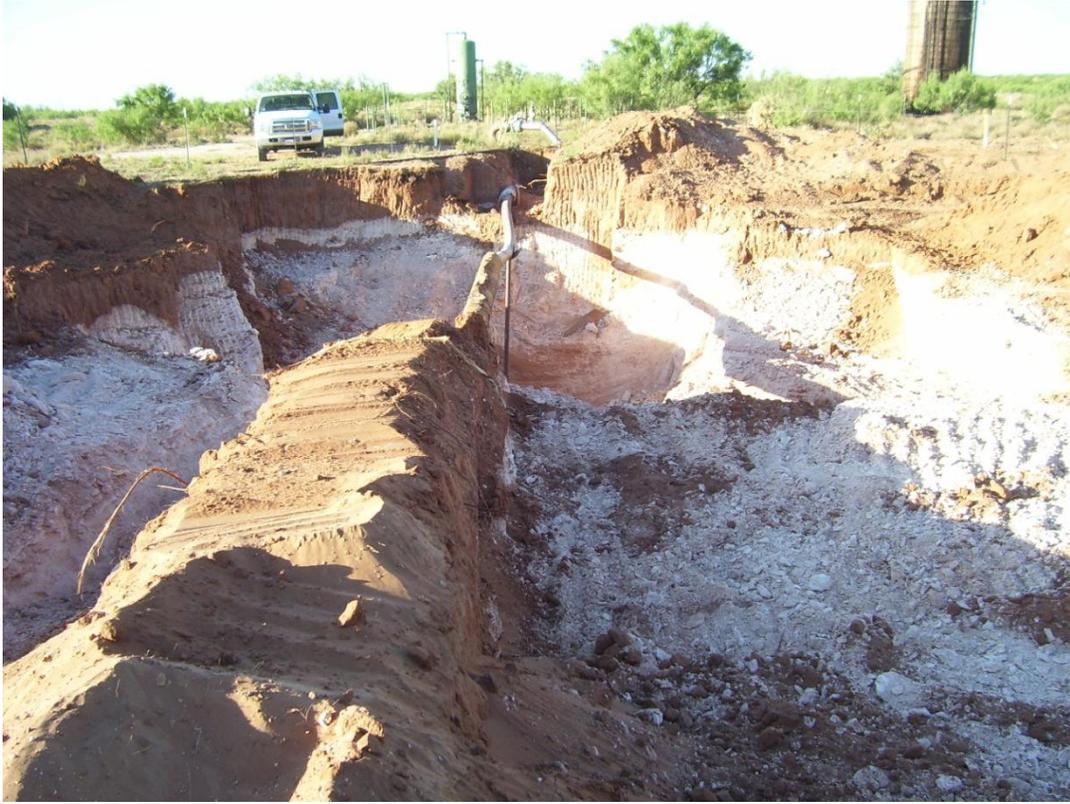
Photograph of excavation activities at the Woolworth 12" Historical Release Site.

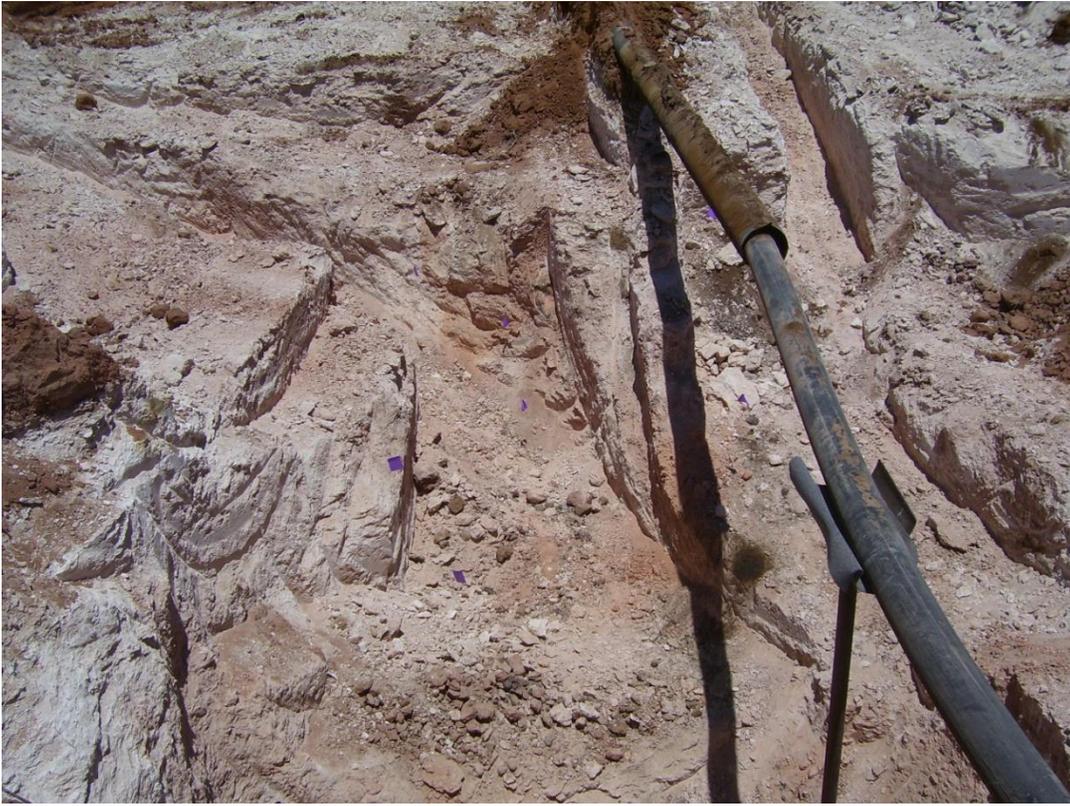
Photograph of excavation activities and sample locations at the Woolworth 12" Historical Release Site.

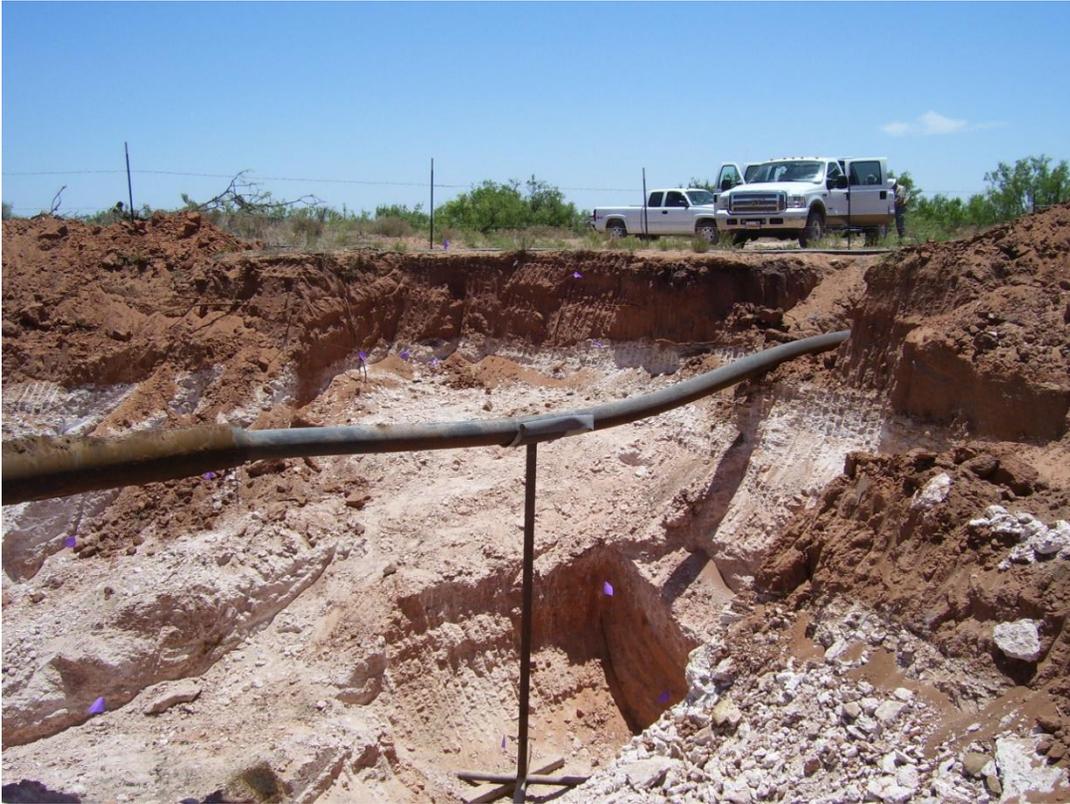
Photograph of excavation activities and sample locations at the Woolworth 12" Historical Release Site.

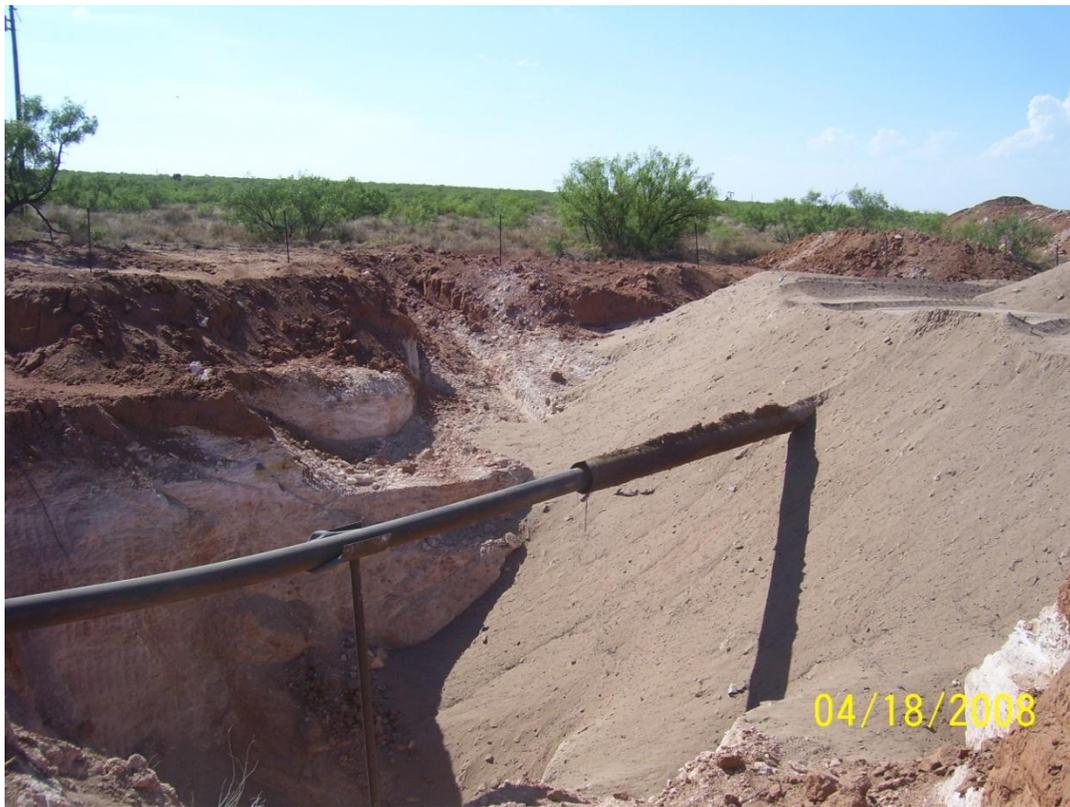
Photograph of backfilling activities at the Woolworth 12" Historical Release Site.

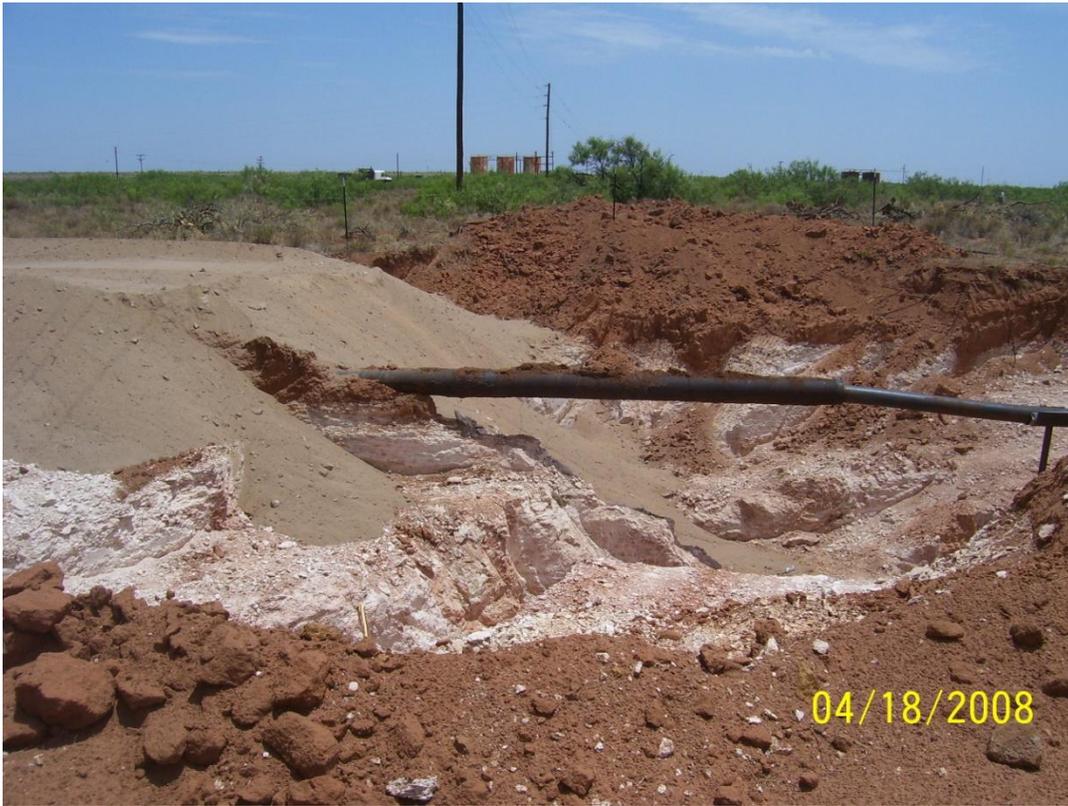
Photograph of backfilling activities at the Woolworth 12" Historical Release Site.

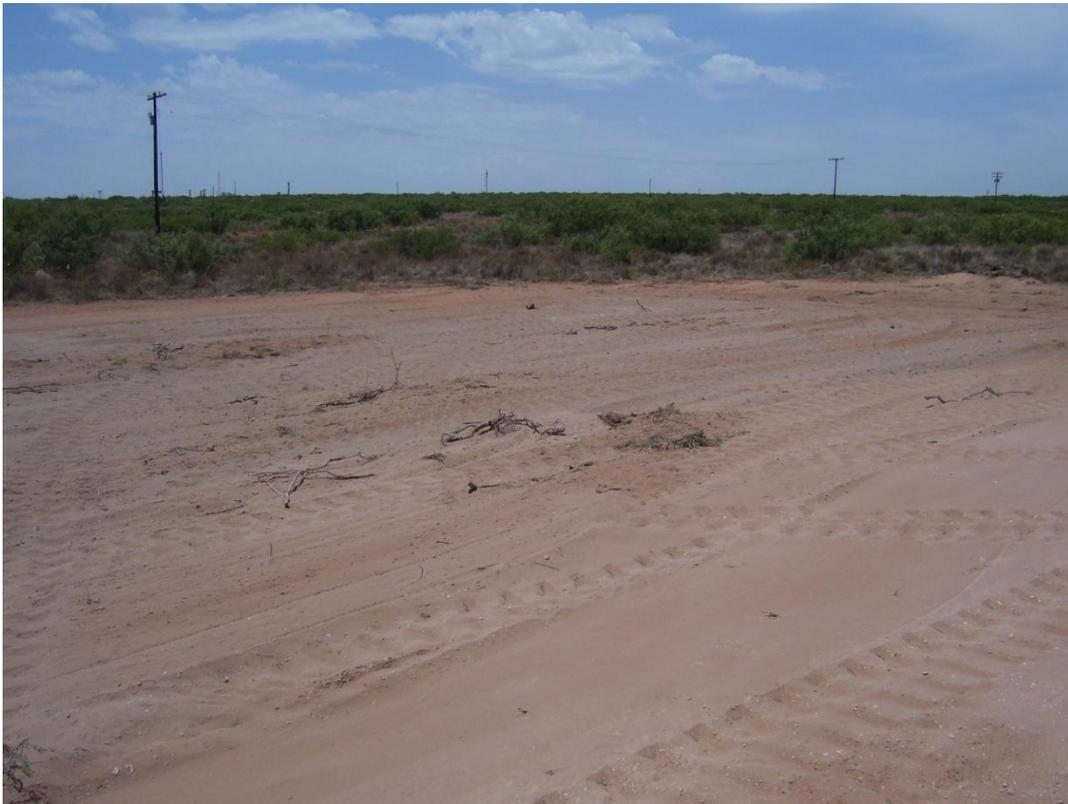
Photograph of the Woolworth 12" Historical Release Site after backfilling.
