REMEDIATION SUMMARY & SOIL CLOSURE REQUEST

**REGENCY FIELD SERVICES LLC.
Highway 18 Drip Tanks
Historical Release Site
Lea County, New Mexico
Unit Letter "D", Section 32, Township 24 South, Range 37 East
Latitude 32.180428, Longitude -103.192786
NMOCD Reference # 1RP-2041**

October 2014
Apex Project No. 7030714G072

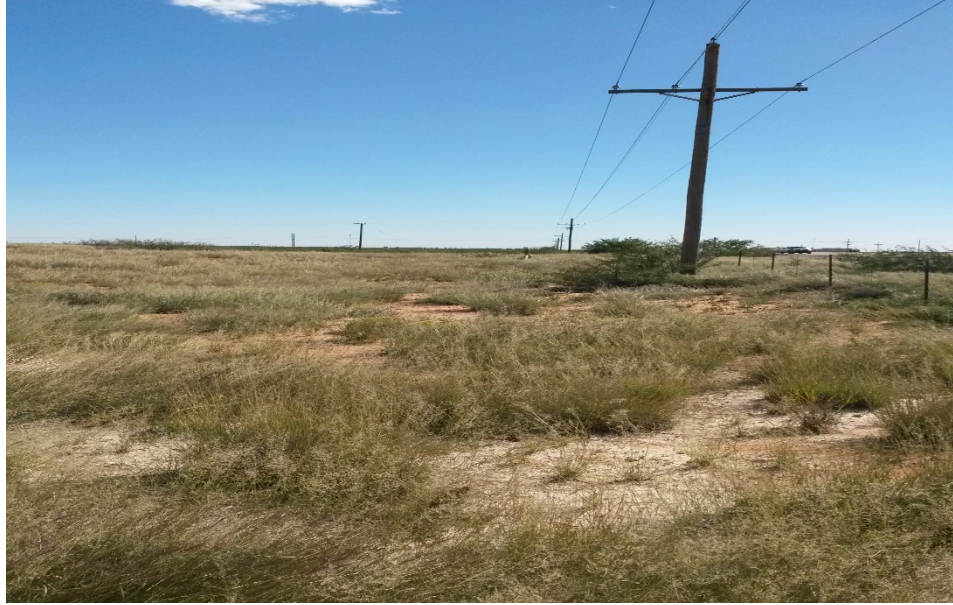
View South – Remediated Area of Drip Tanks

Based upon the data provided, and the photos shown in Appendix C, the site was brought to grade. Based upon the response actions and laboratory analytical results, no additional investigation and/or remediation appears warranted at this time. Regency respectfully requests closure of this site. Copies of the Initial and Final C-141 are provided in Appendix E.

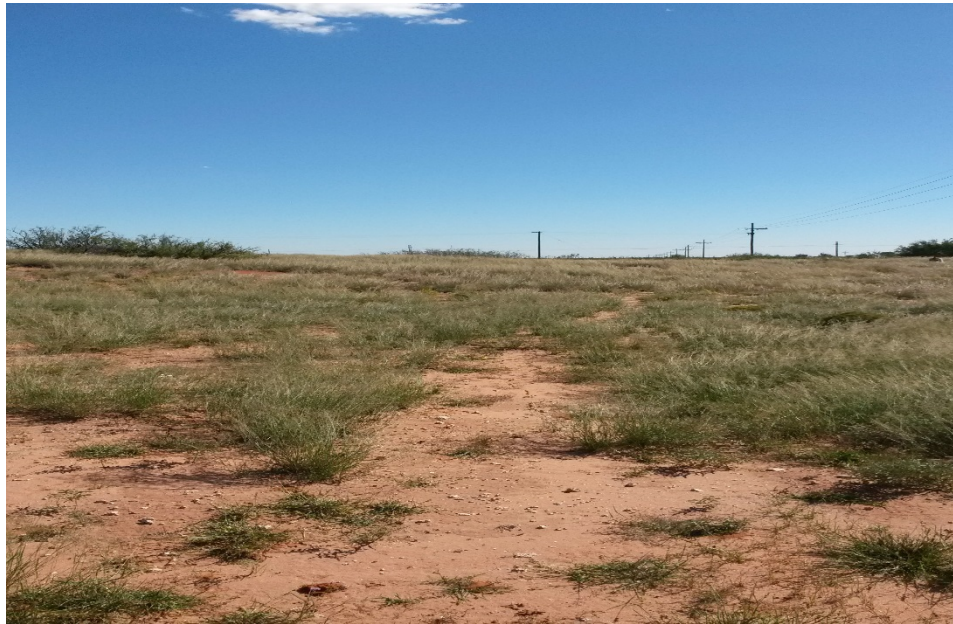
View South – Remediated Area of Drip Tanks
