REMEDIATION SUMMARY & SITE CLOSURE REQUEST

**SOUTHERN UNION GAS SERVICES
WEST EUNICE COMPRESSOR STATION
HISTORICAL RELEASE SITE**

Lea County, New Mexico

NMOCD Reference # 1RP-2724

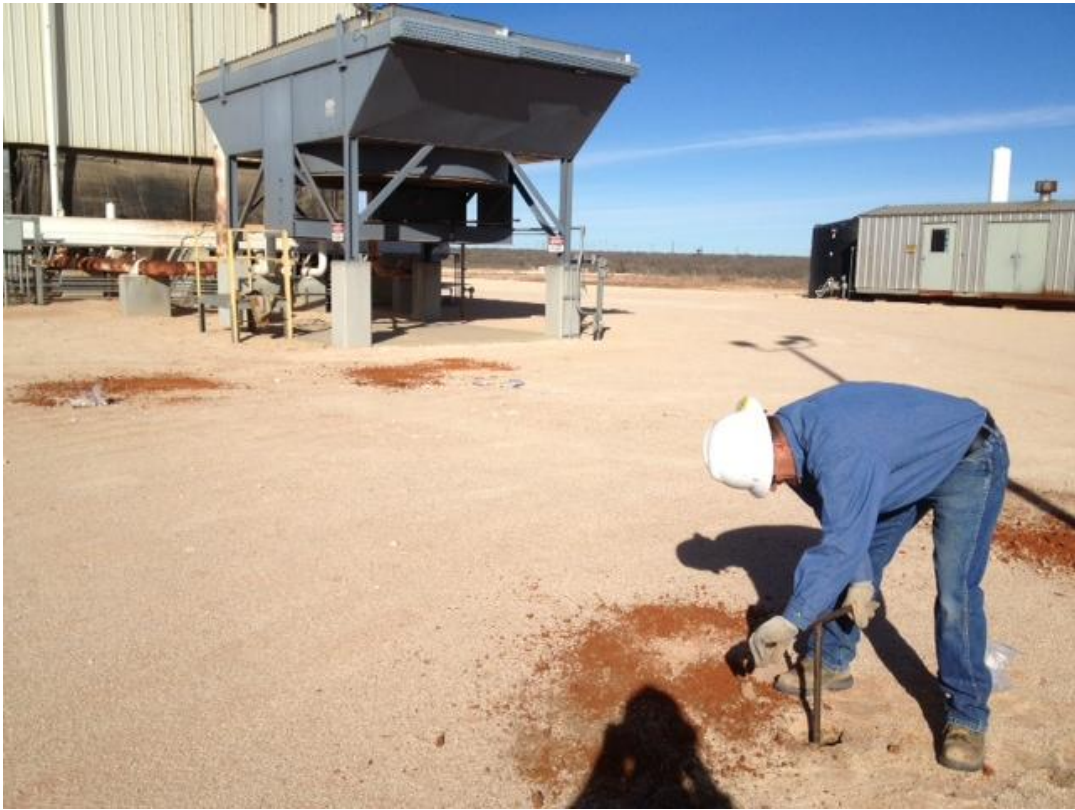
Photograph of soil sample collection at the West Eunice Compressor Station Historical Release Site.

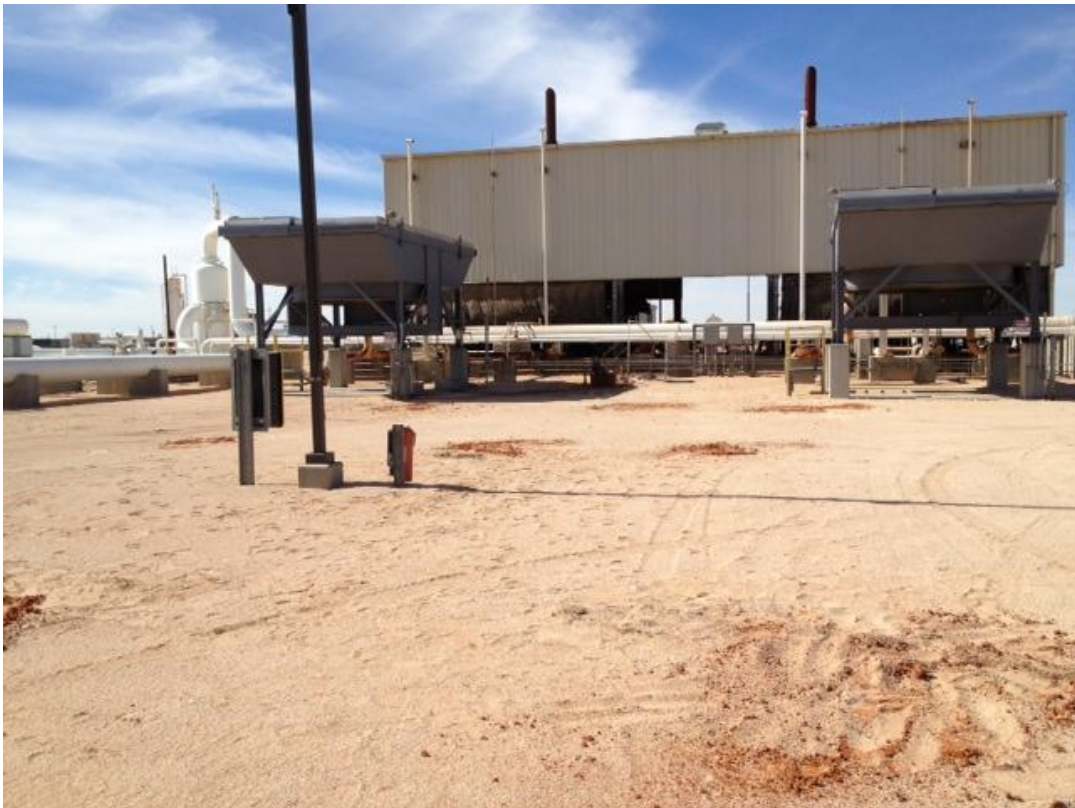
Photograph of soil sample locations at the West Eunice Compressor Station Historical Release Site.

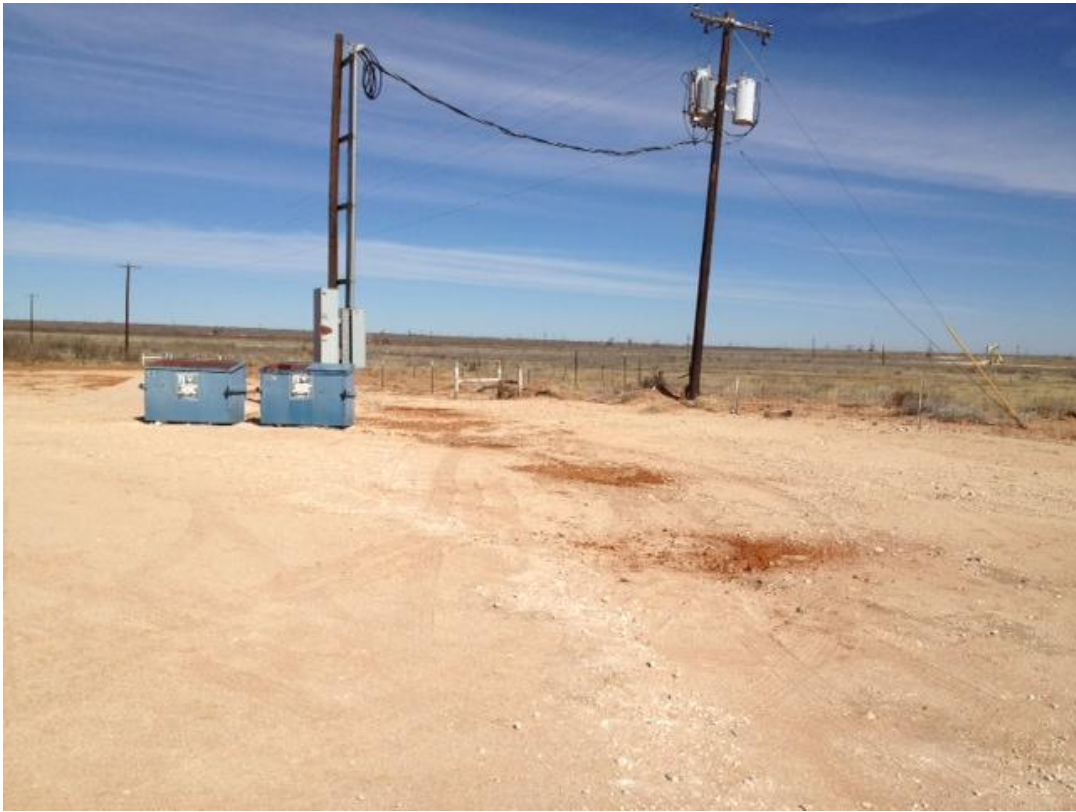
Photograph of soil sample locations at the West Eunice Compressor Station Historical Release Site.

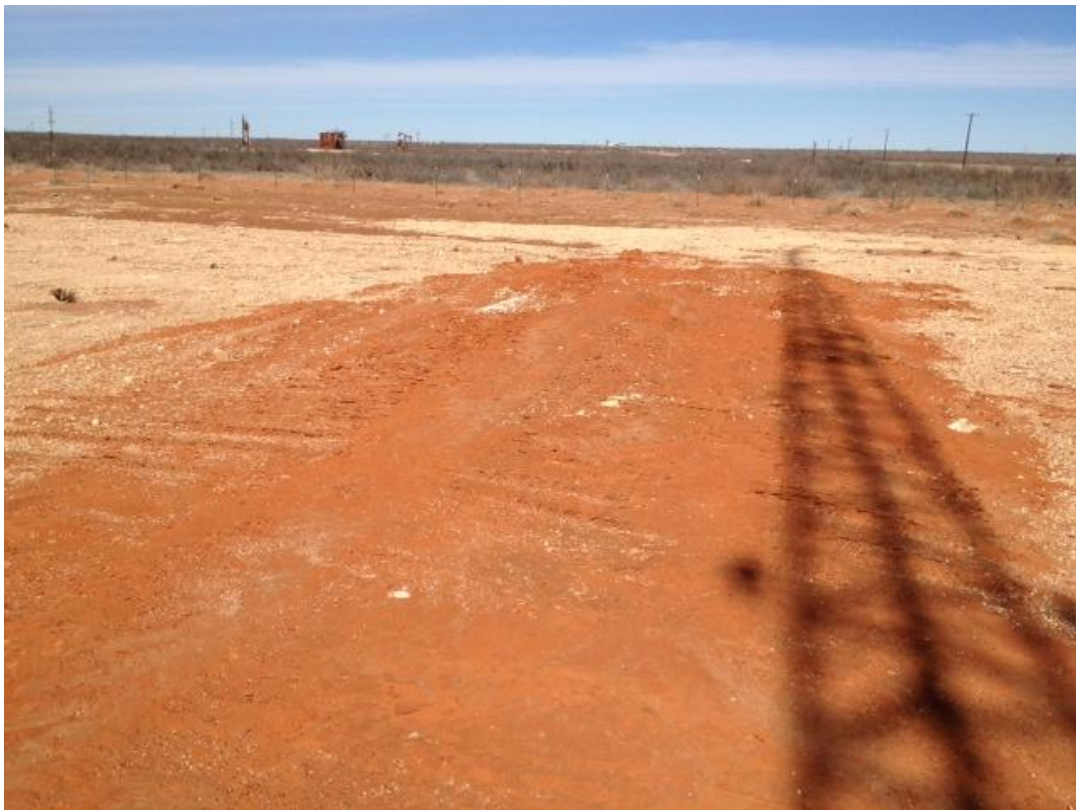
Photograph of the disturbed area at the West Eunice Compressor Station Historical Release Site.
