## **REMEDIATION SUMMARY & SITE CLOSURE REQUEST**

**SOUTHERN UNION GAS SERVICES  
MC-16" (1RP-1511)  
HISTORICAL RELEASE SITE  
Lea County, New Mexico  
Unit Letter "C" (NE/NW), Section 34, Township 22 South, Range 36 East  
Latitude 32° 21.135' North, Longitude 103° 15.345' West  
NMOCD Reference # 1RP-1511**

**November 2012**

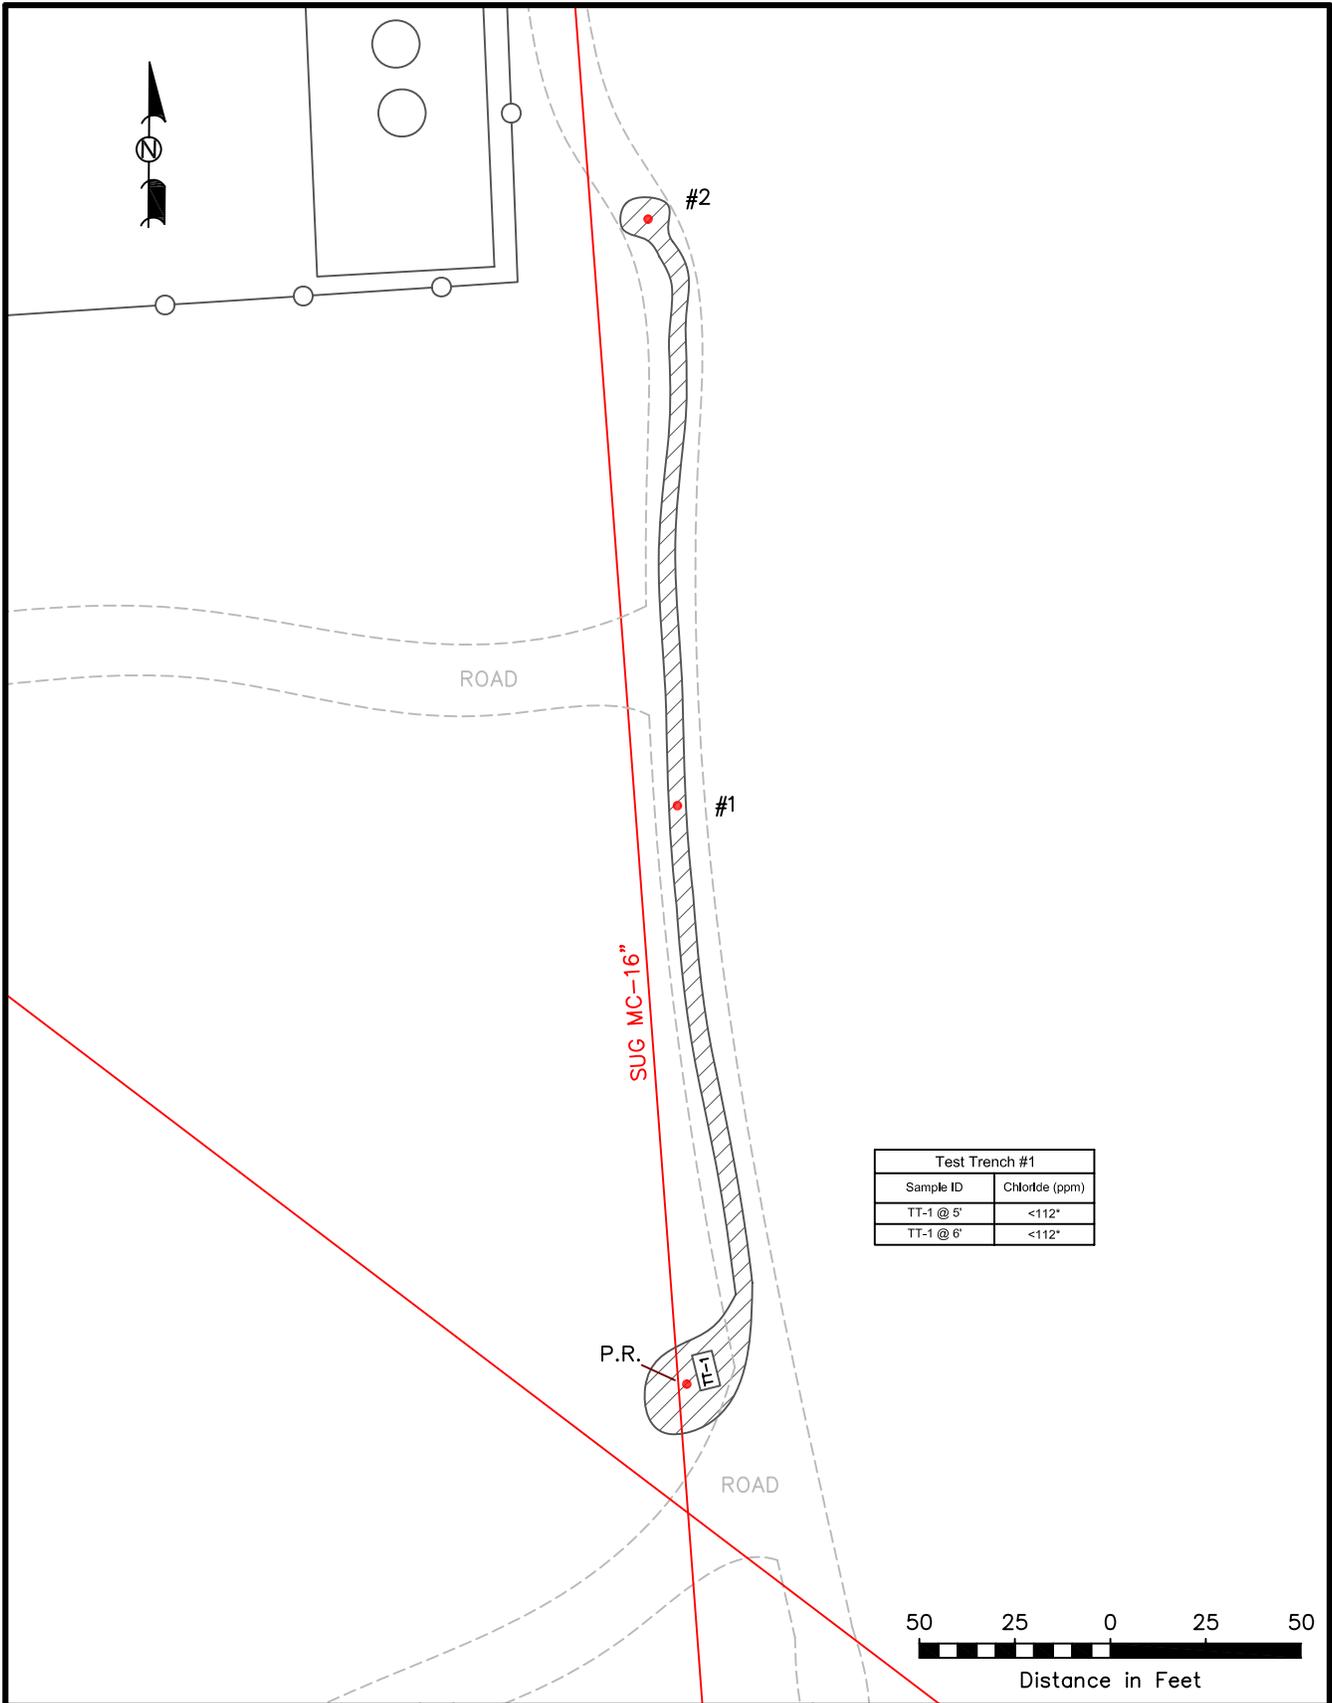
**Figure 2**  
**Site & Sample Location Map**  
 Southern Union Gas Services  
 MC-16" (RP-1511)  
 Lea County, NM

Test Trench #1	
Sample ID	Chloride (ppm)
TT-1 @ 5'	<112*
TT-1 @ 6'	<112*

On October 3, 2012, Basin responded to the MC-16” Historical Release Site. During the initial investigation, no surface impact was visible, and revegetation was noted. Two (2) soil samples (TT-1 @ 5’ and TT-2 @ 6’) were collected from a test trench advanced adjacent to the inferred release point in an effort to collect a confirmation BTEX sample and achieve vertical delineation. Soil samples was submitted to Xenco Laboratories, Inc., of Odessa, Texas, for determination of chloride concentrations in accordance with EPA Method 300/300.1. Soil sample TT-1 @ 6’ was also analyzed for BTEX constituent concentrations in accordance with EPA Method SW 846-8021b. Laboratory analytical results indicated chloride concentrations ranged from 1.02 mg/Kg for soil sample TT-1 @ 5’ to 3.41 mg/Kg for soil sample TT-1 @ 6’. The BTEX concentration for soil sample TT-1 @ 6’ was 0.00119. Based on these laboratory analytical results, the vertical extent of soil impact had been determined.

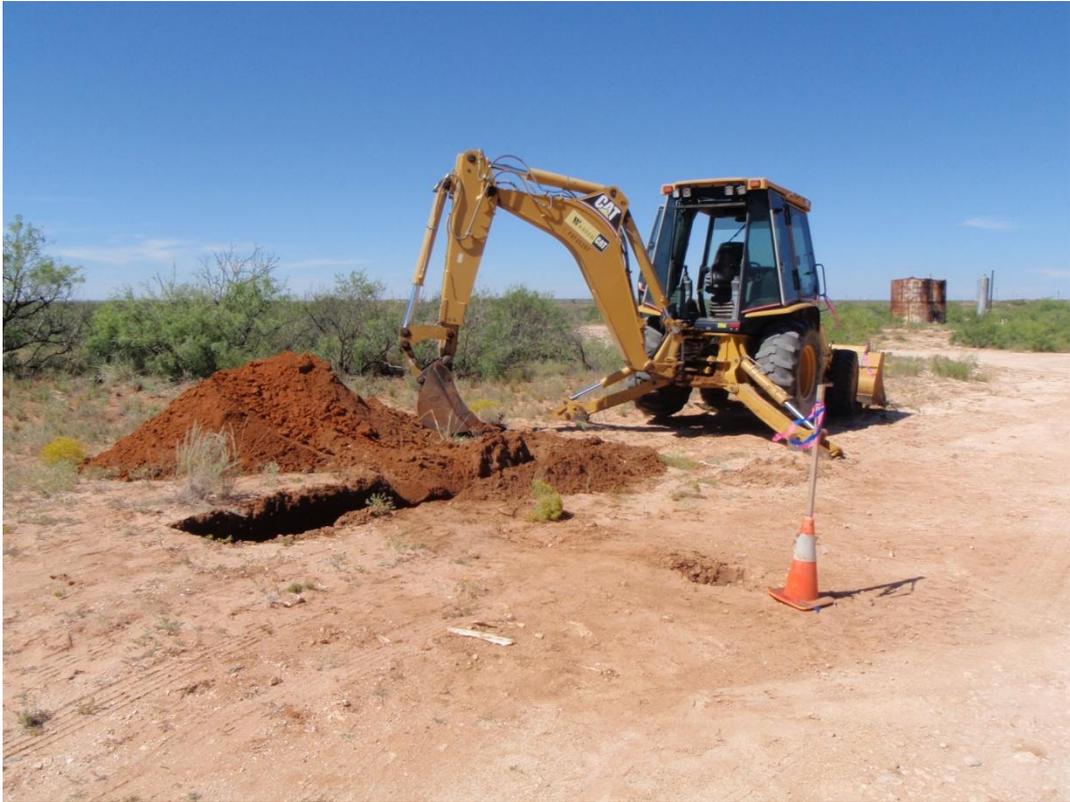
Photograph of the advancement of Test Trench TT-1 at the MC-16" Historical Release Site.

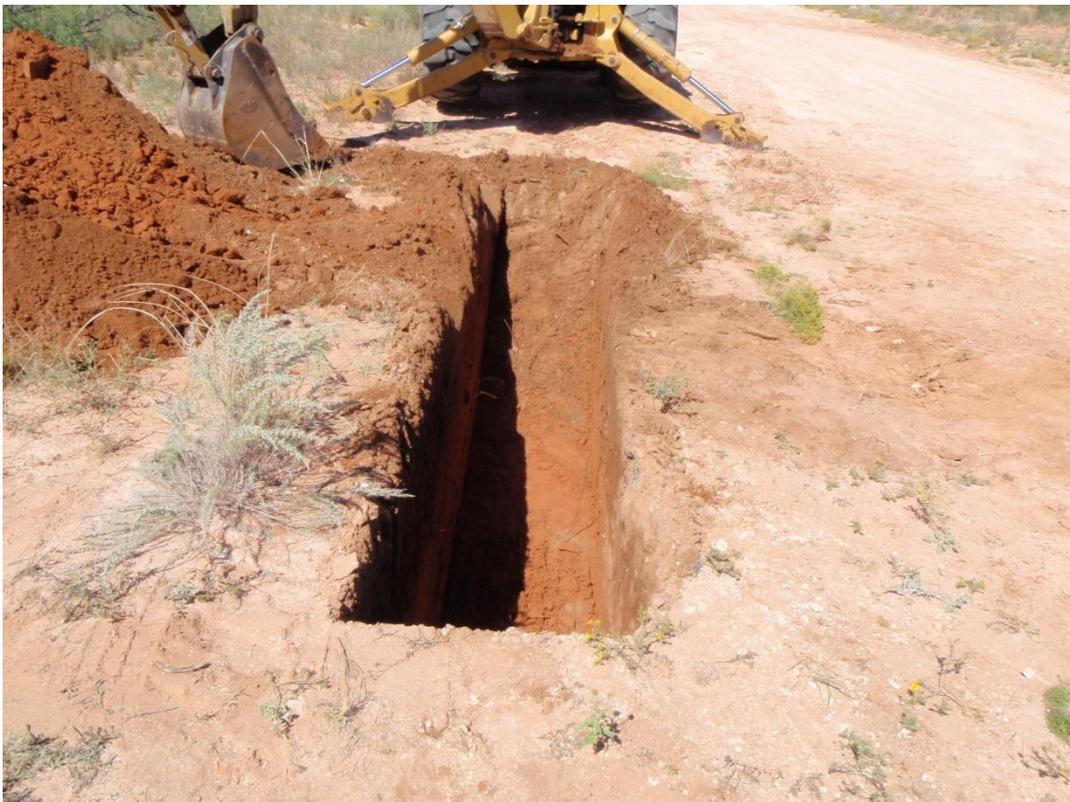
Photograph of the advancement of Test Trench TT-1 at the MC-16" Historical Release Site.
