## E Woods Battery Termination Request

**Apache Corporation – E Woods Battery**

**UL/G sec. 22 T22S R37E**

**API No. 30-025-39687**

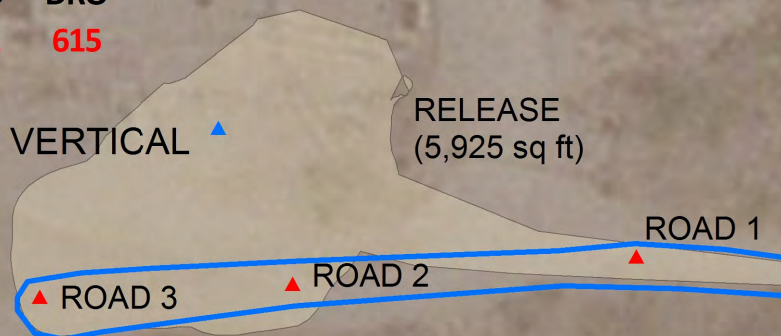
## Figure 1

# Excavation Data

## Road Composite

| Vertical | | | | |

## APACHE E WOODS BATTERY

RECS personnel were on site beginning on March 3<sup>rd</sup>, 2014, to assess the release. The release in the road was scraped down 6 inches and the excavated soil was taken to a NMOCD approved facility for disposal. A three point bottom composite sample of the scrape was taken and field tested for chlorides and organic vapors (Figure 1). The sample was sent to a commercial laboratory for analysis (Appendix B). The laboratory chloride reading returned a value of 128 mg/kg. The Gasoline Range Organics (GRO) reading returned a value of 19.2 mg/kg, and the Diesel Range Organics (DRO) reading returned a value of 615 mg/kg. To determine the depth of contamination at the battery, a vertical was installed to a depth of 7 ft bgs. As the vertical was installed, soil samples were taken every 6 inches to 1 ft and field tested for chlorides and organic vapors. Representative samples from the vertical were taken to a commercial laboratory for analysis. Laboratory analysis confirmed low chloride levels beginning at 1 ft bgs, GRO levels of non-detect throughout, and DRO levels that were elevated until 5 ft bgs.

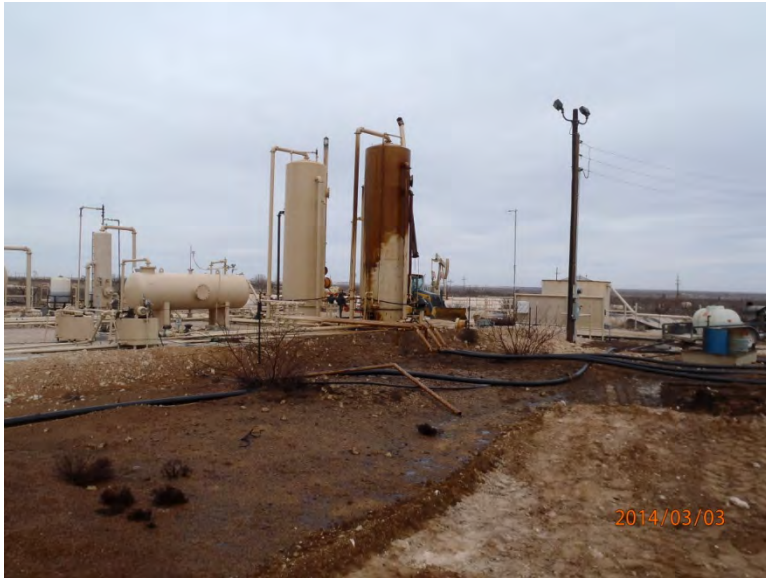
Initial release area, facing northeast

3/3/14

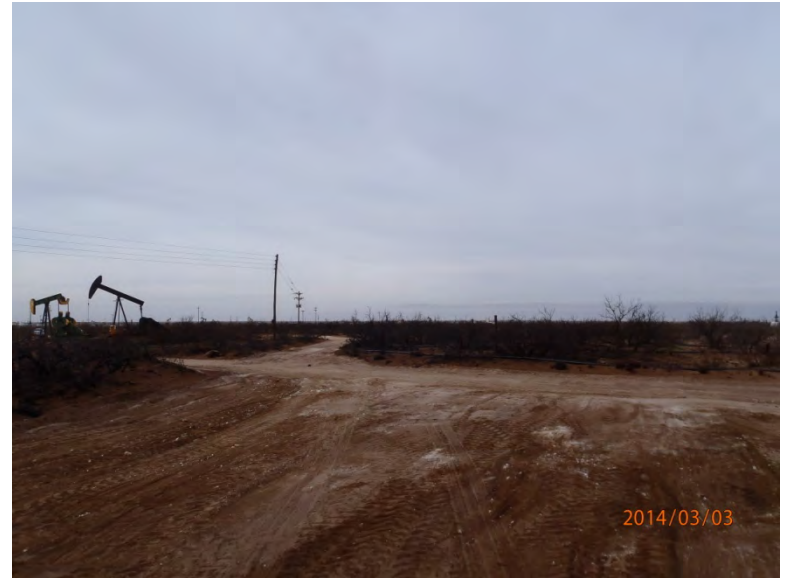
Initial release area, facing west

3/3/14

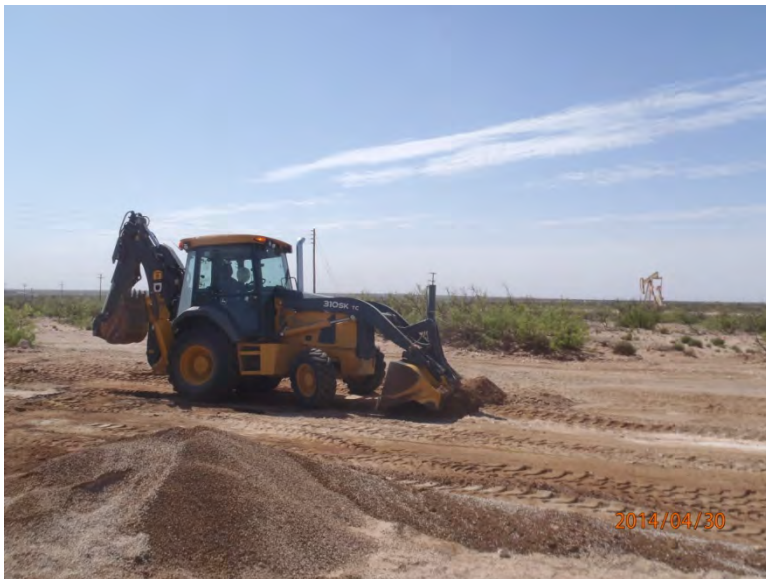
Scraping road, facing southeast

4/30/14

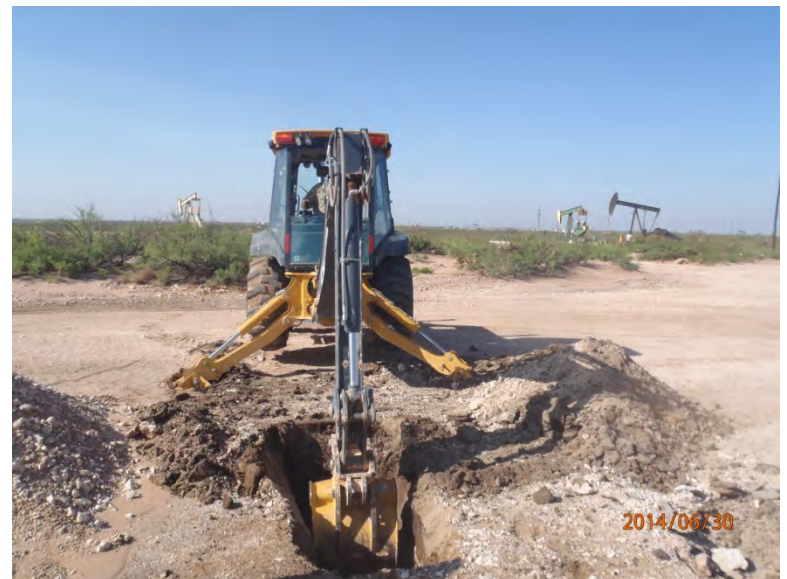
Installing vertical, facing south

6/30/14

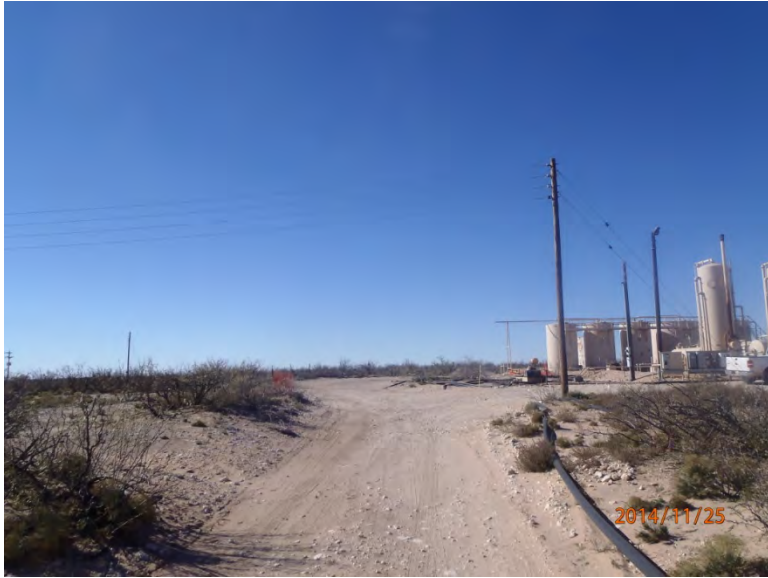
Completed site, facing west

11/25/14

The road scrape was backfilled with clean, imported caliche. The remainder of the release, located near the battery, was not addressed. The asphaltene will provide an infiltration barrier for the release. In addition, any work conducted in this area will pose a safety hazard to personnel and equipment because it encloses multiple production components. Therefore, the release area inside the facility and on the battery pad will be addressed during site abandonment.

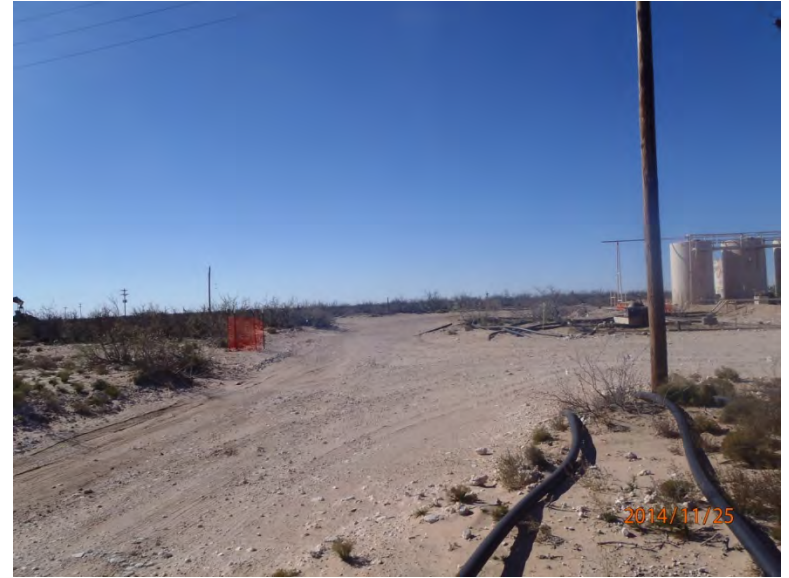
Completed site, facing southwest

11/25/14
