**Sharp Oilfield Services
Waste Oil Cleanup
Delineation Report and Work Plan
Section 4, T23S, R37E
Lea County, New Mexico**

January 15, 2015

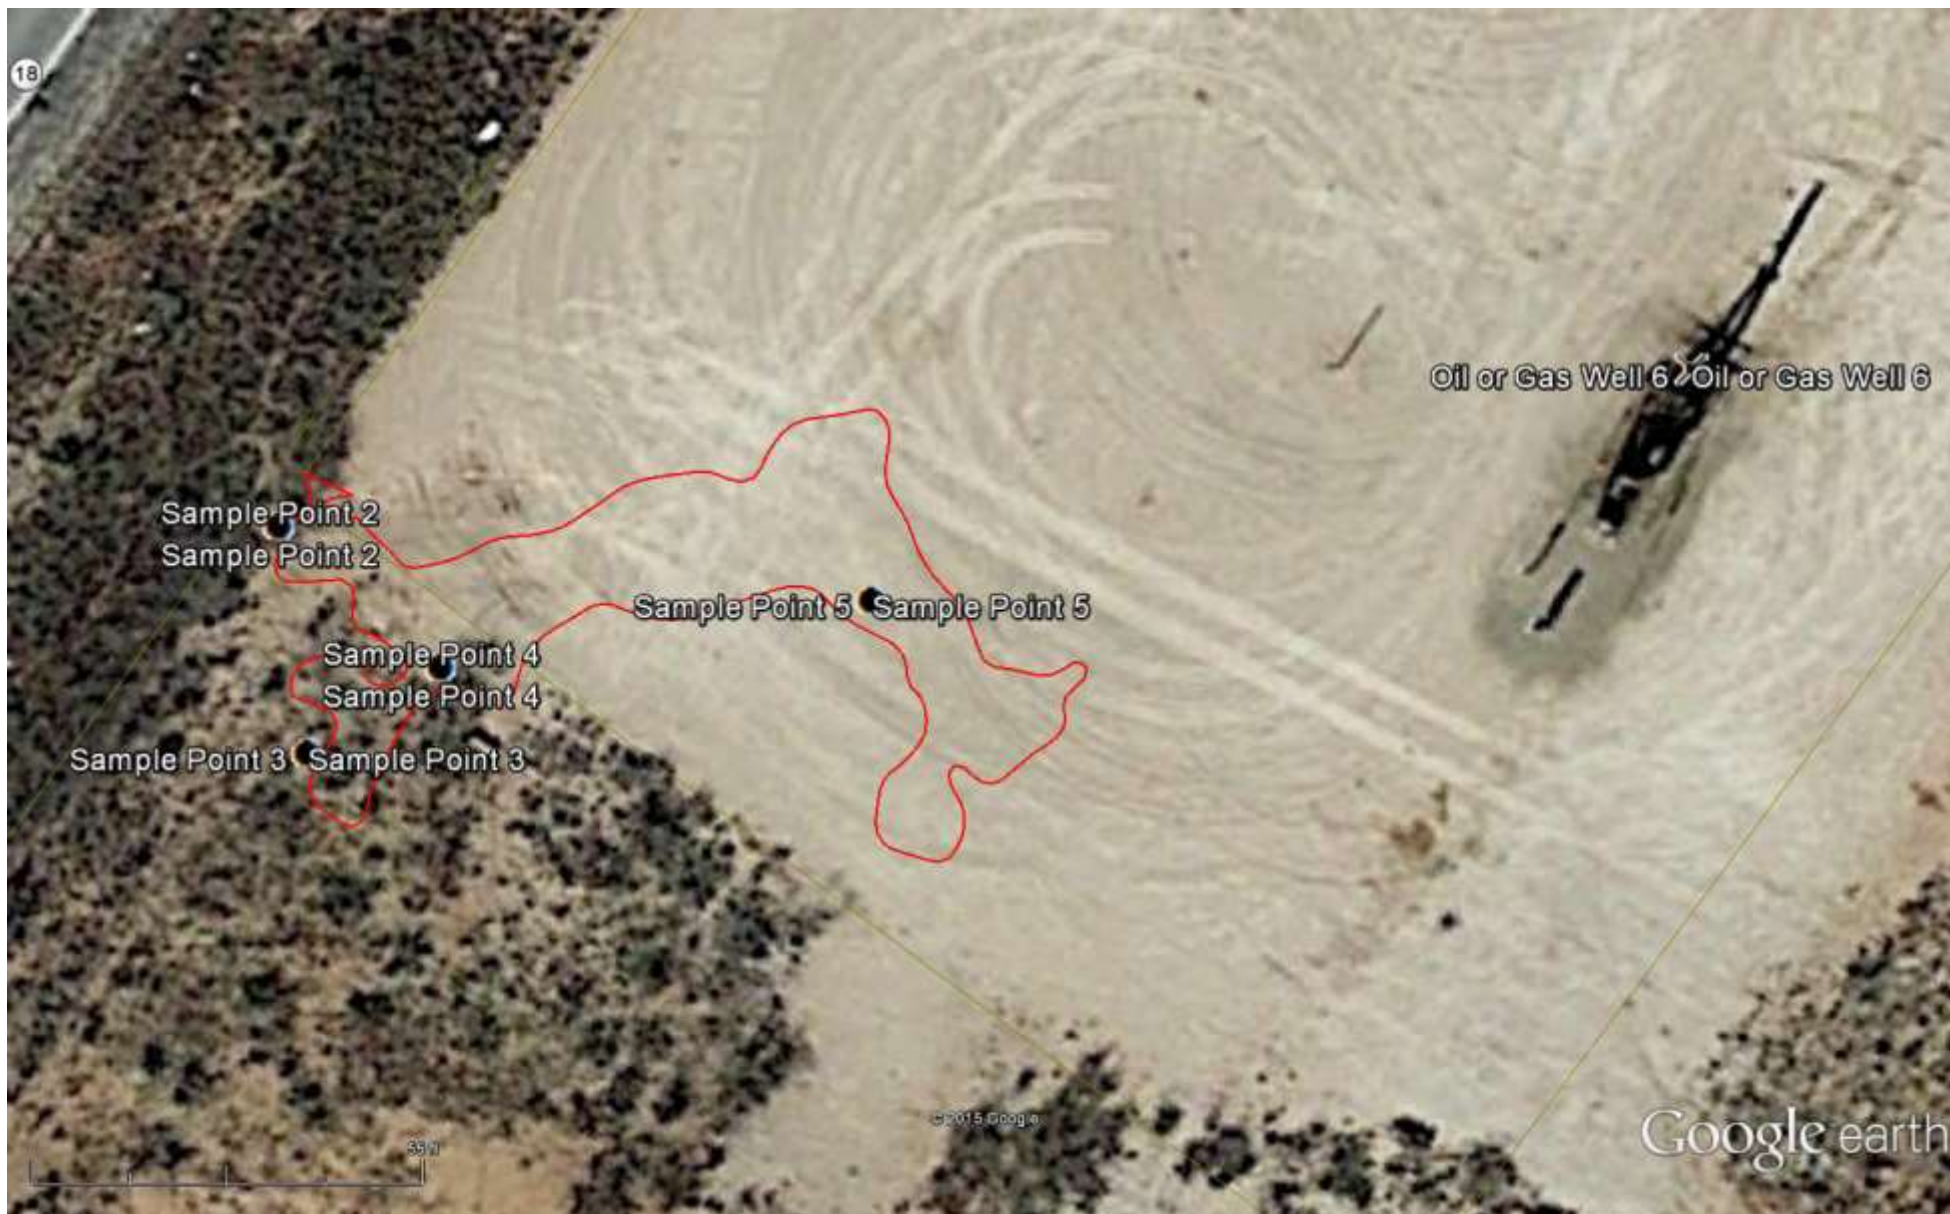
Figure 2
Site Plan

On December 29, 2014, Safety & Environmental Solutions, Inc. was onsite to determine vertical extent of contamination. Samples AH-1 and AH-2 was taken at a depth of 1.5', Sample AH-3 was taken at a depth of 2' and sample AH-4 was taken at a depth of 1'. All samples were properly packaged, preserved and transported to the Laboratory, Hobbs New Mexico and analyzed for Benzene, Toluene, Ethylbenzene, Xylenes, Total BTEX

1. Excavate 2' remove all contaminated soil transport to an approved NMOCD facility for disposal.
2. The excavated area will be backfilled with native soil and returned to natural grade.
3. No further action is necessary.
