Re : Chevron Special Projects – VGSAU 15 (RP# 3255)

Please find enclosed for your records, a copy of the final report documenting the assessment activities at the Vacuum Grayburg San Andres Unit No. 15 (RP #3255).

Release Notification and Corrective Action

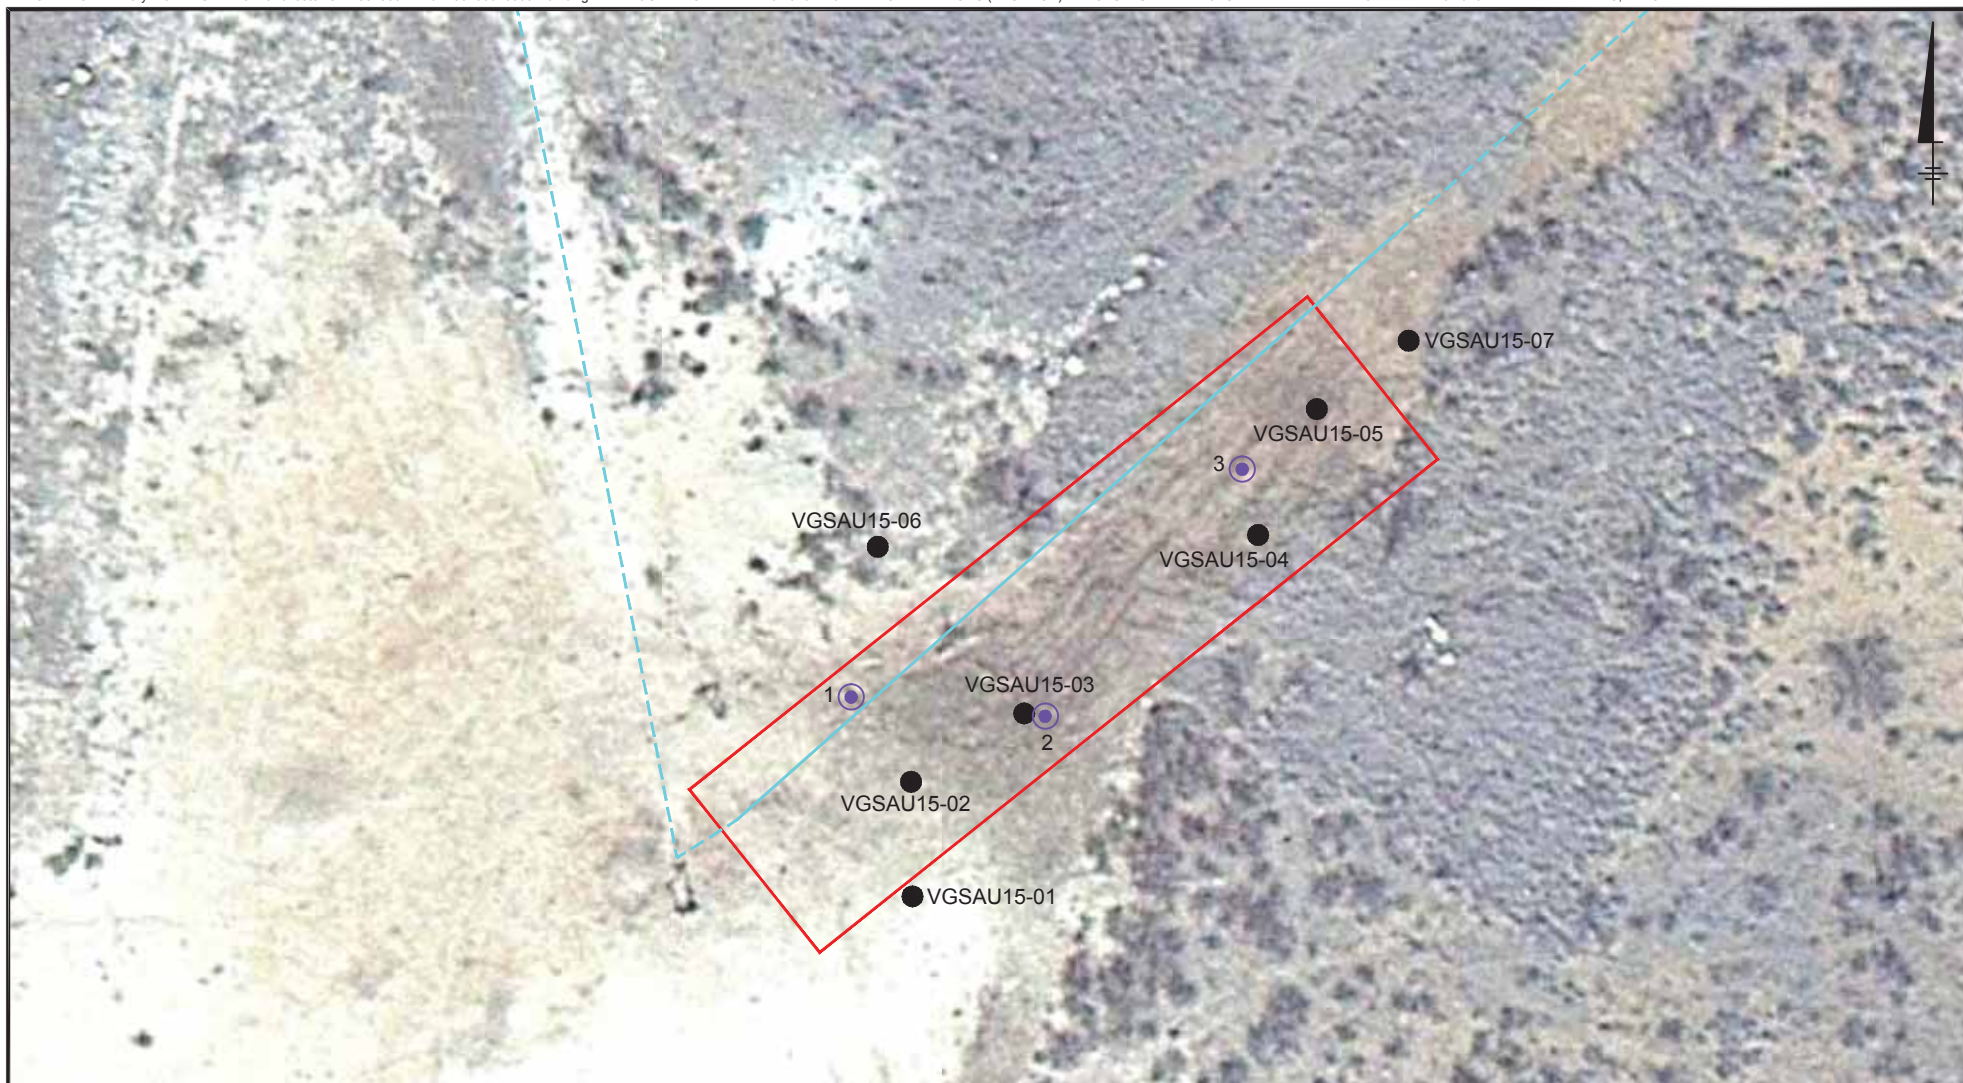
- MAY 2013 ASSESSMENT SOIL SAMPLING LOCATION
- ¹○ OCTOBER 2011 CONFIRMATION SOIL SAMPLING LOCATION
- - - - - POTENTIAL UNDERGROUND UTILITY LINE NOT DETECTED BY THIRD PARTY SURVEYOR
- UNDERGROUND UTILITY LINE
- APPROXIMATE EXTENT OF SPILL

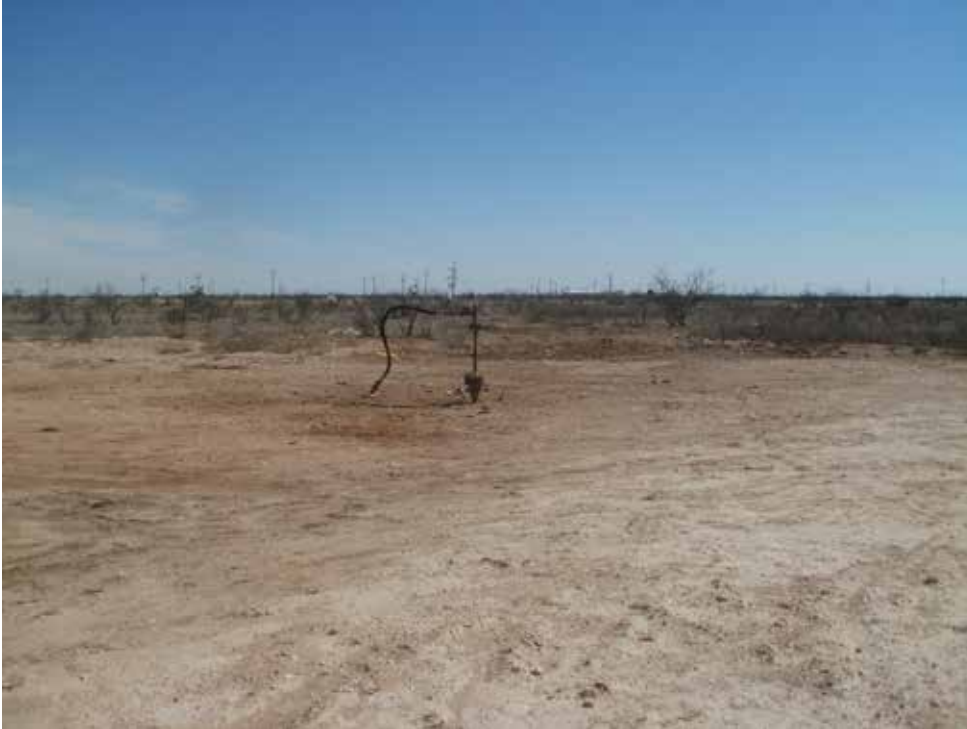
Photograph 1 – Vacuum
Grayburg San Andres Unit
Well #15; Facing Northeast
