Cimarex Red Hills SWD #1

CLOSURE REPORT

UL/M Sec 28, T25 south, R33 east, Lea county NM

API # 30-025-35598

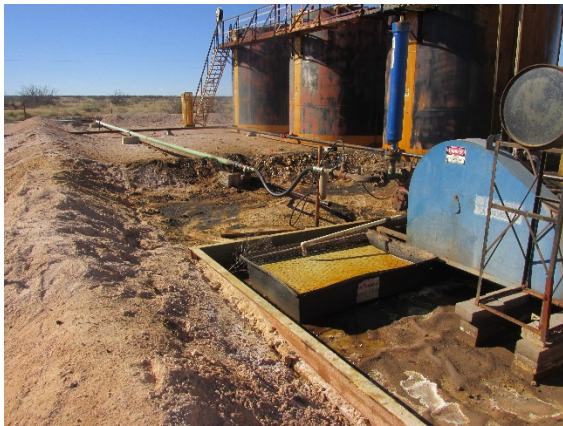
Initial spill photos inside bermed area

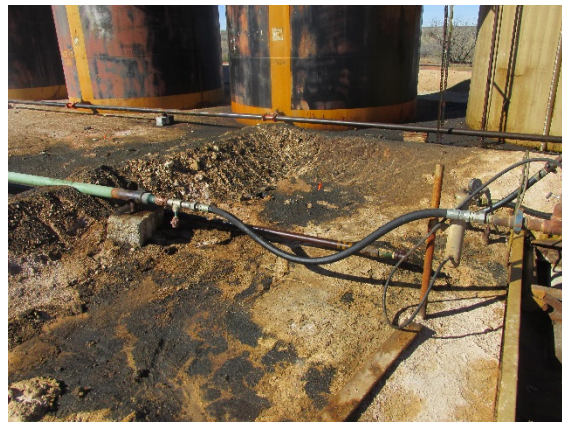
Initial spill photos inside bermed area

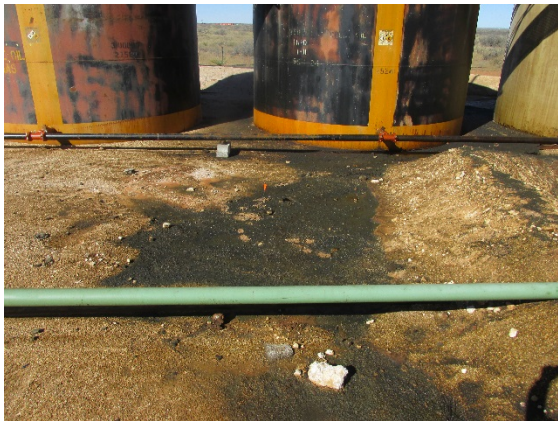
Initial spill photos inside bermed area

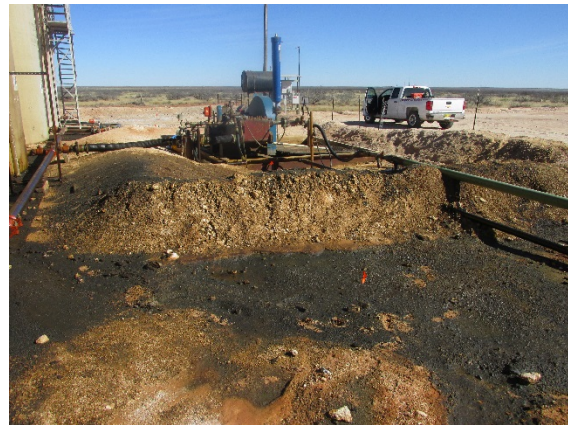
Initial spill photos inside bermed area

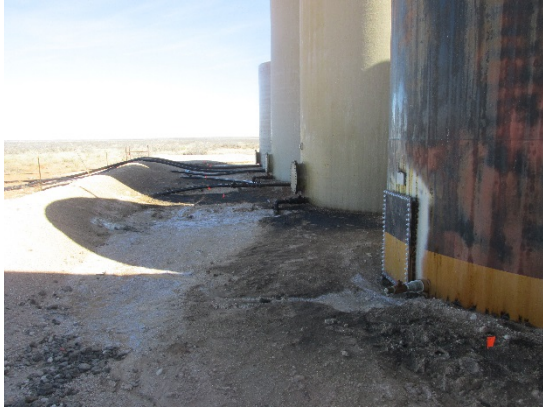
Initial spill around tanks

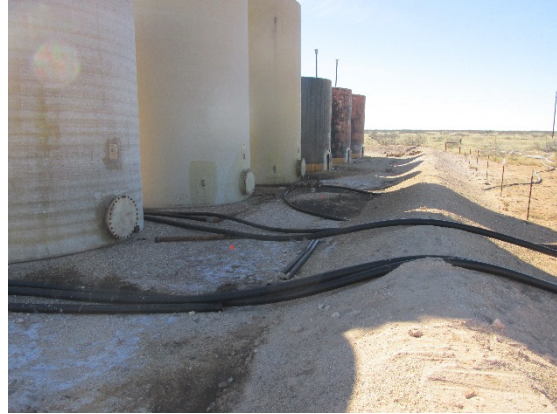
Initial spill around tanks

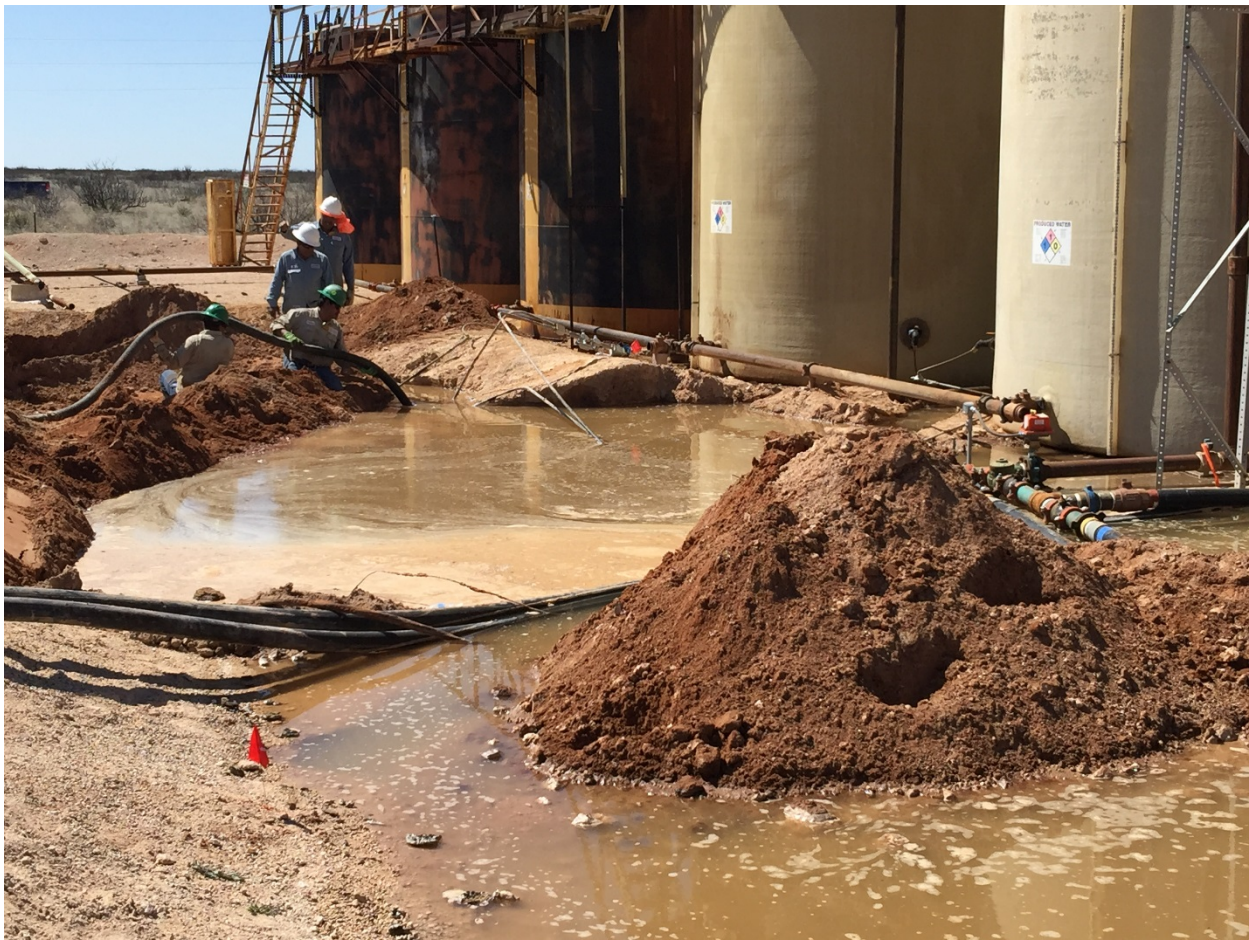
Second spill inside bermed area. Fluid being recovered by vacuum truck

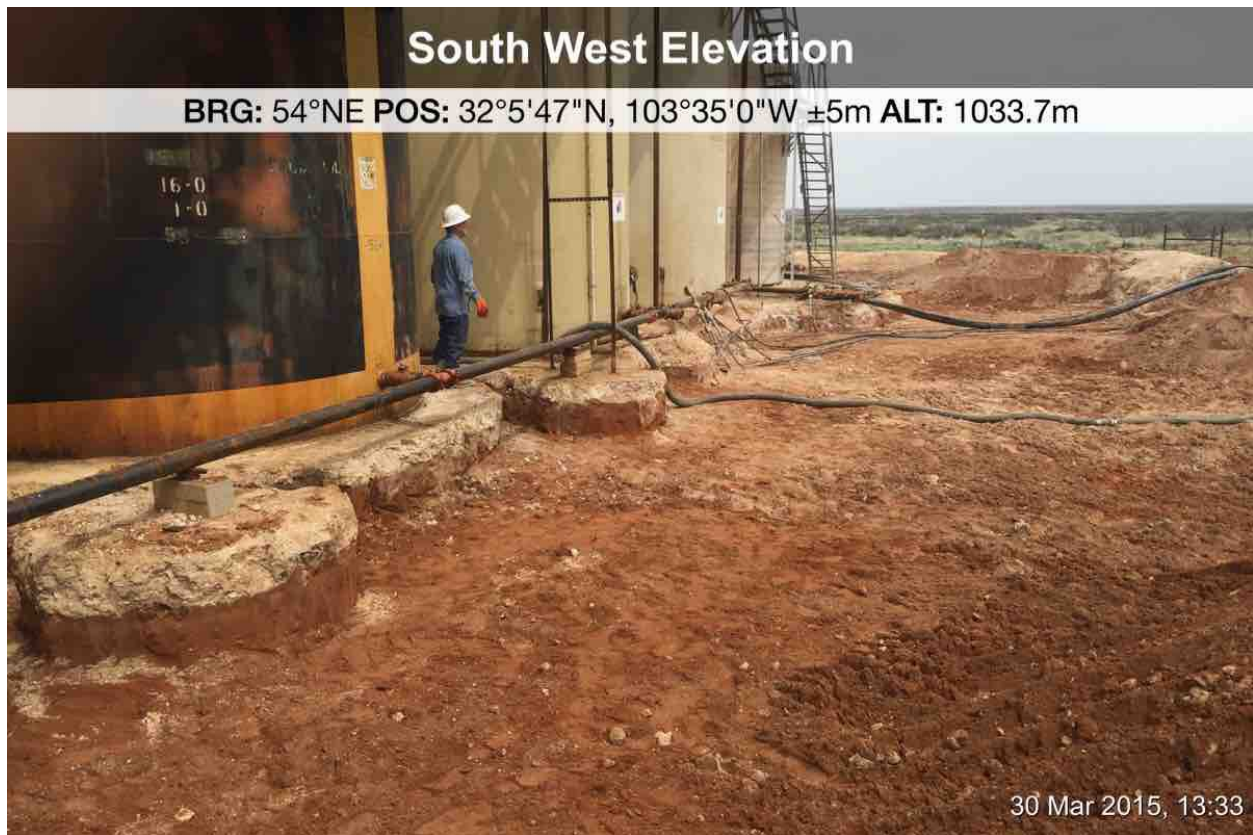
Spill area excavated to 2' bgs

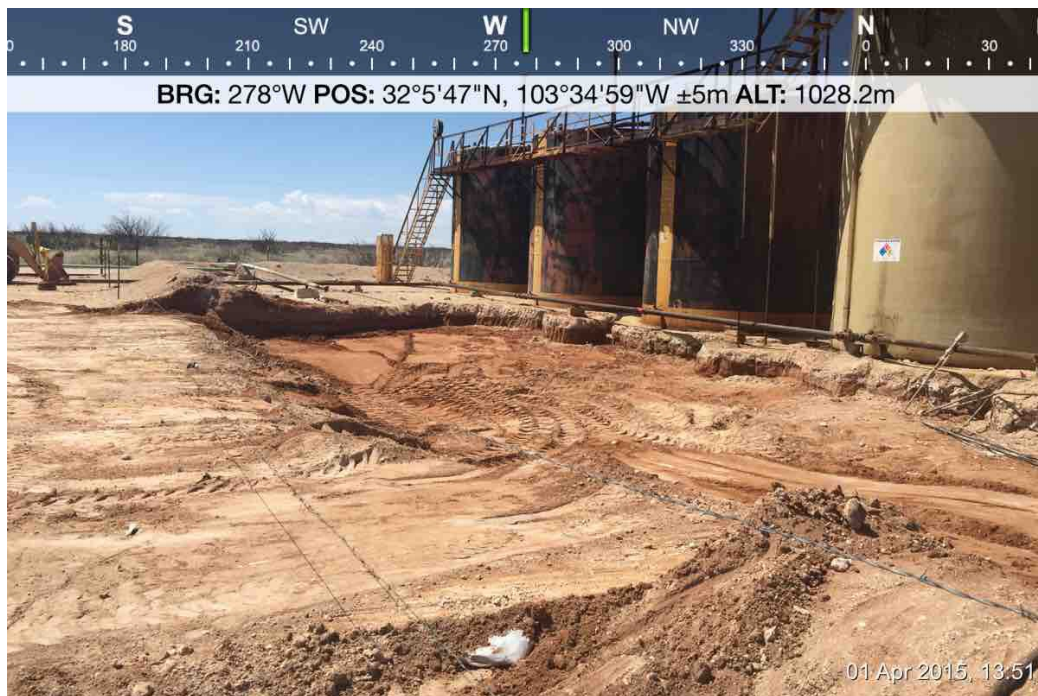
Spill area excavated to 2' bgs

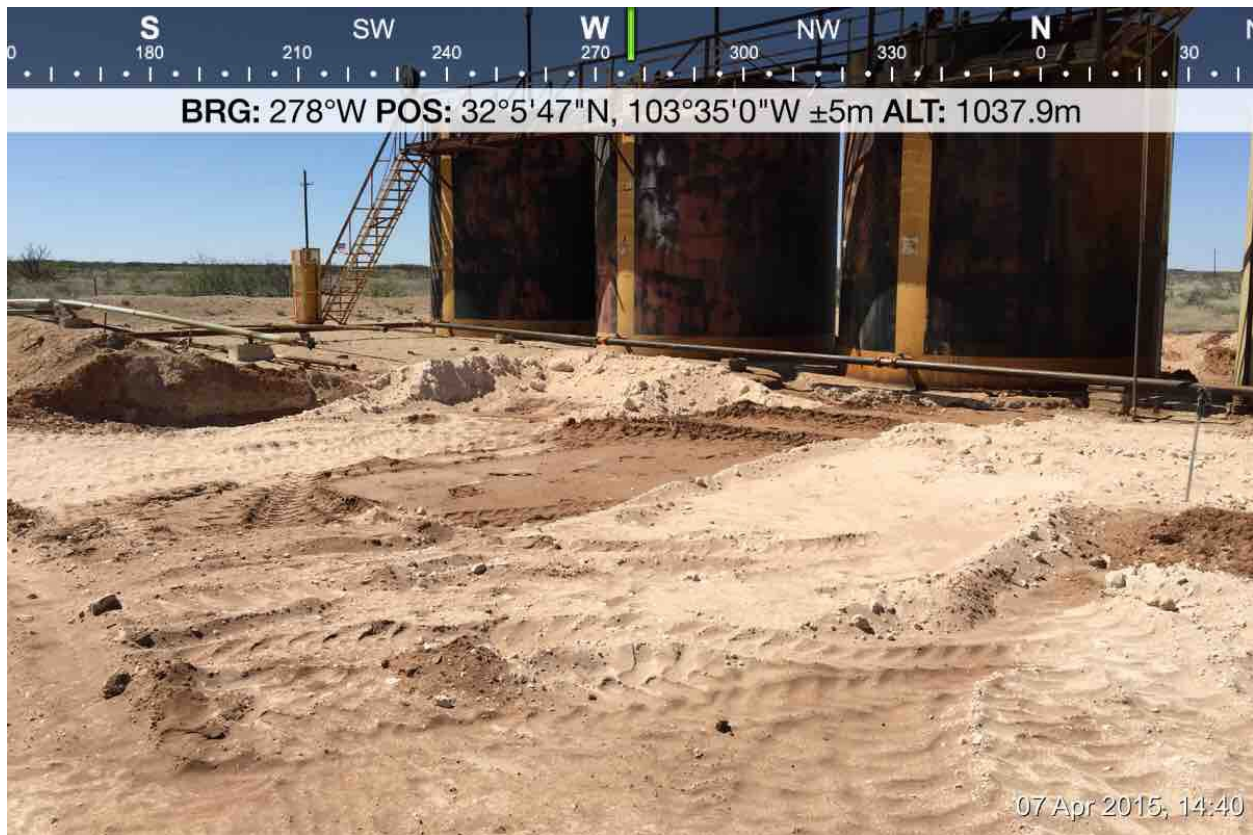
Fresh caliche being brought in for backfill

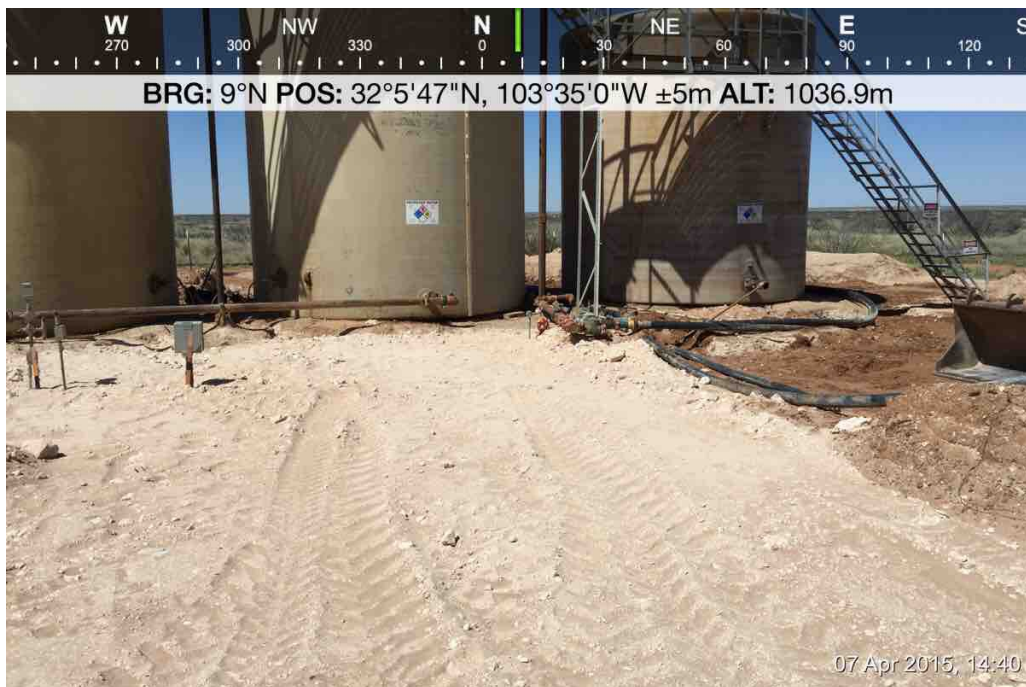
Fresh caliche being used for backfill

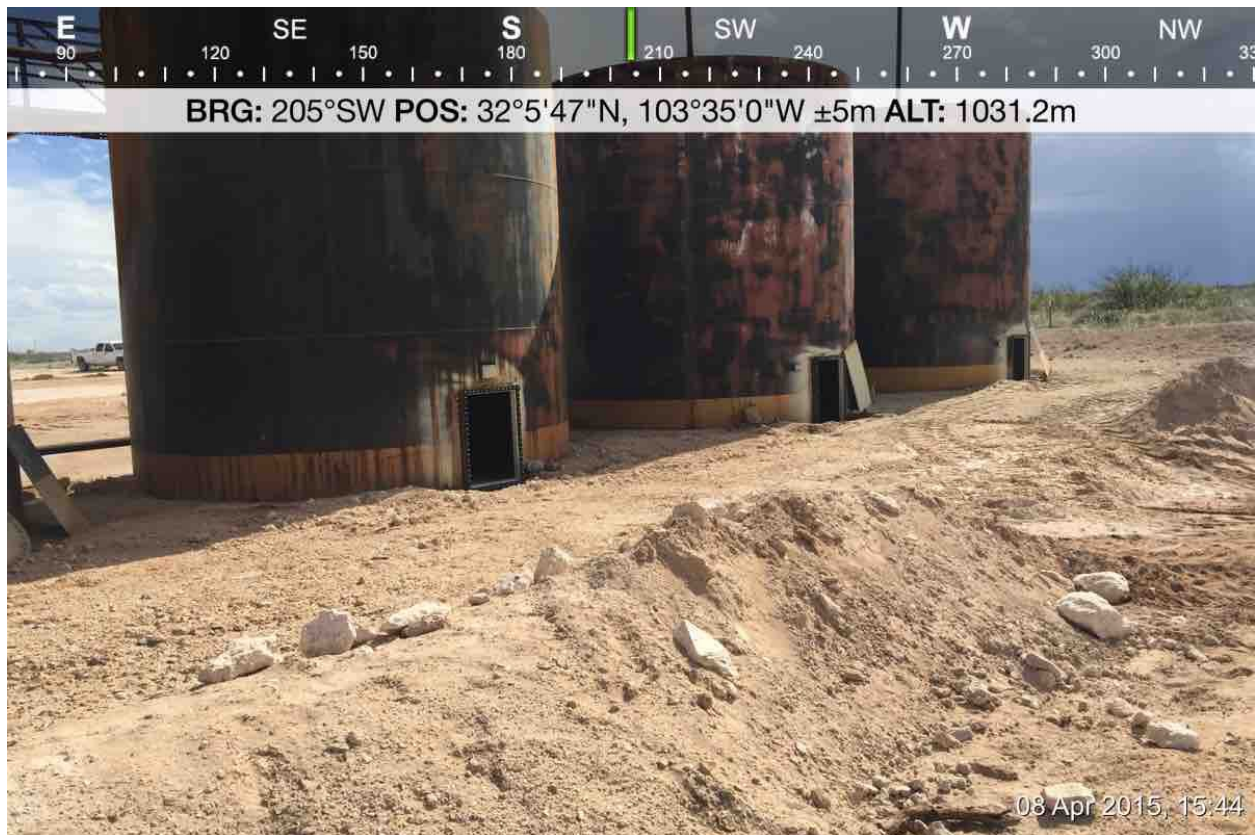
Caliche used for backfill around tanks

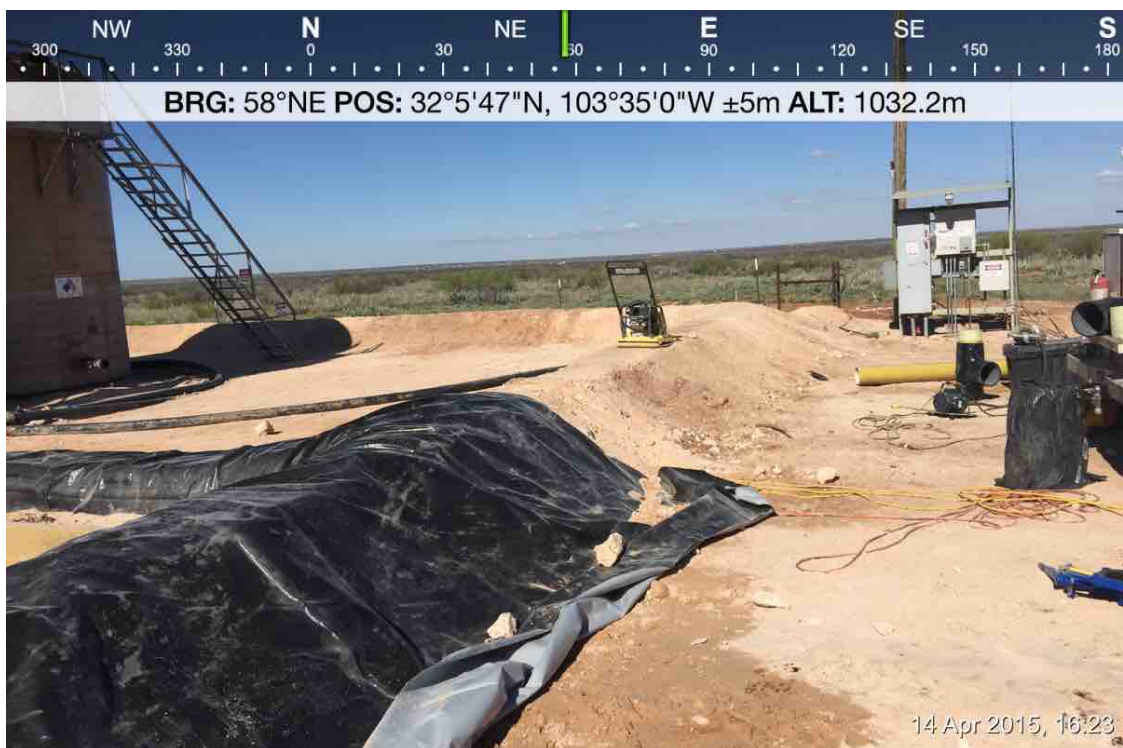
Compacting and constructing new berms around facility

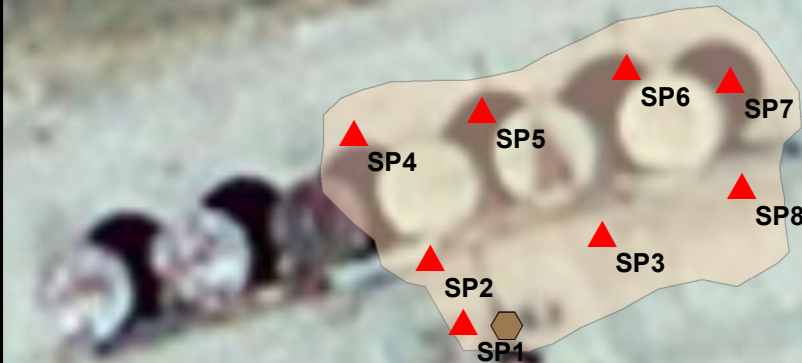
Site Diagram

Spill Area:
2,881 sq. ft.
