Re: **Remediation and Closure Report**
SOGO III, LLC, Wimberly 5,6,7 Battery – RP No.: 3666
API No.: 30-025-24482
Legal: Unit G – Sec 12 – T24S – R32E – 660 FSL, 660 FEL - Lea Co., NM
GPS: 32.2376546, -103.6389687
Depth to Groundwater: 525 ft bgs
Release Type: Crude Oil

Etech Environmental & Safety Solutions, Inc. (Etech) is pleased to submit the following remediation and closure report on the aforementioned site for your review and approval.

Attachment A
Final C-141

Attachment C
Photograph Log

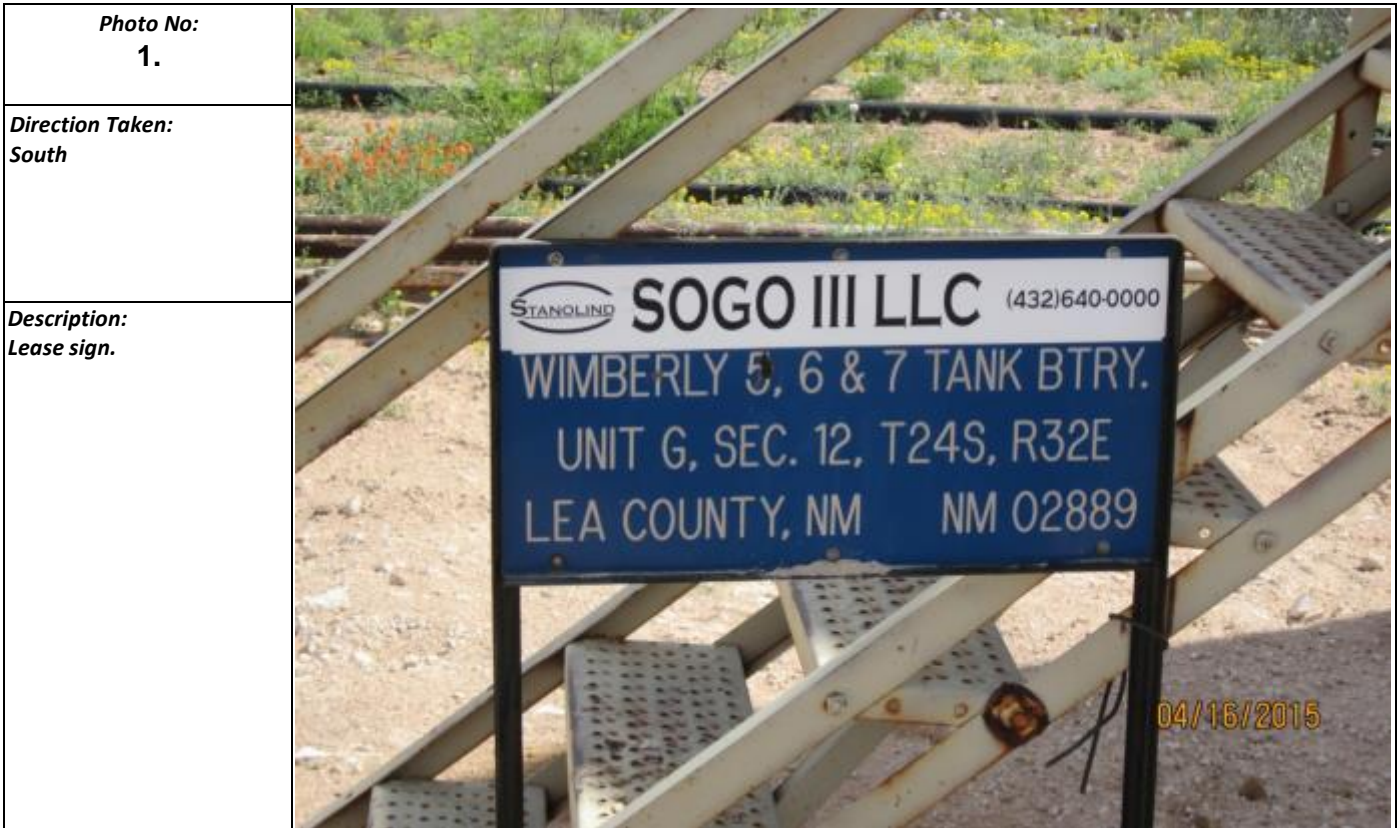
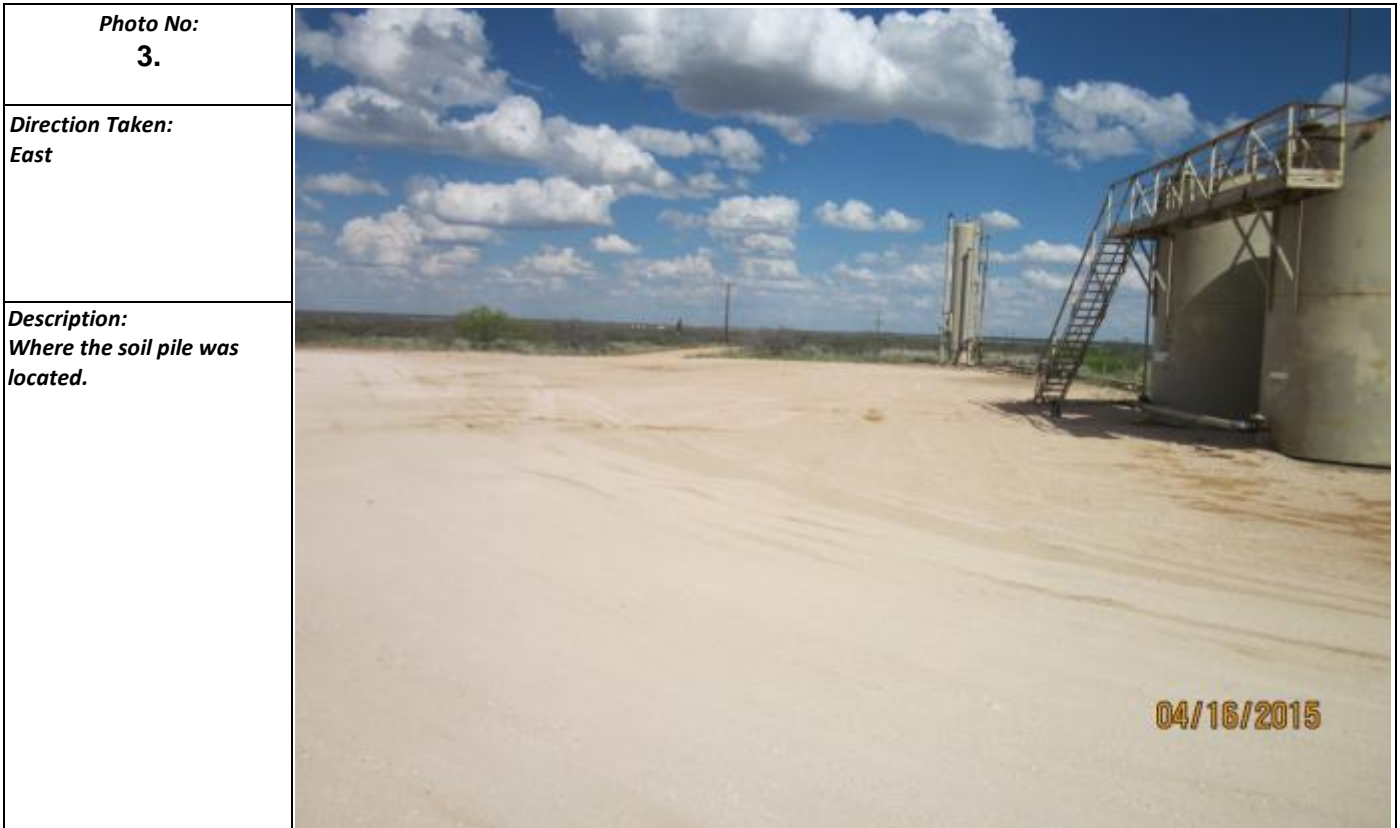
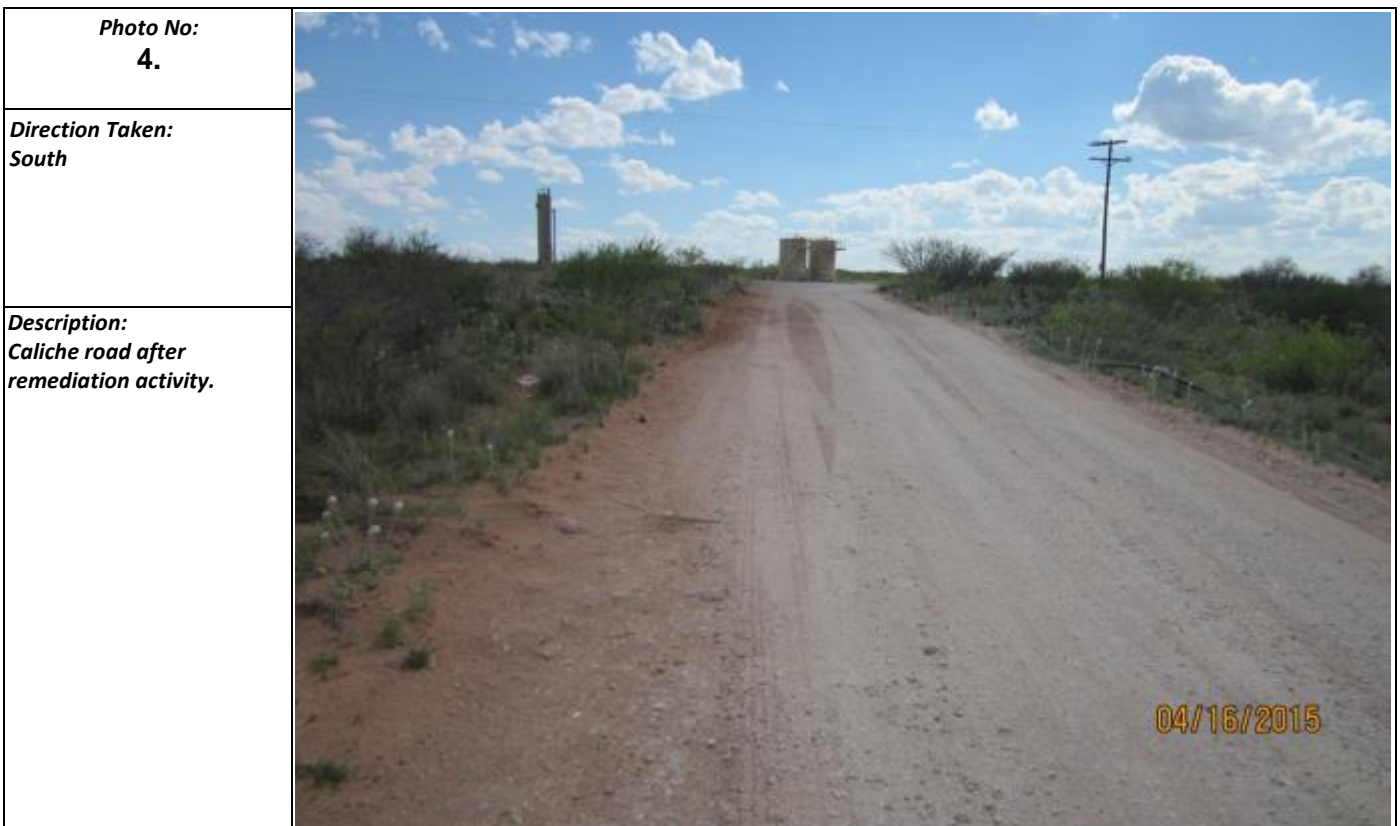
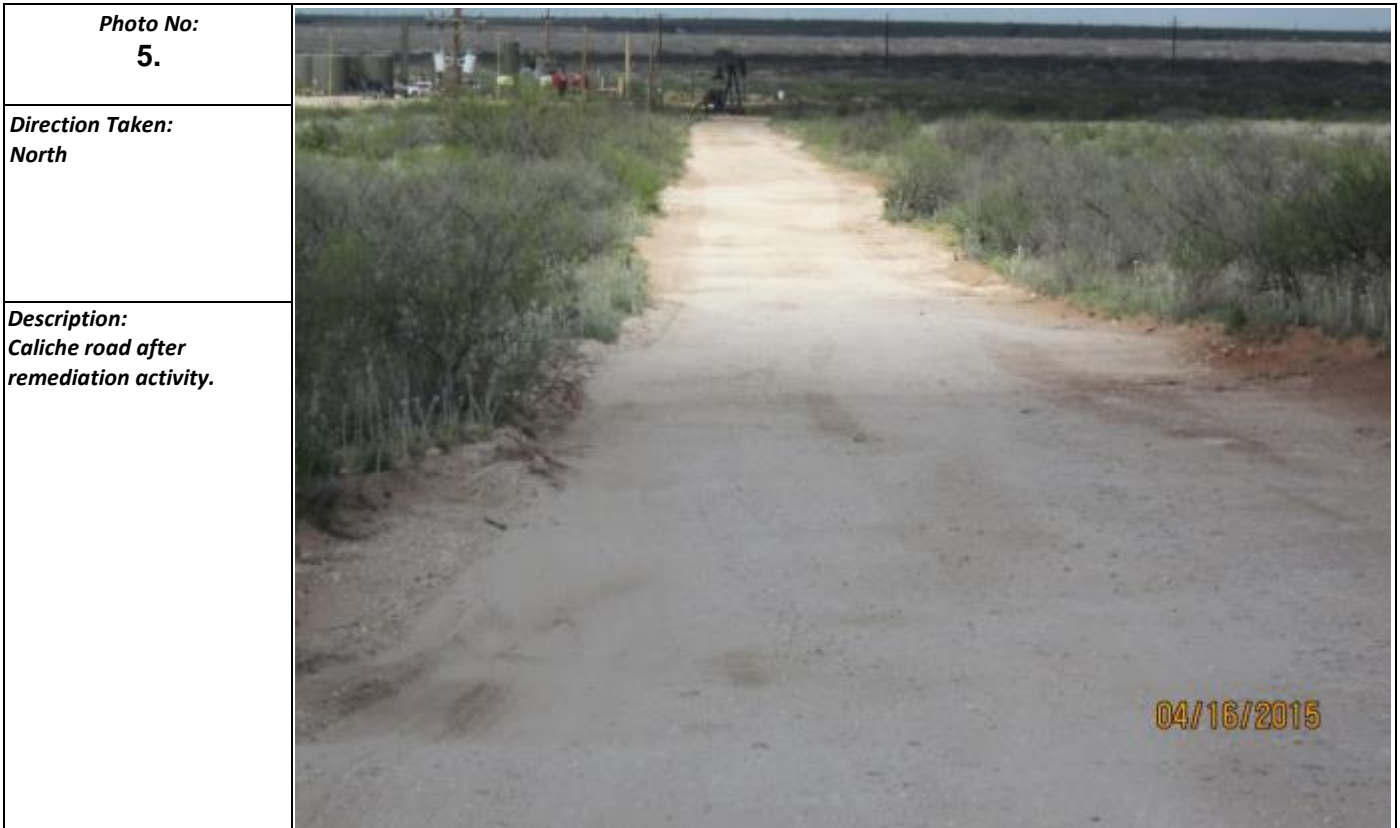
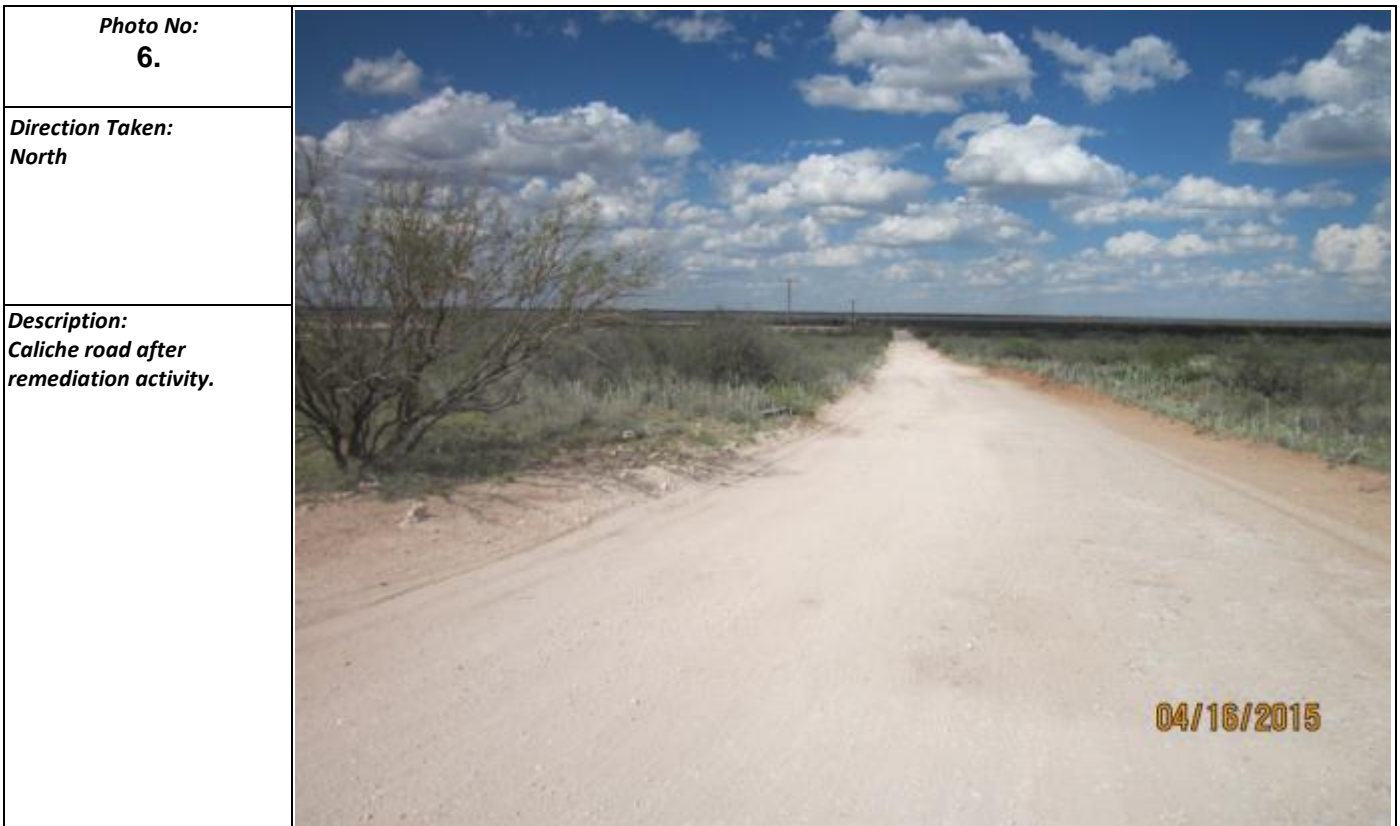
The release occurred due to a tank overflow. The release migrated northeast on the production pad, then migrated northeast off site and followed a lease road for approximately 600 feet, and impacting a pasture area 30 feet long by 8 feet wide. The impacted area of the production pad, caliche road and the pasture appeared to be surficial and limited to 6 inches. An immediate response was made in an effort to remove the standing fluids and minimize the depth of the impacted area. A copy of the C-141 is provided in Attachment A. An annotated aerial photograph showing the release area and TPH levels is provided in Attachment B. Photographs of the release area are provided in Attachment C. Analytical data is provided in Attachment D.

The impacted soils above regulatory threshold levels were excavated from the spill area utilizing a backhoe. Impacted soils were transported off site for disposal. Once the impacted soils were removed to acceptable levels, the production pad, caliche road, and pasture areas were backfilled with like materials. The site was restored to "as near as possible" to its original state. Seeding will take place when the seasonal conditions are conducive to maximizing the potential for seed germination. The site will be seeded with a range mix approved by the land owner.
