# SPILL CLEANUP REPORT

Devon Energy Production  
Coachwhip 26 Federal  
Lea County, New Mexico

Date of Spill: June 16, 2015

Re: Spill Cleanup Report at Devon Energy Production  
Coachwhip 26 Federal, Lea County, New Mexico

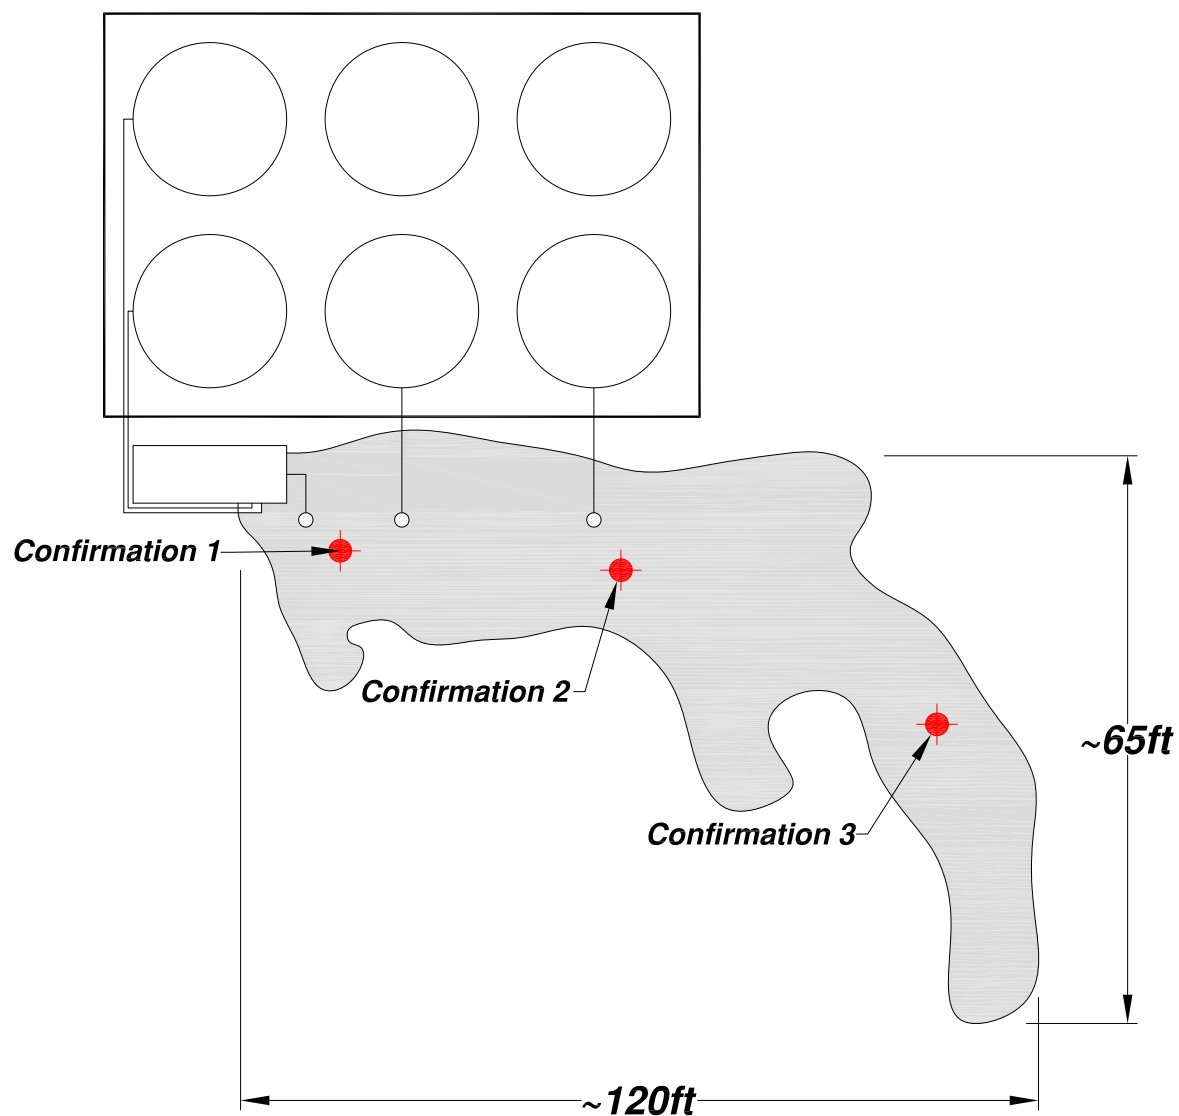
### Site Map with Soil Sample Locations

In Attachment 1 you will find a site map with the location of samples and photographic documentation of cleanup activities in Attachment 2. Table #1 in Attachment 3, summarizes soil analysis of sampling activities during spill cleanup along with copies of laboratory analysis reports. Attachment 4 includes a summary of average depth to water at the site, based on the New Mexico Water Rights Reporting System. Attachment 5 includes a water well search report confirming the absence of water wells within ½ mile radius of the affected area. Attachment 6 includes a USGS topographic map confirming the absence of surface water bodies in the vicinity of the affected area. See Attachment 7 for disposal documentation of waste generated during cleanup.

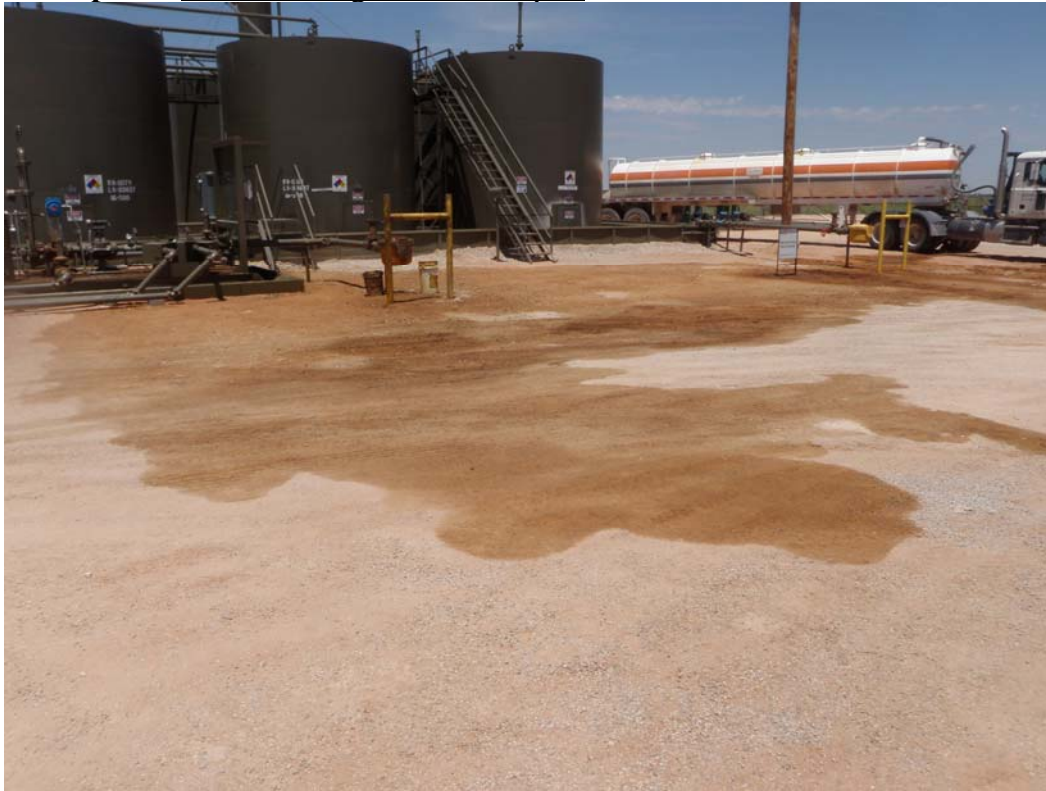
**Photograph:** 1

**Description:** View showing location of spill.

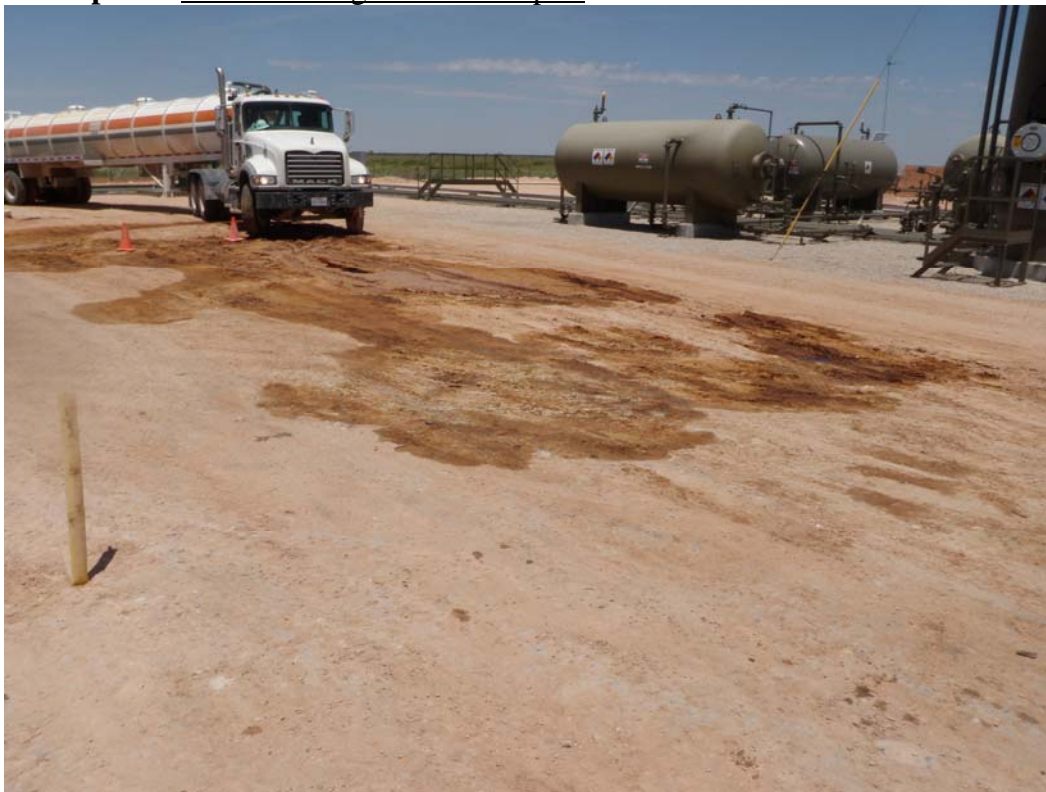
**Photograph:** 2

**Description:** View showing location of spill.

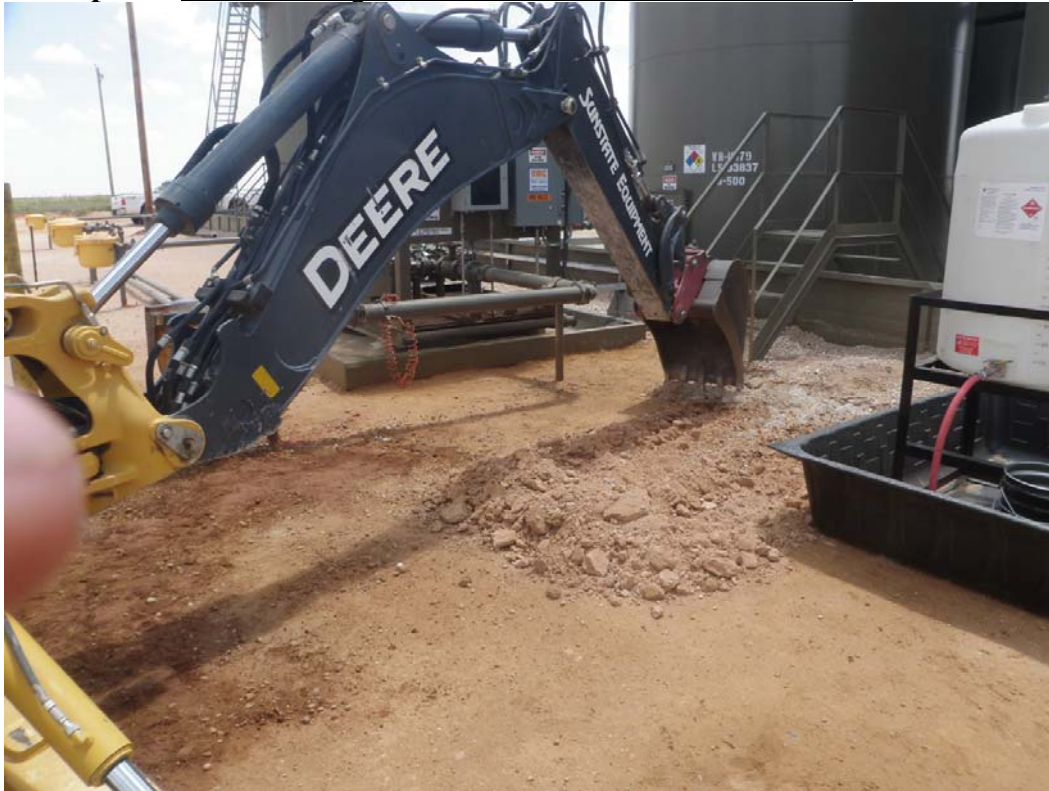
**Photograph: 3**

**Description:** View showing excavation activities of affected area.

D&H personnel arrived to the site on June 25, 2015, to begin cleanup activities. Excavation and disposal activities took place from June 25 through June 29, 2015. A total of 68 cubic yards of contaminated soil were removed and transported to Lea Land landfill in Carlsbad, NM. As of the date of this report, backfilling activities are pending.

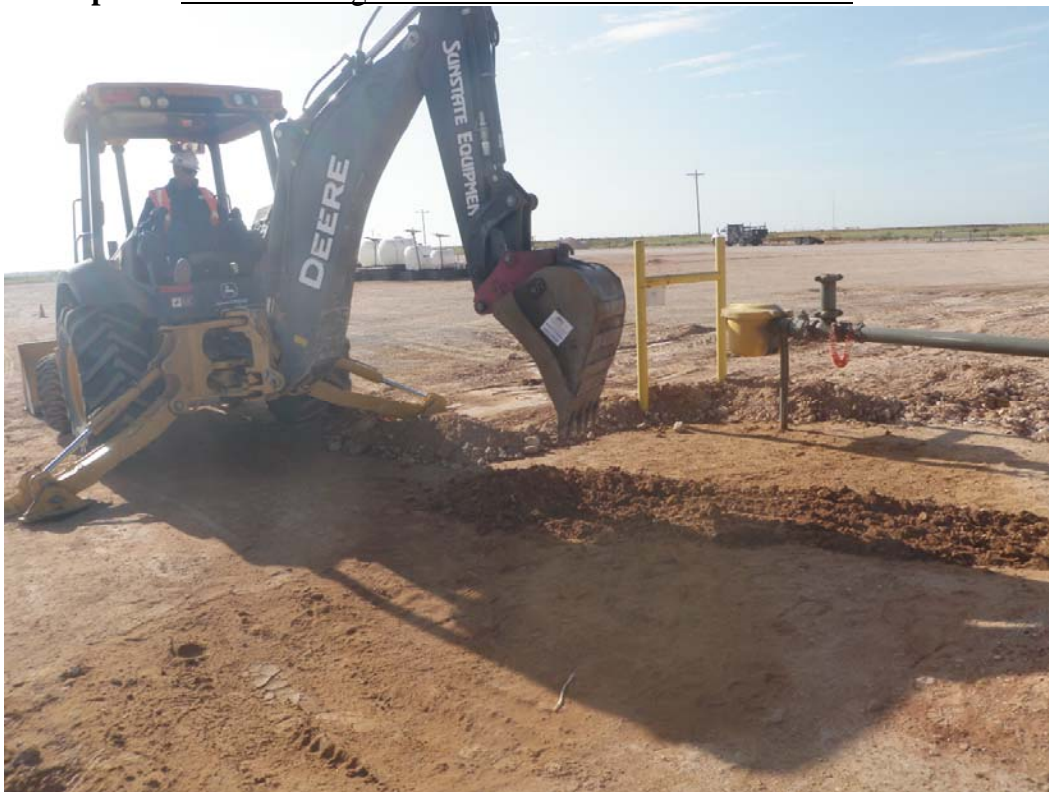
**Photograph: 4**

**Description:** View showing excavation activities of affected area.

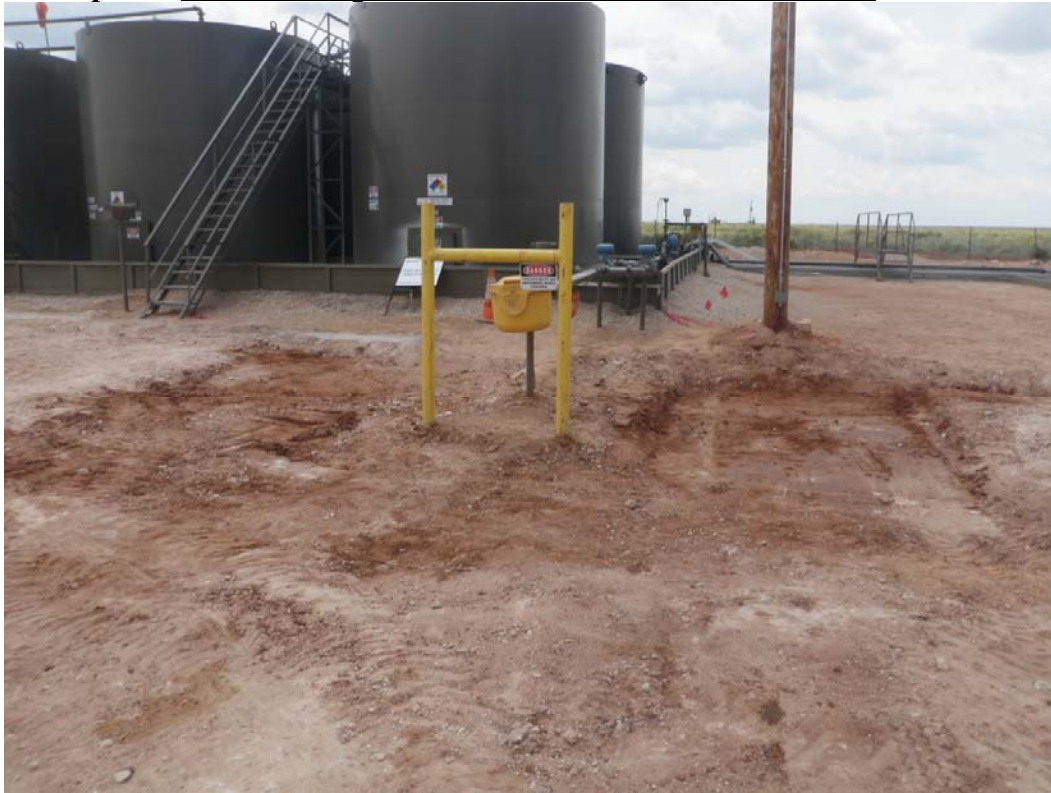
**Photograph:** 5

**Description:** View showing affected area after excavation activities.

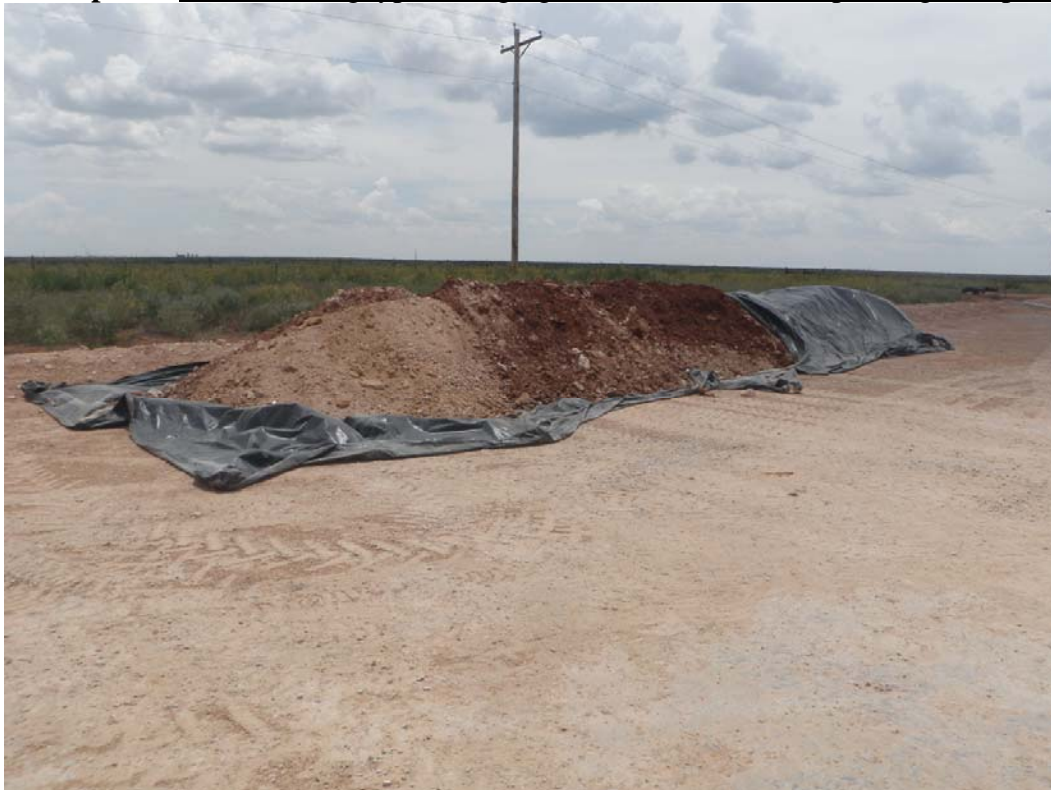
**Photograph:** 6

**Description:** View showing typical staging of contaminated soils pending transportation to landfill.

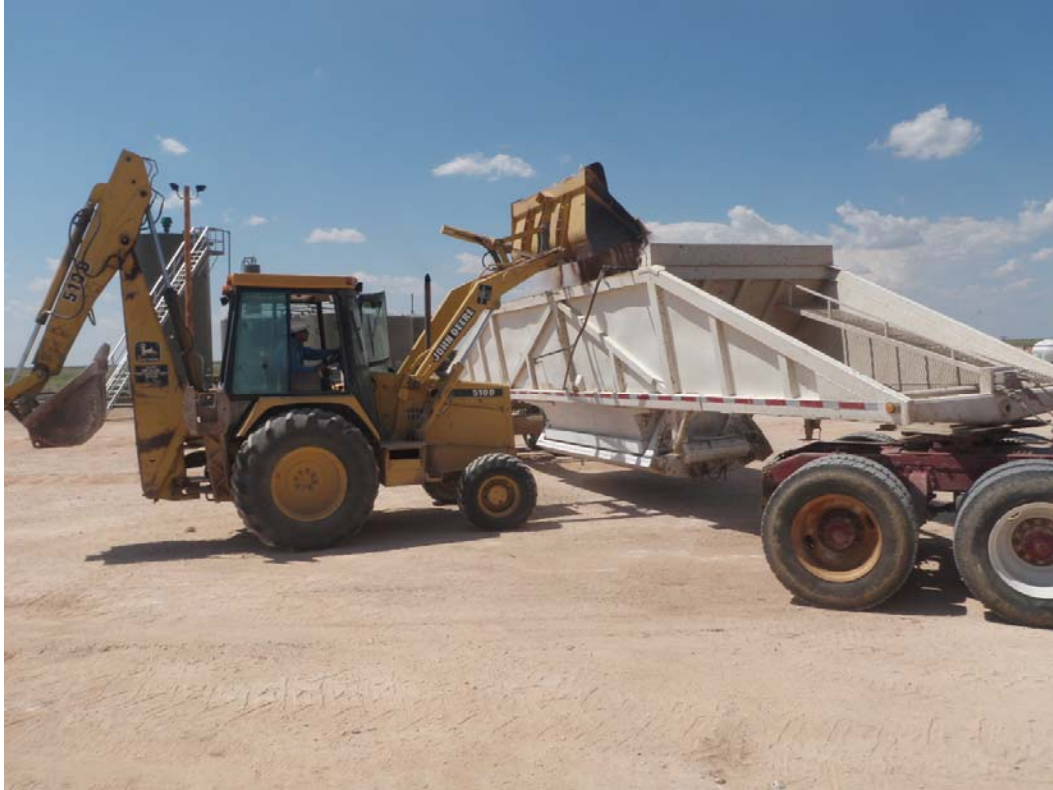
**Photograph:** 7

**Description:** View showing typical loading of contaminated soil for transportation to landfill.

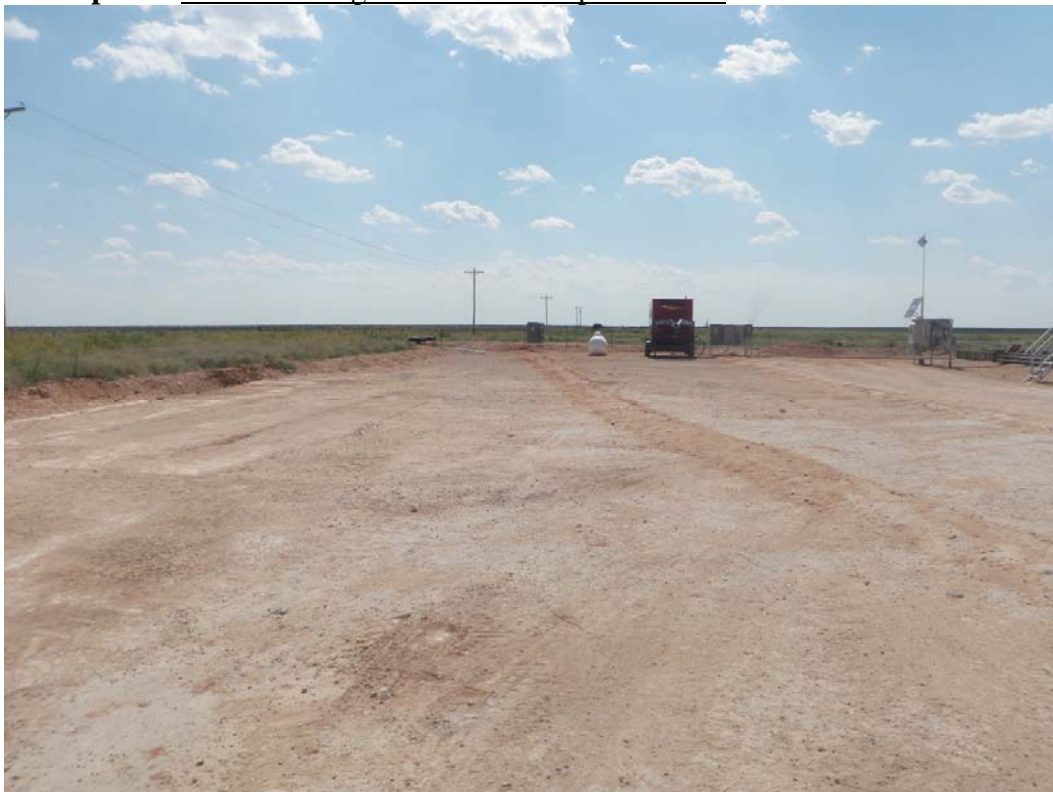
**Photograph:** 8

**Description:** View showing site after cleanup activities.

As outlined in the OCD Guidelines for Remediation of Leaks, Spills and Releases and based on our findings, the site's top ranking score is 0. Therefore, the remediation action level for TPH is 5,000 mg/Kg. Confirmation samples show that the affected area has been cleaned to OCD standards and we recommend final closure. D&H requests approval to backfill excavated areas.
