Closure Report**APPROVED**

Site Name:	HV Pike 3 Battery
Company:	Oxy Permian Ltd.
Legal Description:	U/L D, Section 6, T23S, R38E
County:	Lea County, NM
GPS Coordinates:	N 32.33908° W 103.10629°

Oxy
H V Pike 3 Battery

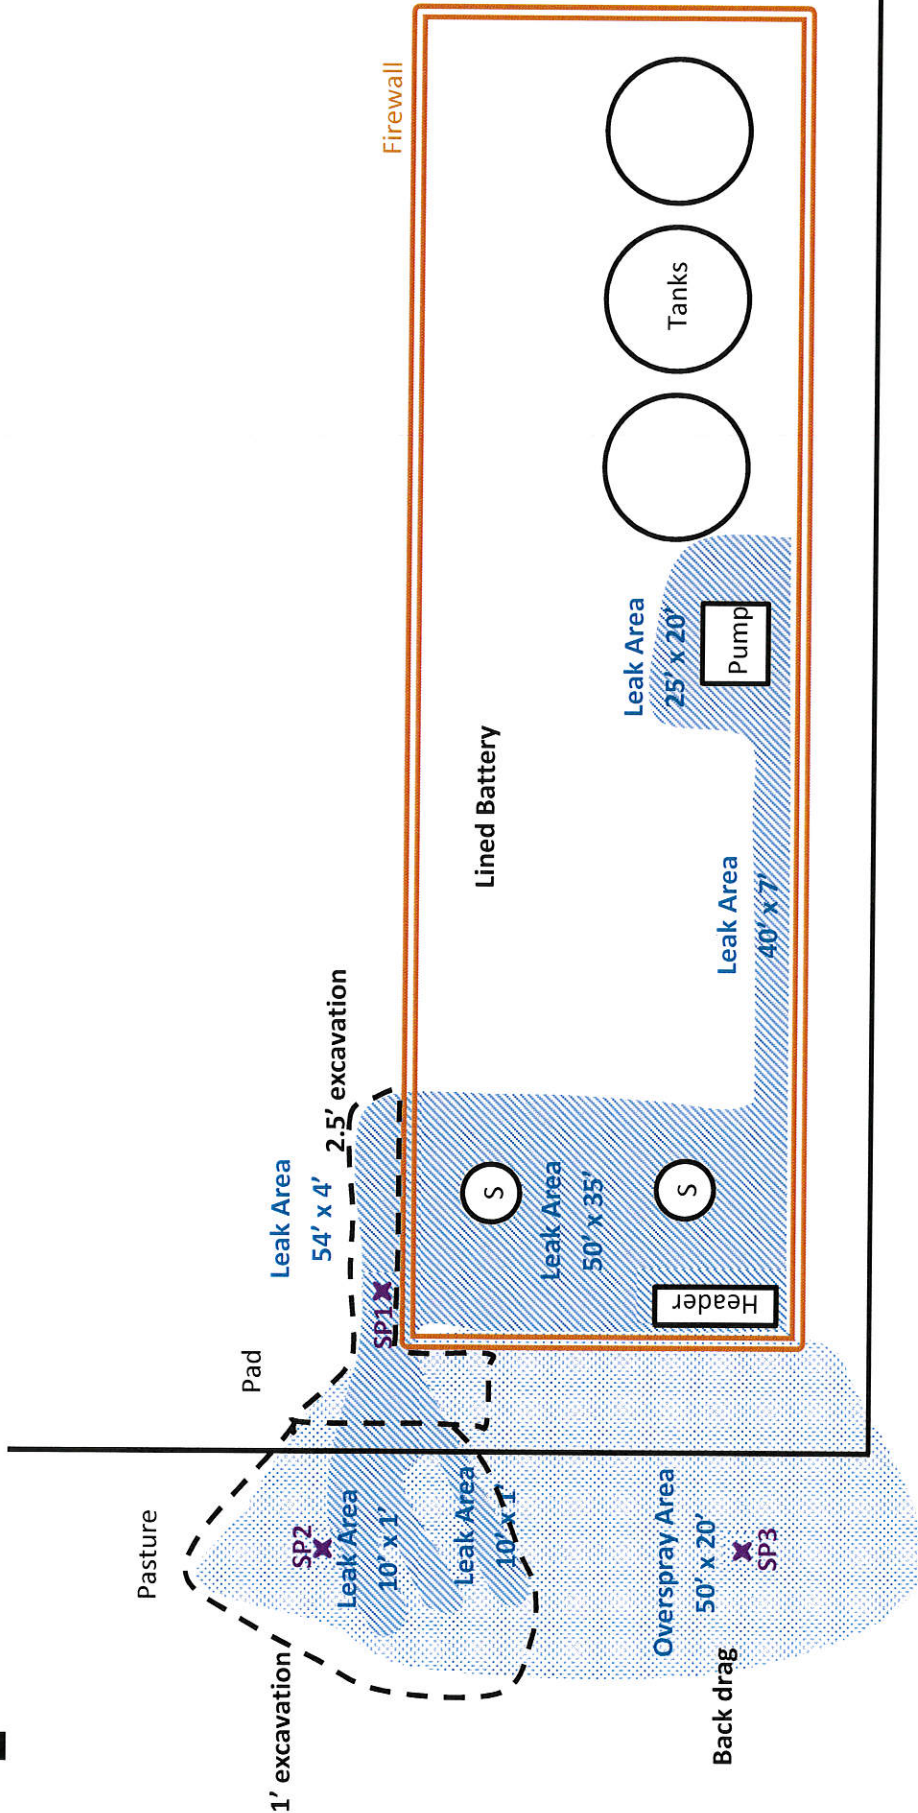
U/L D, Section 6, T23S, R38E
Lea County, NM
N 32.33908° W 103.10629°
API# 30-025-34951°

BBC International, Inc.	
Oxy	
H V Pike 3 Battery	
Date: 05/07/2014	DRWG by: K. Purvis
NOT TO SCALE	File: Oxy 2014

Remediation Parameters:	Excavate the area around SP1 to a depth of 2.5 feet. Excavate the area around SP2 to a depth of 1 foot. Remove the impacted soil from inside the lined battery. Backdrag the overspray area. Backfill the site with clean soil.	
Remediation Activities:	05/18/2015 to 06/12/2015	
Plan Sent to OCD:	10/20/2014	Email from Cliff Brunson to Tomas Oberding
OCD Approval of Plan:	10/20/2014	Email from Tomas Oberding to Cliff Brunson
Plan Sent to BLM:	n/a	n/a
BLM Approval of Plan:	n/a	n/a

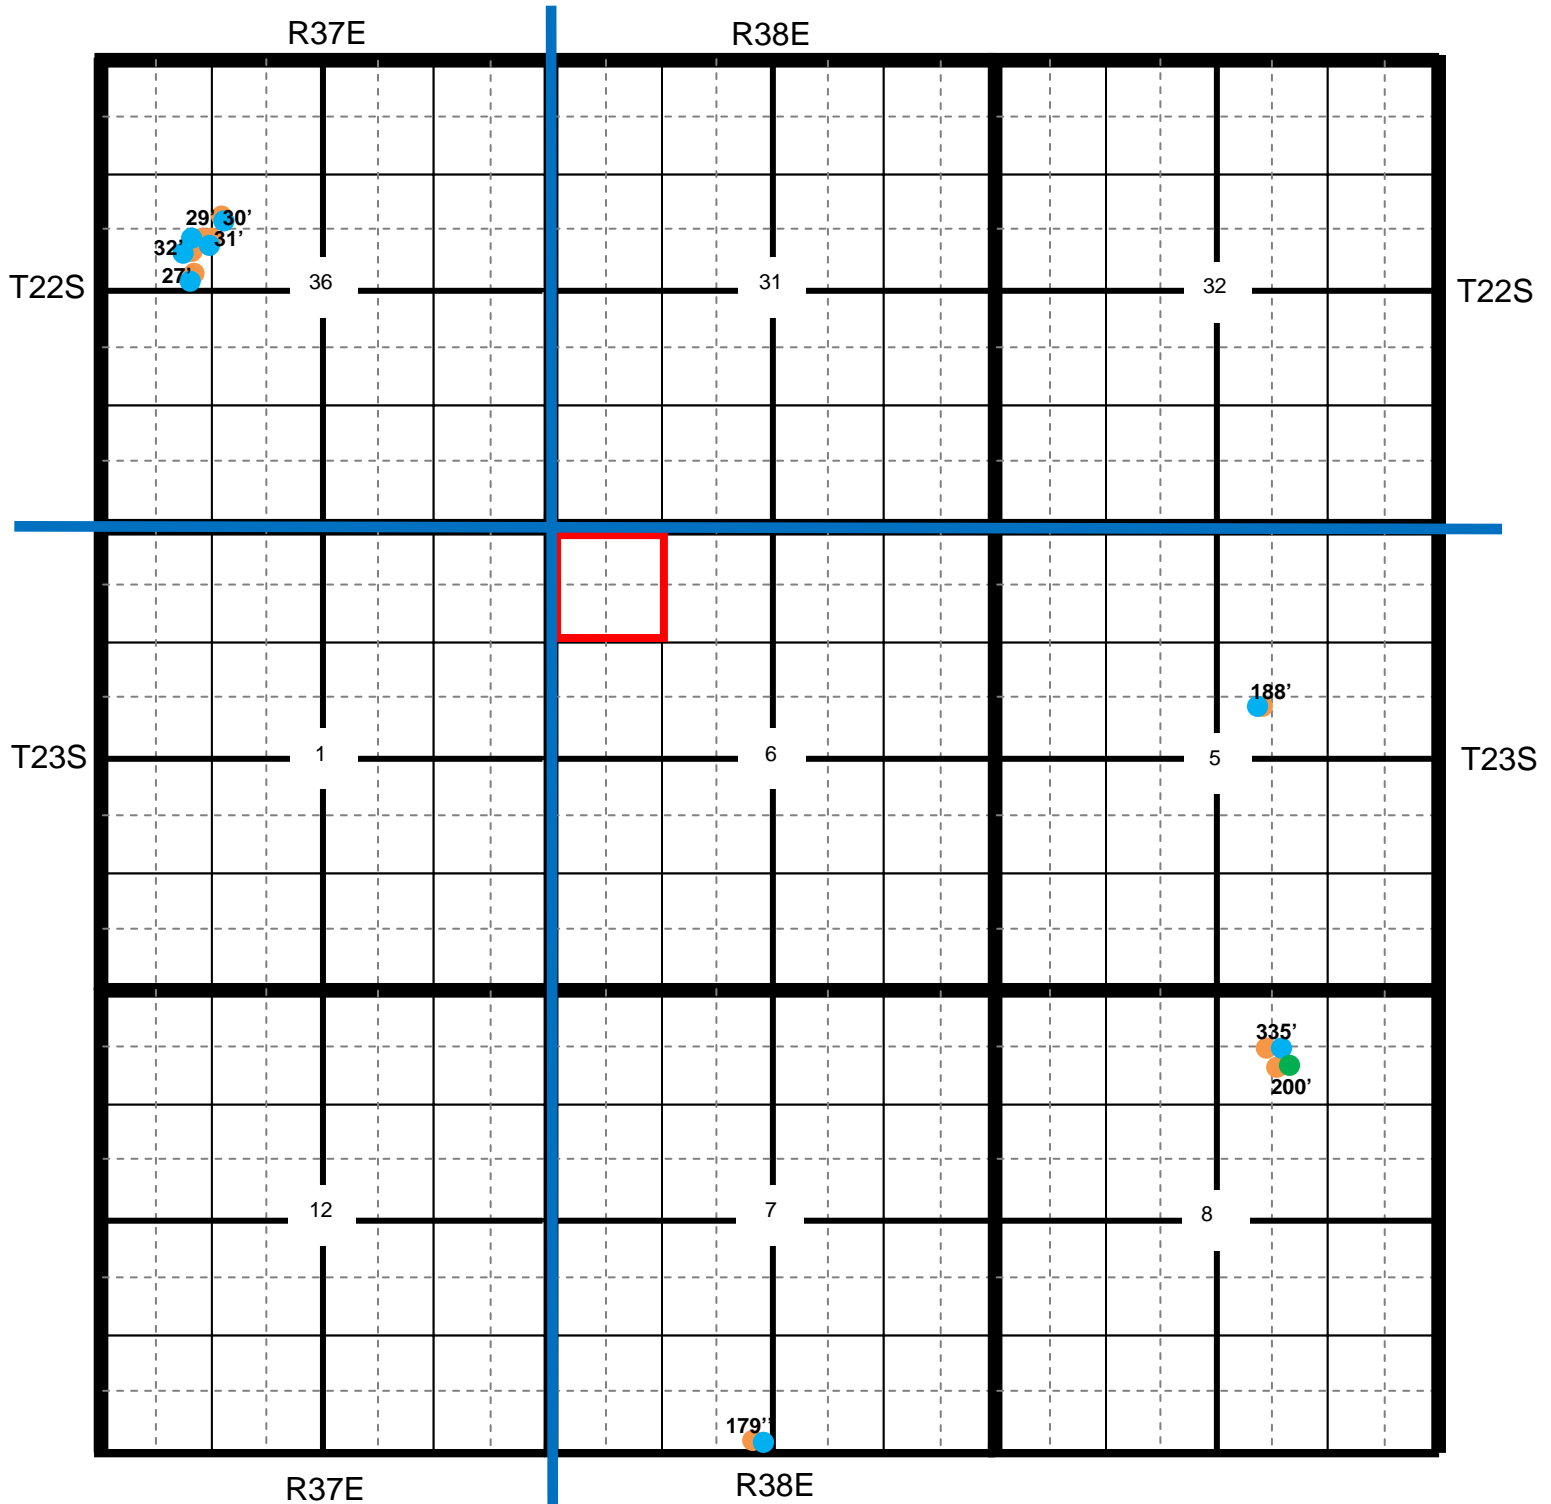
Groundwater Plot

Oxy H V Pike 3 Battery

Trend Map 100'

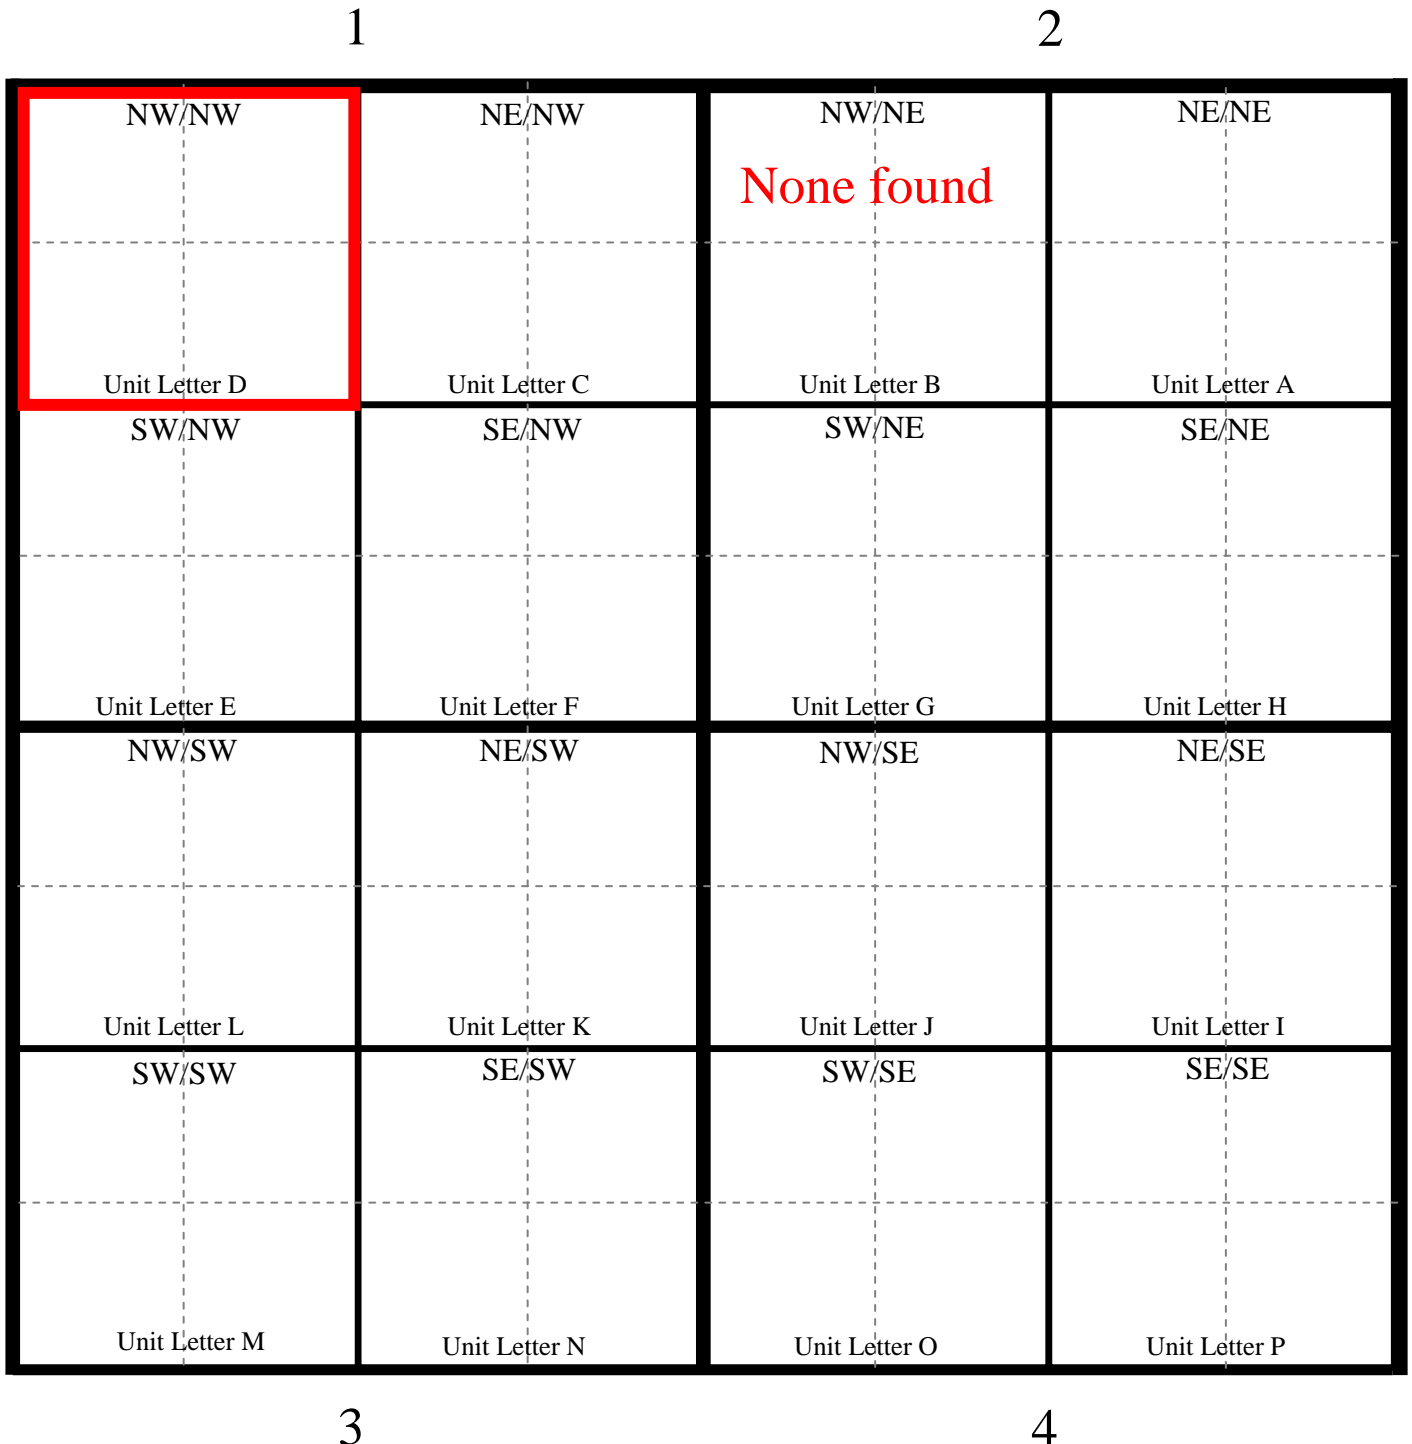
Oxy H V Pike 3 Battery

Trend Map 100'
