RE: Final Closure Report  
XTO Energy – EMSU #209  
UL-J, Section 3, Township 21 South, Range 36 East  
Lea County, New Mexico  
NMOCD Reference # 1RP-3651

The following *Final Closure Report* serves as a condensed update on closure activities for the above referenced Site.

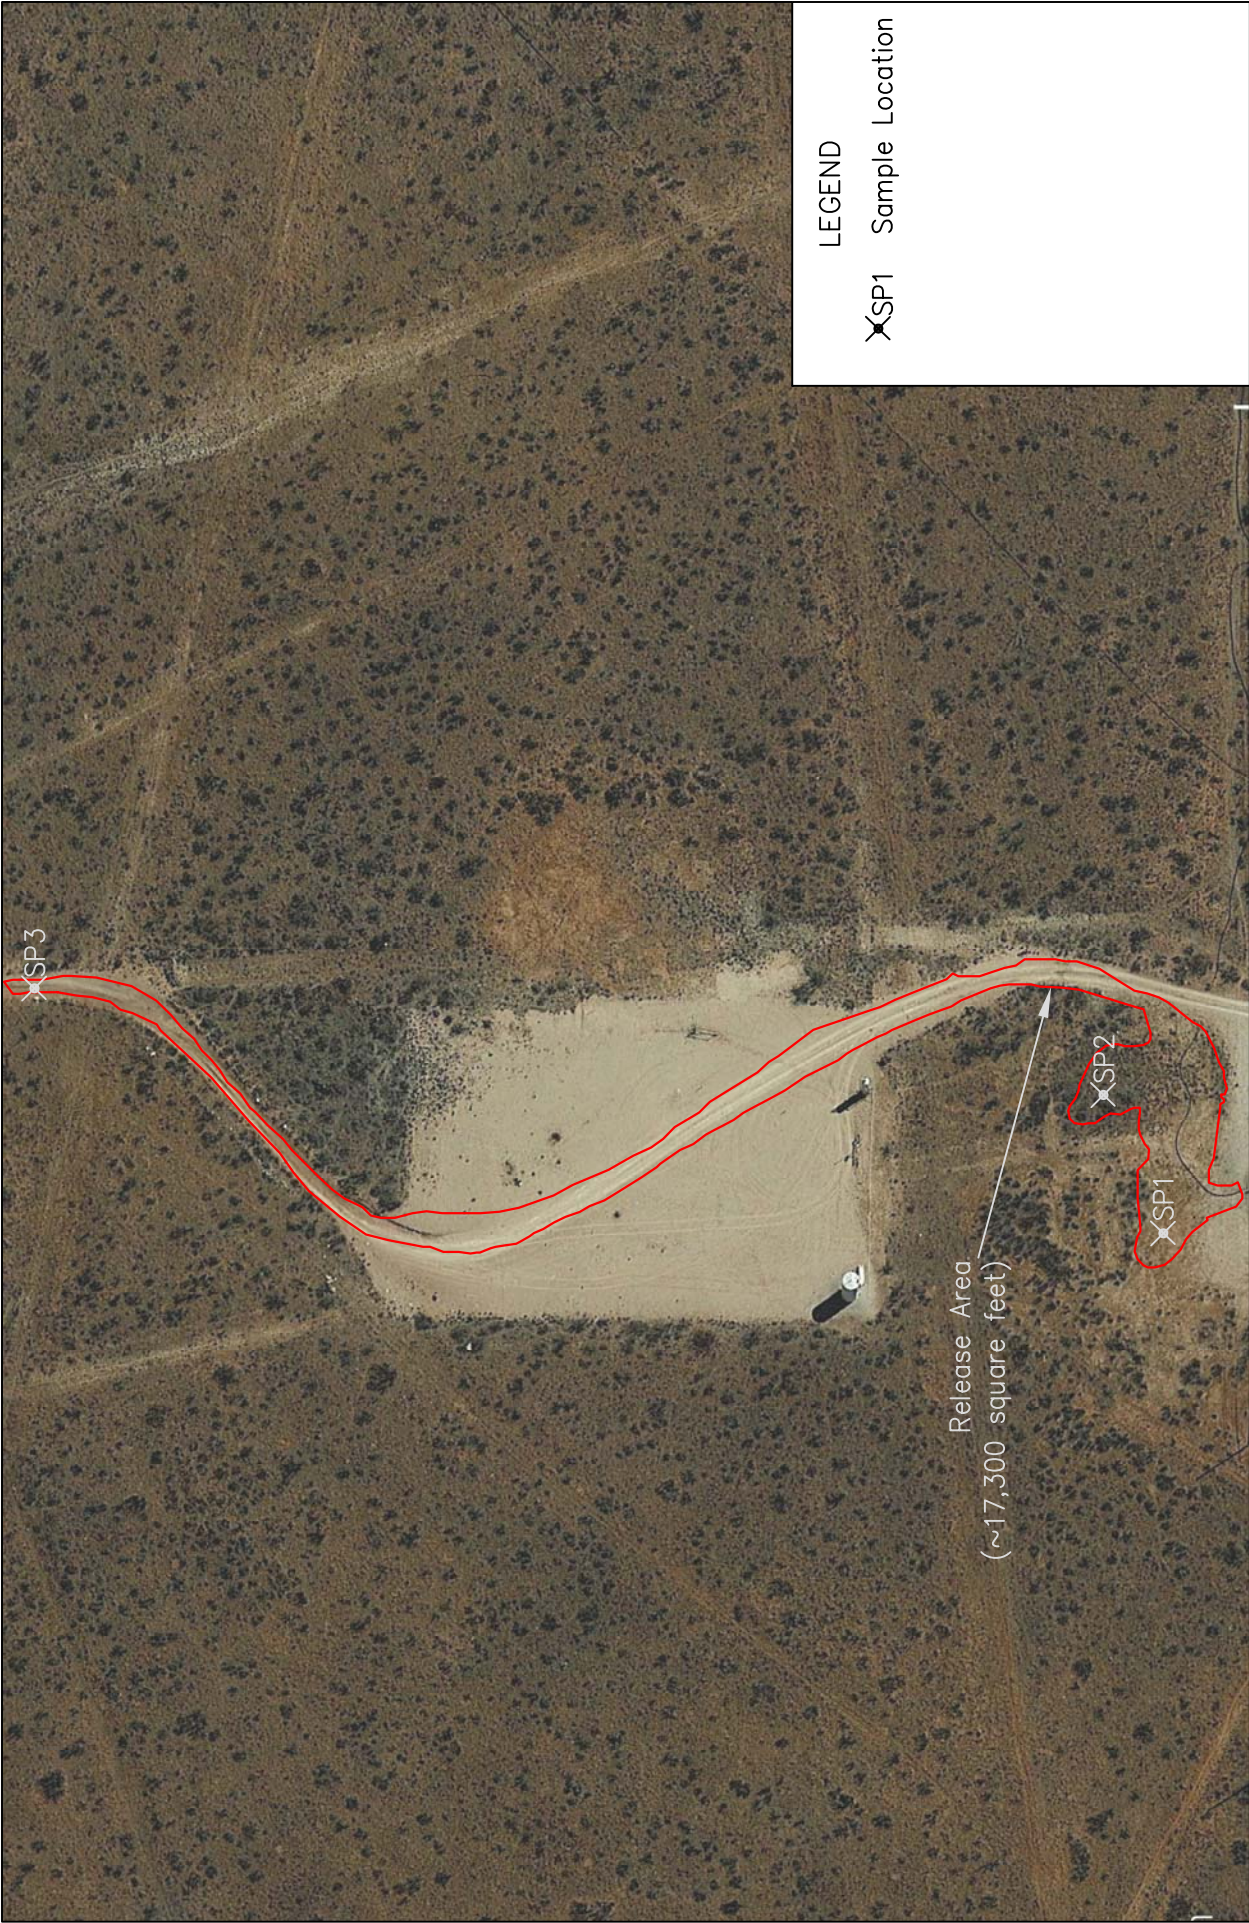
EPI personnel mobilized on the site on April 3, 2015 to collect soil samples to determine the vertical extent of contamination. A total of nine (9) soil samples were collected at varying depths from three (3) sample location; SP1 – SP3. All samples were sent to Cardinal Labs for testing. Laboratory analytical results indicate Benzene, BTEX and TPH concentrations do not exceed NMOCD Recommended Remedial Action Levels (NMOCD RRALs) of 10 mg/Kg, 50 mg/Kg, and 5,000 mg/Kg, respectively, at any depth. Chloride concentrations exceed NMOCD RRALs of 1,000 mg/Kg to a depth of twenty-five (25) feet bgs in the area of SP1. Chloride concentrations do not exceed NMOCD RRALs of 1,000 mg/Kg in the areas of SP2 and SP3 (reference *Figure 3* and *Table 2*).

The release area around SP1 and SP2 has been excavated approximately two (2) feet bgs; the release area on the lease road has been scraped up. All contaminated material has been transported to a state approved facility for disposal.

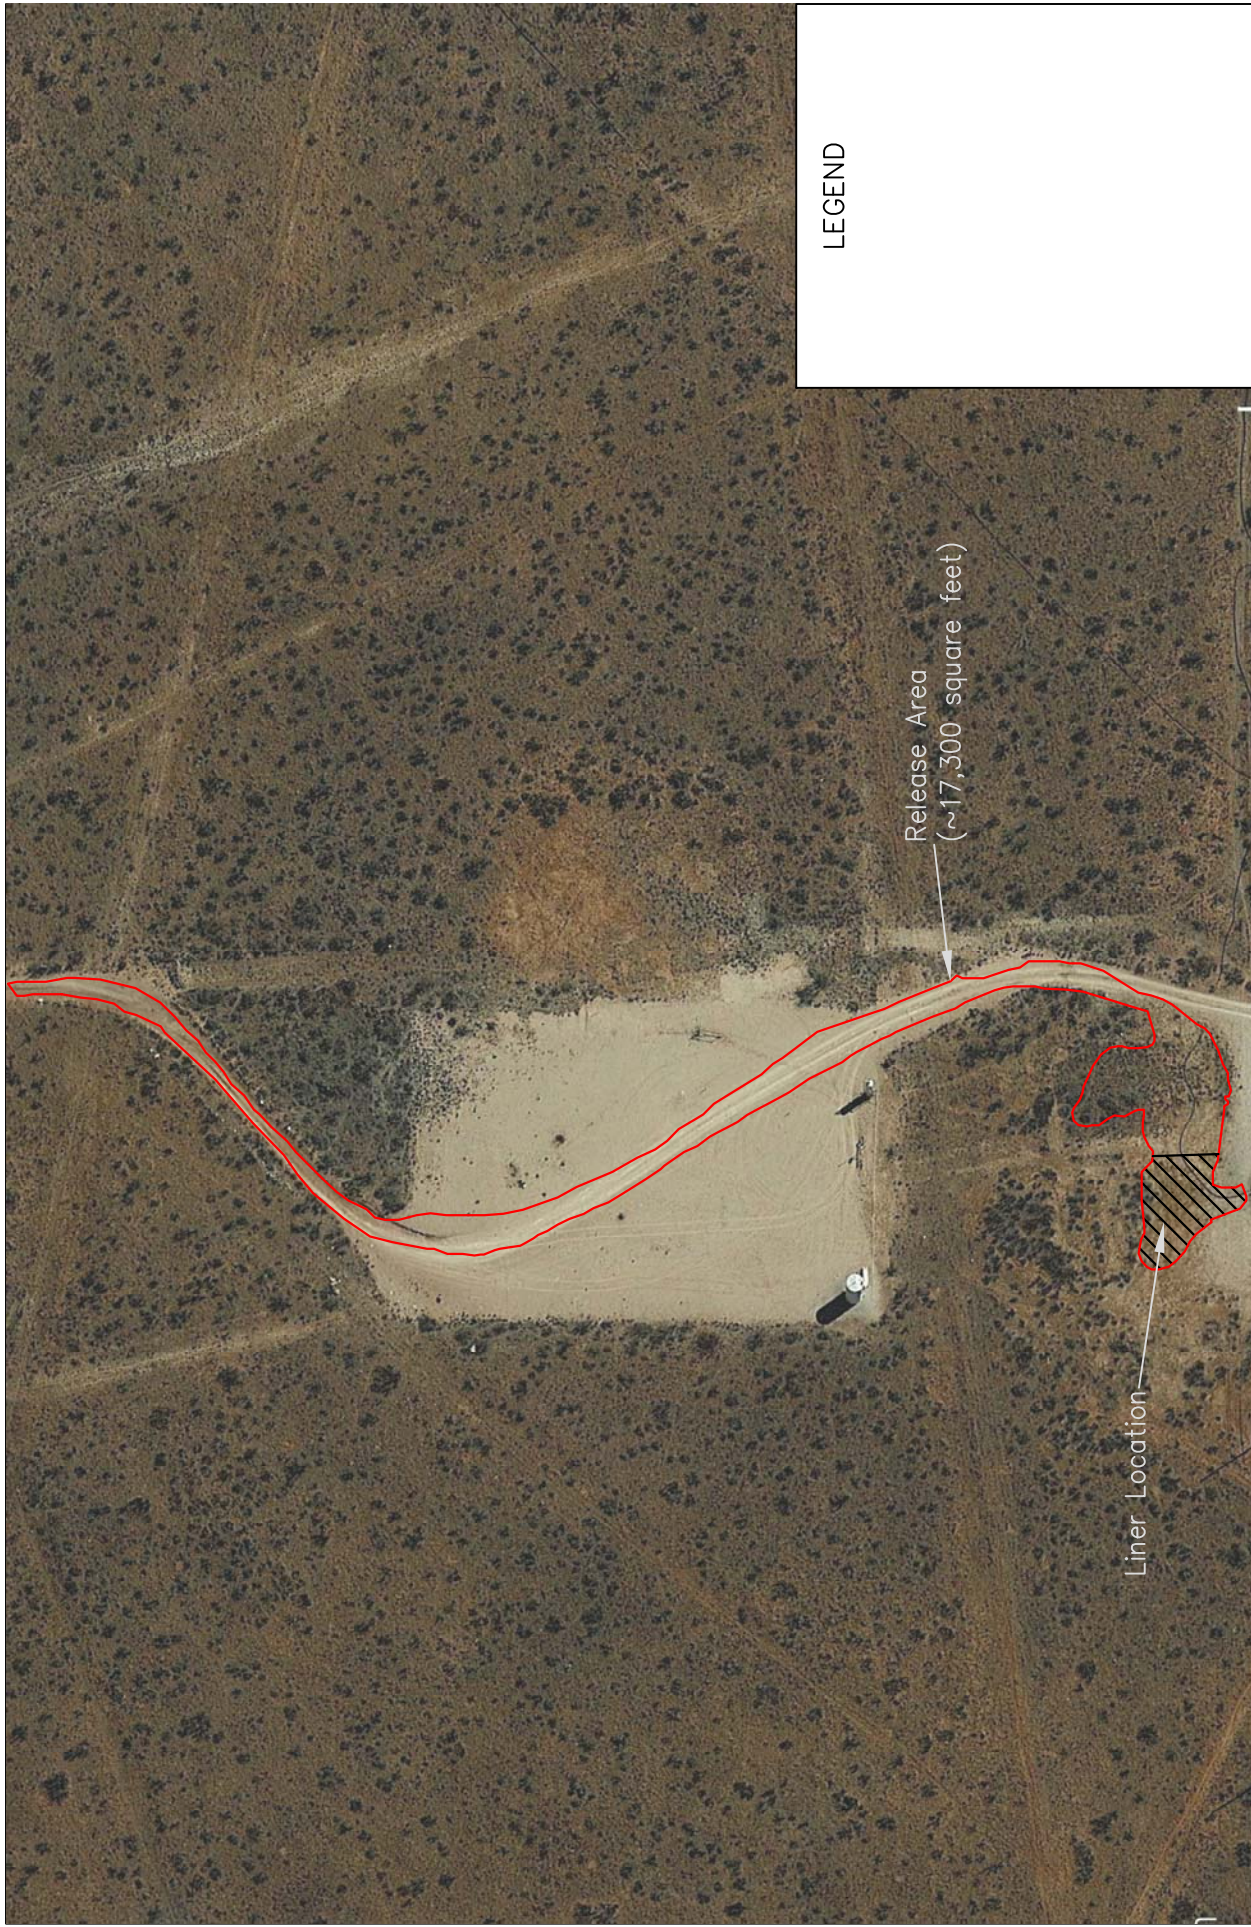
Figure 4 Liner Location Map XTO Energy EMSU #209	Lea County, New Mexico NW 1/4 of SE 1/4, Sec. 3, T21S, R36E N 32° 30' 48.09" W 103° 16' 20.75" Elevation: 3,563 feet amsl	DWG By: D Dominguez May 2015	REVISED: August 2015

Taking into consideration the vertical depth of contamination, it would require a very large excavation for removal of all Chloride impacted soil to a depth of approximately twenty five (25) vertical feet. In lieu of this, the area around SP1 was excavated an additional two (2) feet and a twenty (20) mil thick polyethylene liner was installed in the bottom of the excavation (reference *Figure 4*). Approximately 930 yards of contaminated soil were hauled to a state approved

facility for disposal. Bottom of polyethylene liner was laid on a one (1) foot thick layer of clean soil. The excavation was backfilled with approximately 930 yards of clean soil to finish grade. Soil is free of deleterious material or rocks or large clumps.

Backfilling continued until the entire excavation was closed. Upon completion of backfill activities, the entire disturbed area has been contoured to blend with existing pad area and protected against wind/water erosion.

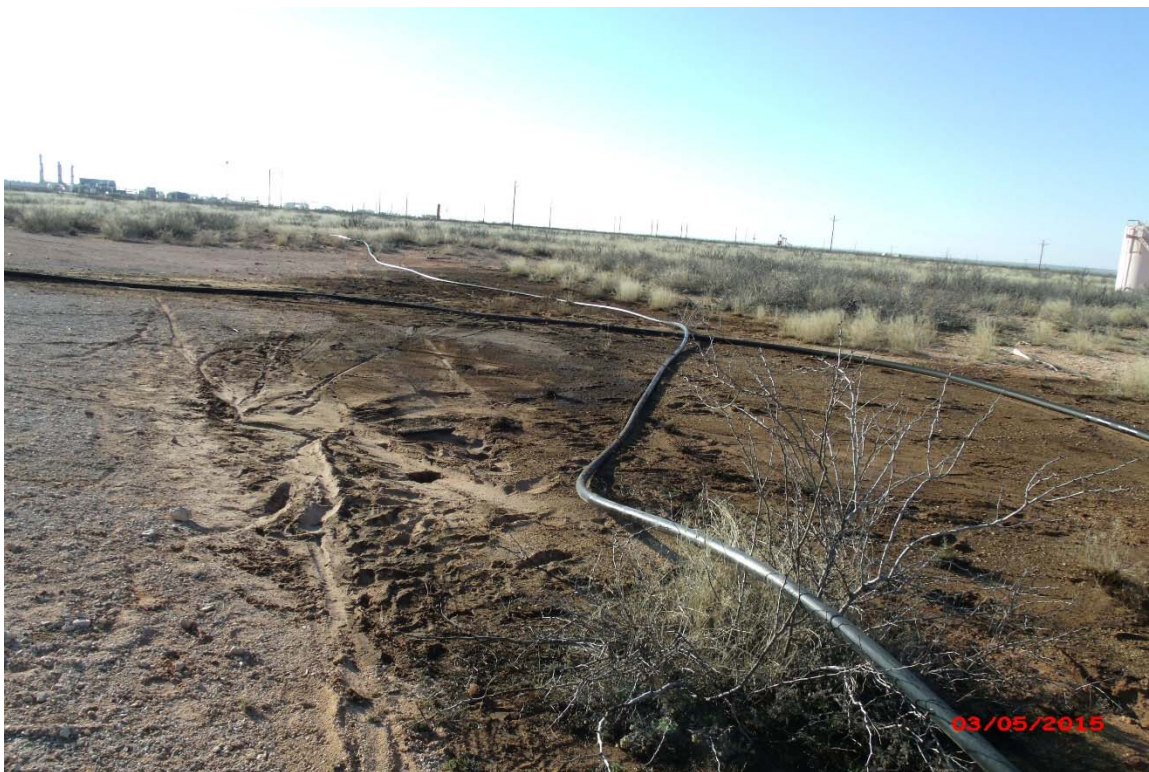
Flow line was shut in at the header. The flow line pressured up and blew out by the well pad. Had a vacuum truck suck up all fluid possible. Pasture and an old abandoned location were affected.

Photograph #1 – Looking across release area

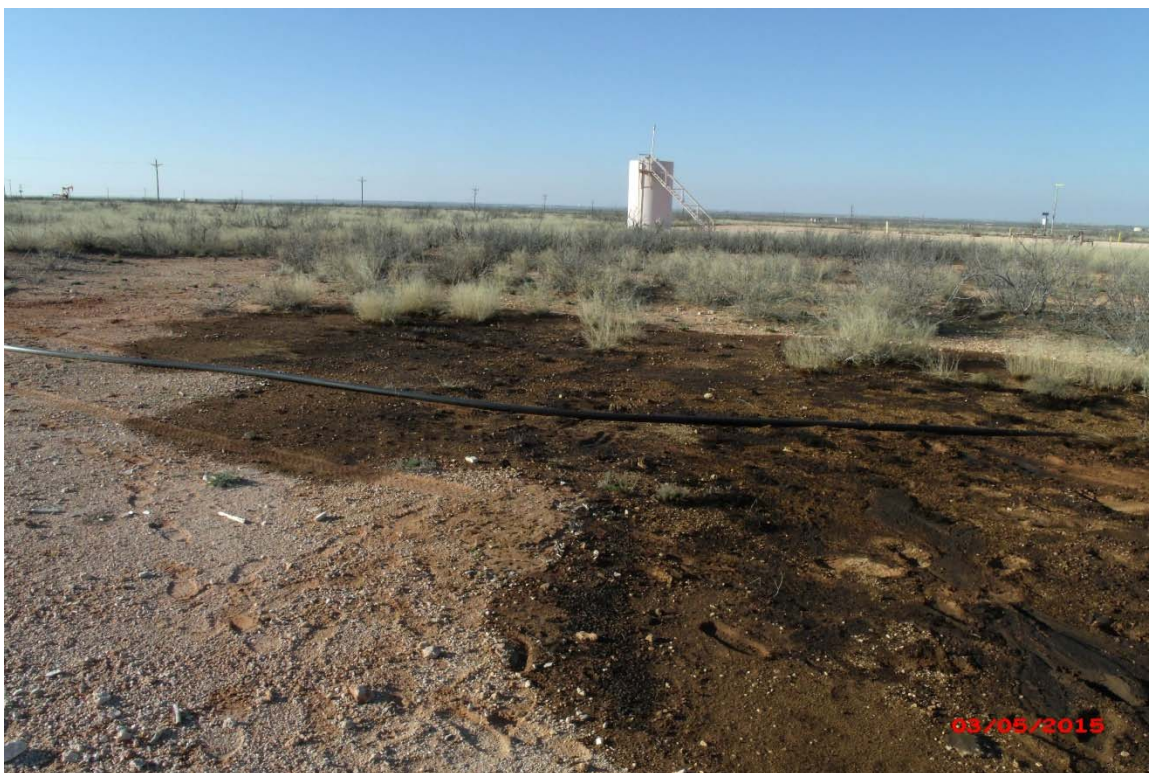
Photograph #2 – Looking across release area

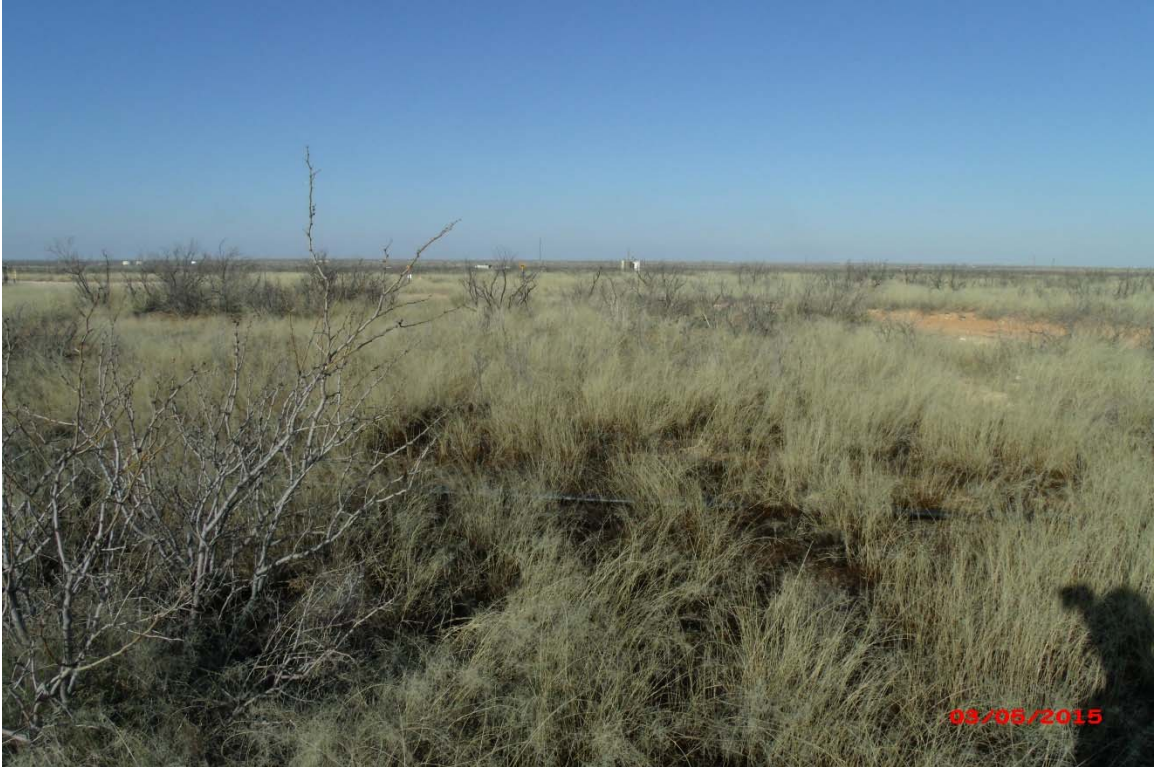
Photograph #3 – Looking across release area

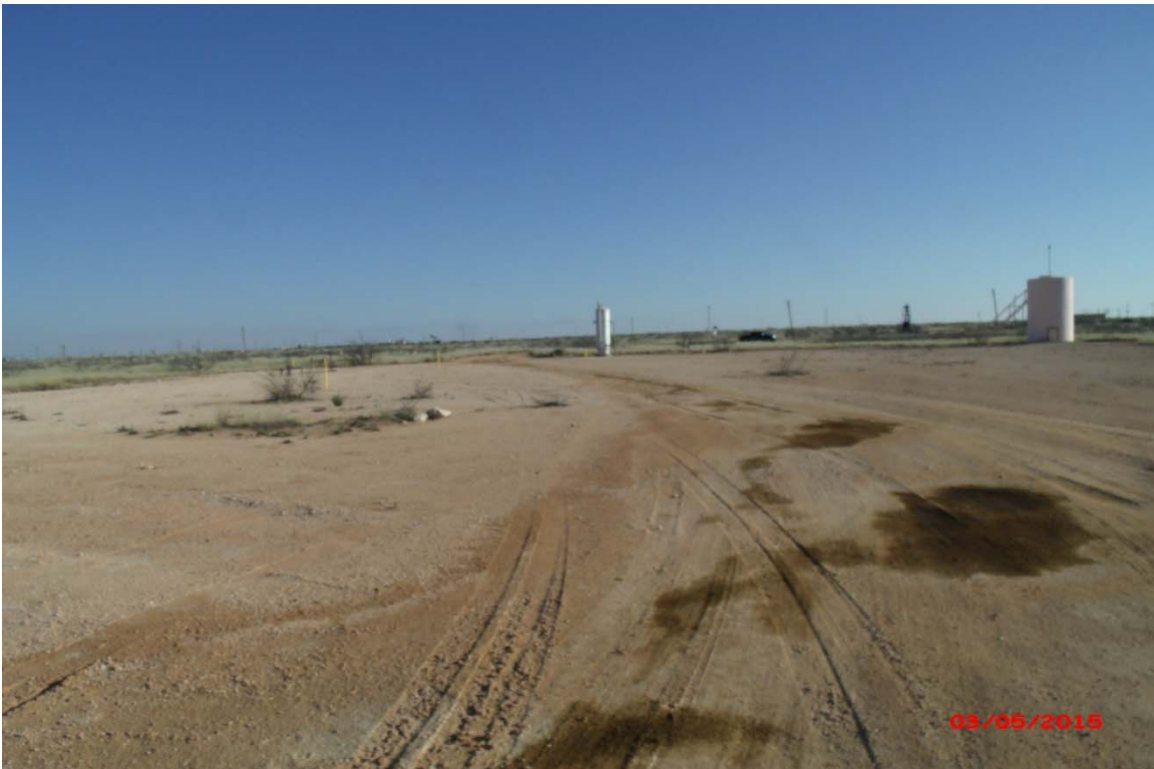
Photograph #4 – Looking across release area

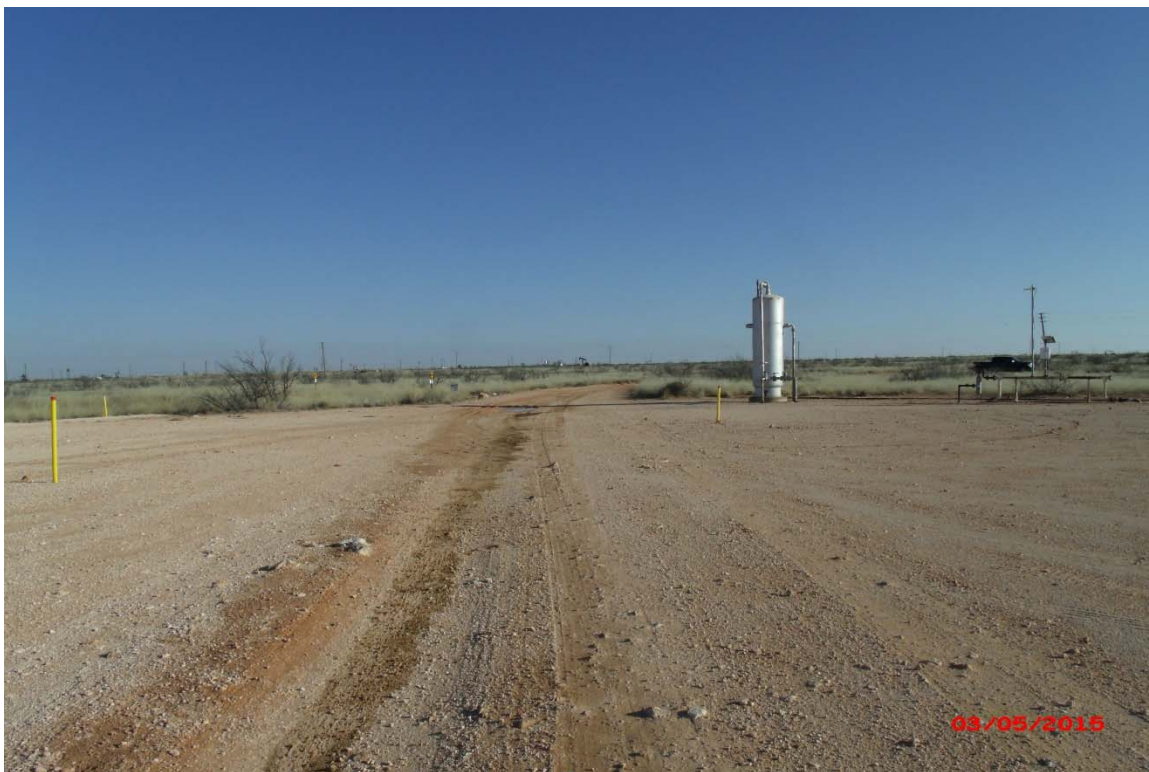
Photograph #5 – Looking across release area

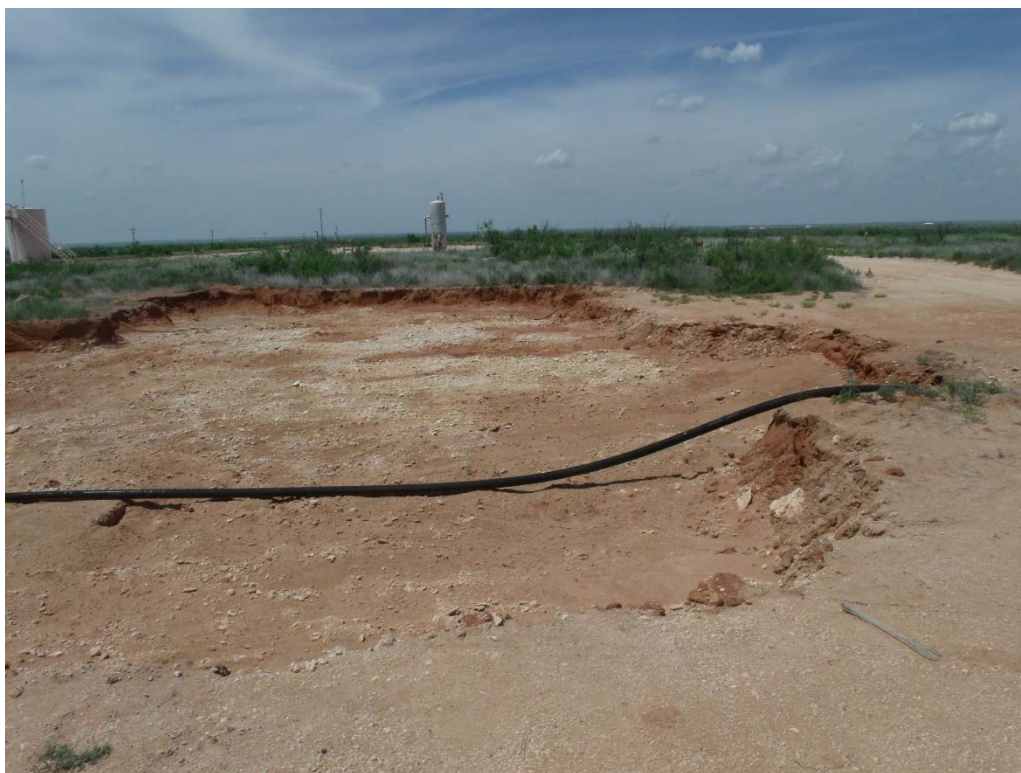
Photograph #6 – Excavated area

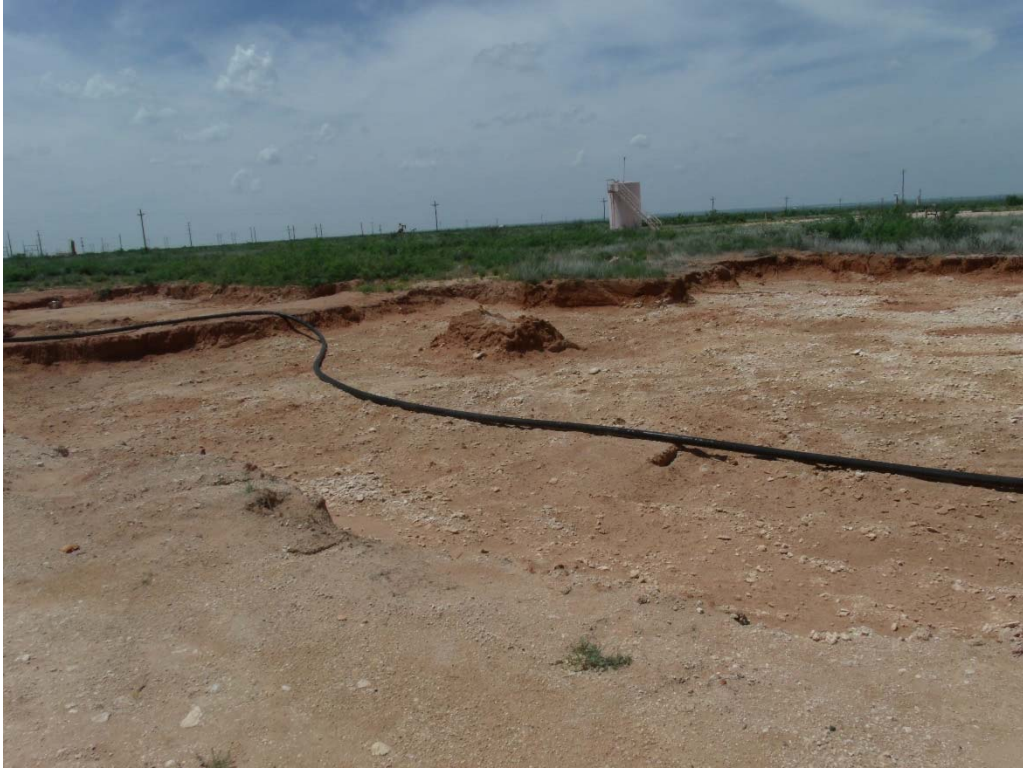
Photograph #7 – Excavated area

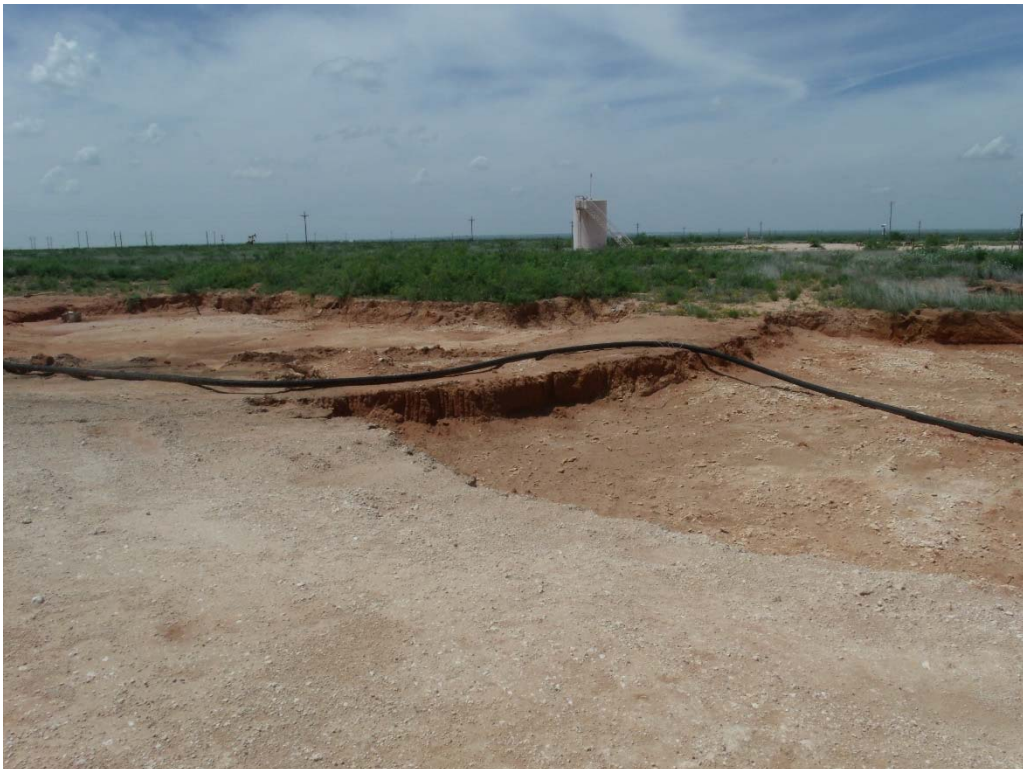
Photograph #8 – Excavated area

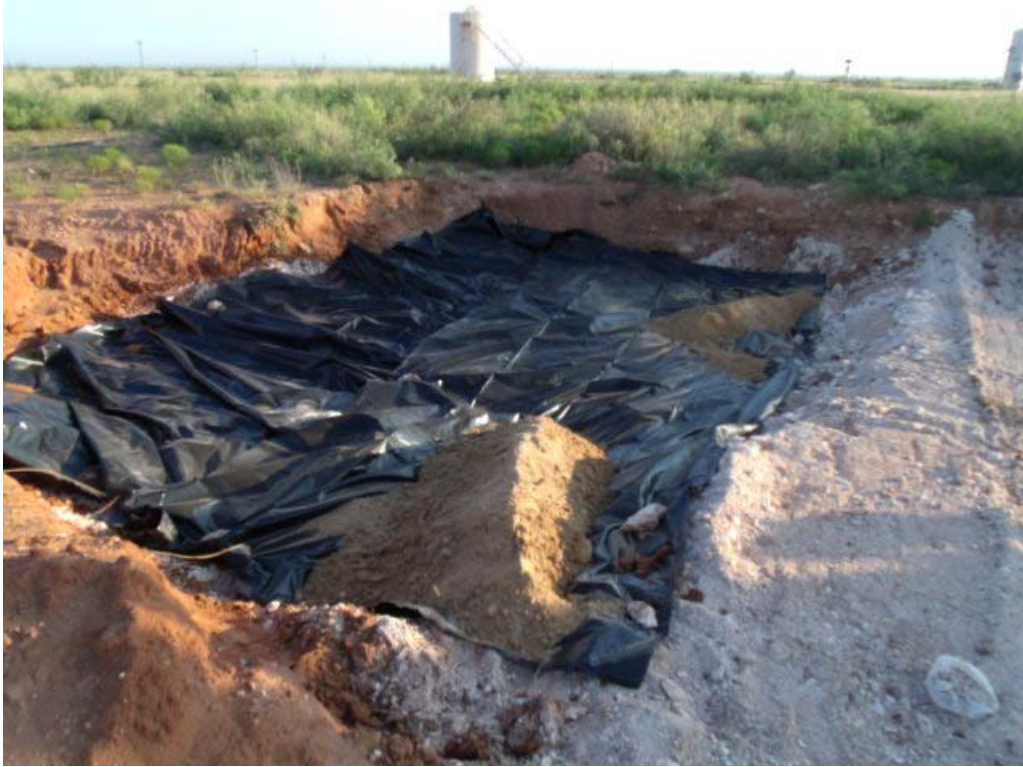
Photograph #9 – Installation of liner

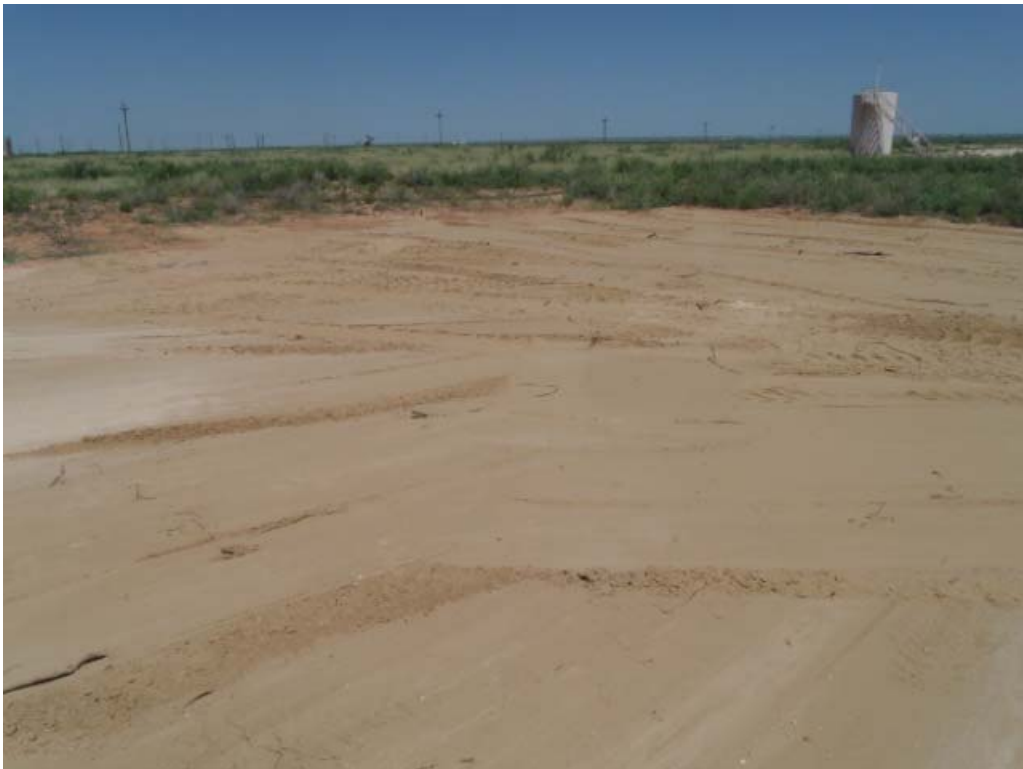
Photograph #10 – Backfilled

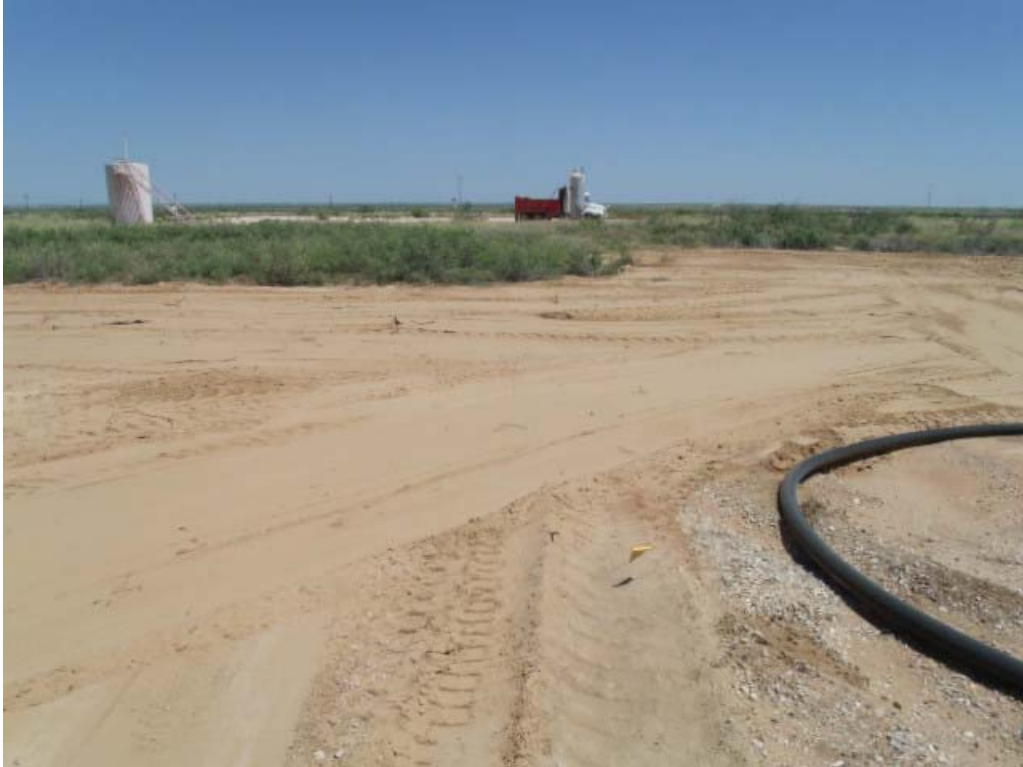
Photograph #11 – Backfilled

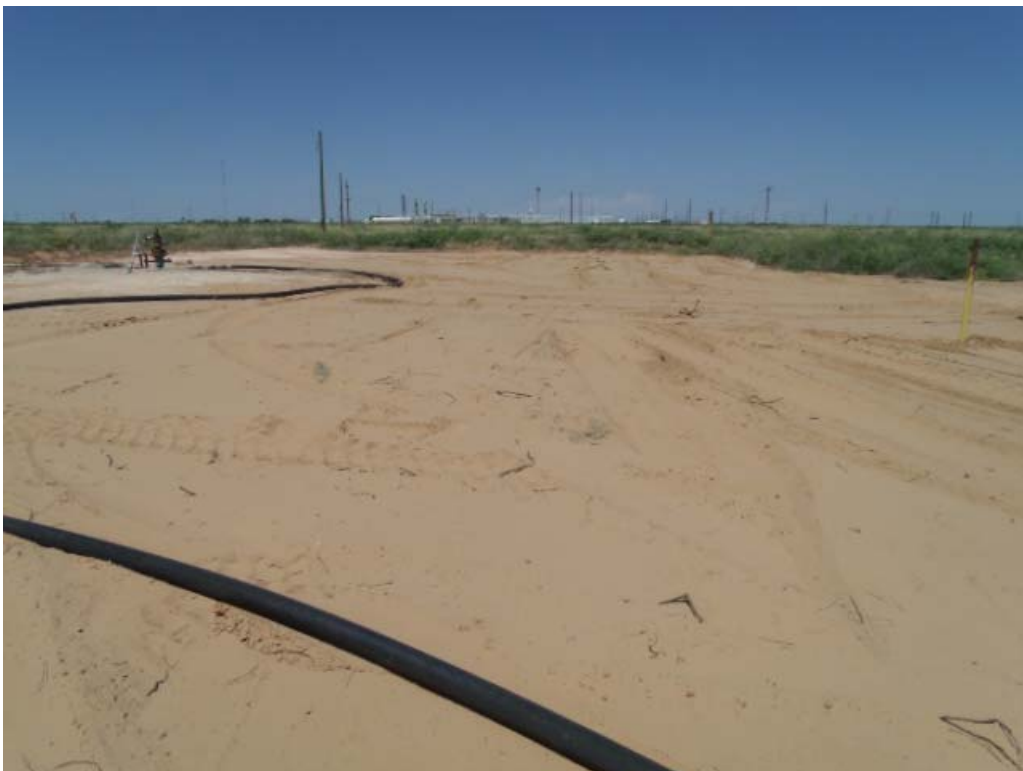
Photograph #12 – Backfilled
