Mallon 34-16

REMEDIATION WORK PLAN

Release Date: 6/14/2015

UL/ Sec 34, T19 south, R34 east, Lea county NM

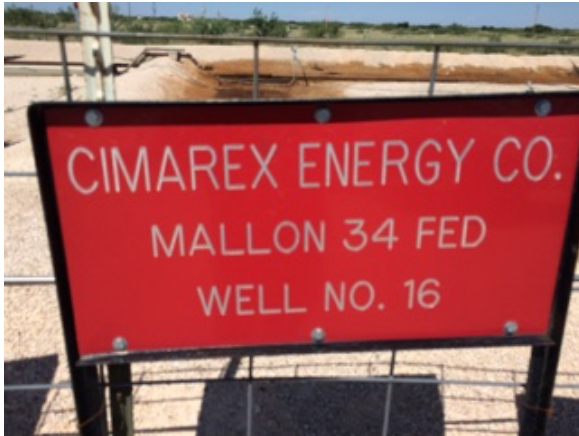
PHOT PAGE

The site is located west of Hobbs NM, in Lea County. The leak site resulted from a hole developing in an oil tank. The impacted area is inside a lined firewall of the battery. Approximately 345 bbls of oil was released, and 290 bbls recovered. A C-141 was submitted to the NMOCD on July 23rd, 2015. The C-141 is attached.

On July 30th, 2015 DFSI personnel delineated 3 sample points of the leak area. Each sample was tested for chlorides levels as well as BTEX. The BTEX samples were performed using a Mini Rae Photoionization Detector (PID). Clean samples were taken to a lab for confirmation. The results are attached.

Remove 2' bgs of the contaminated soil inside the bermed facility. Haul all contaminated material to an approved NM state disposal. New caliche will be used to backfill the excavated area. Because there is no eminent danger of groundwater impact or threat to
