Release Notification and Corrective Action

SPILL CLEANUP REPORT

Devon Energy Production
Coachwhip 26 Federal
Lea County, New Mexico

Re: Spill Cleanup Report at Devon Energy Production
Coachwhip 26 Federal, Lea County, New Mexico

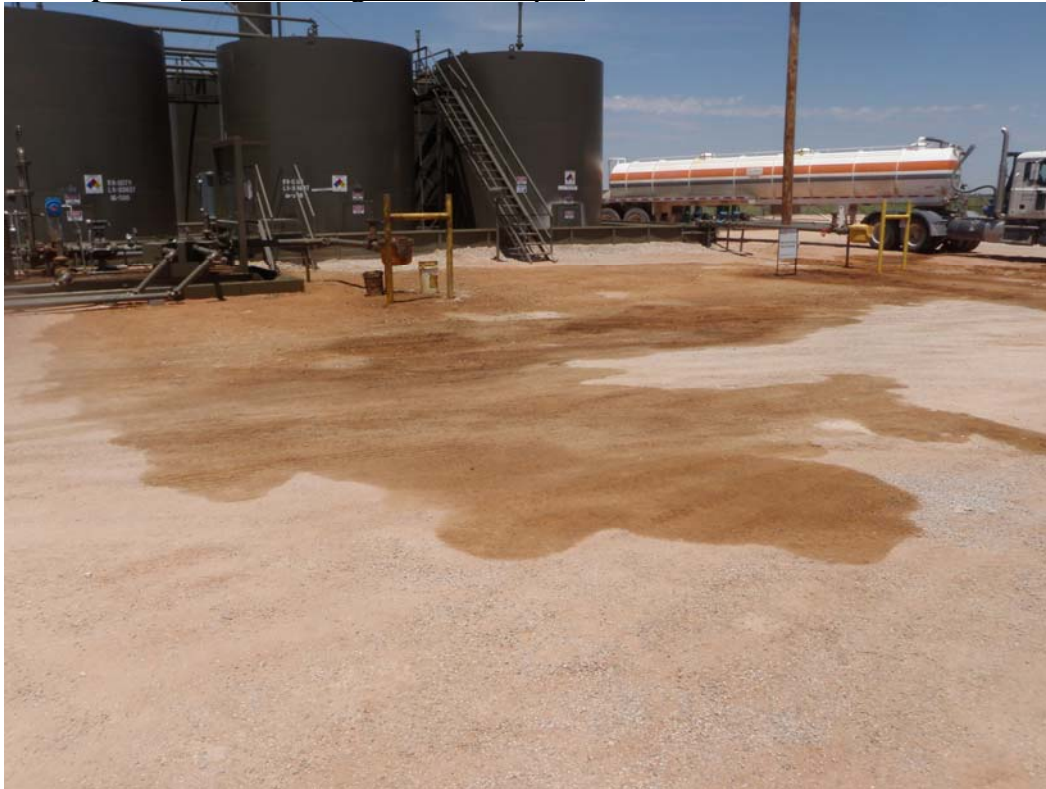
Photograph: 1

Description: View showing location of spill.

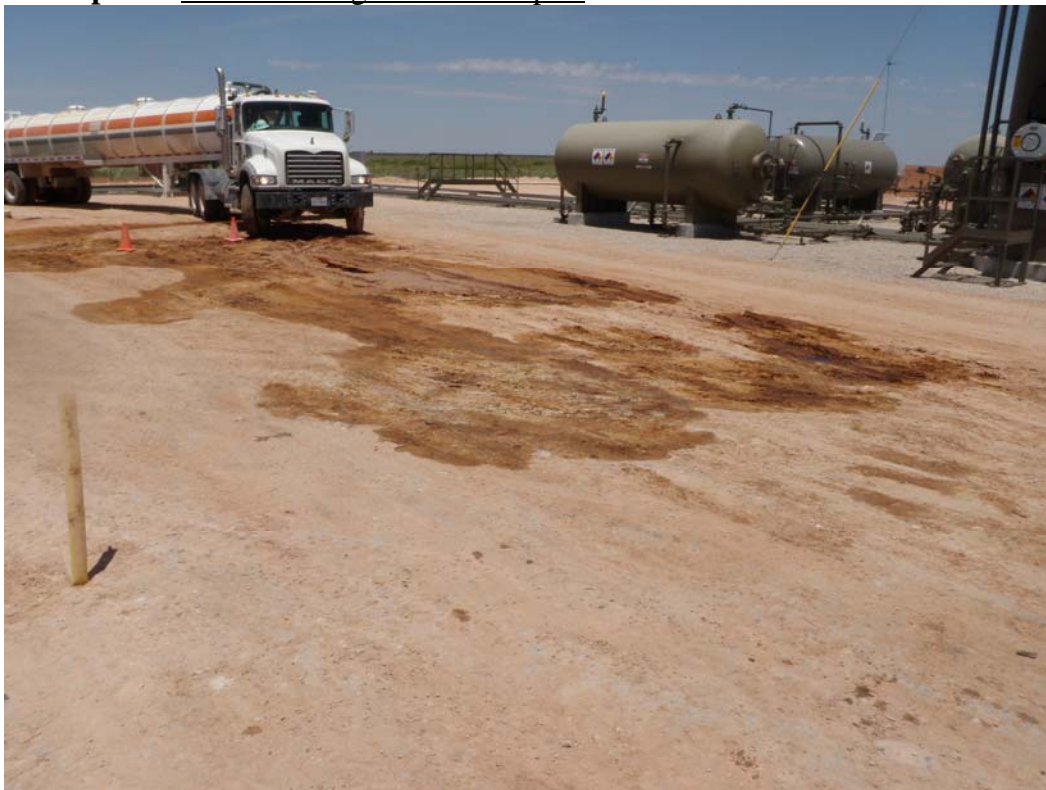
Photograph: 2

Description: View showing location of spill.

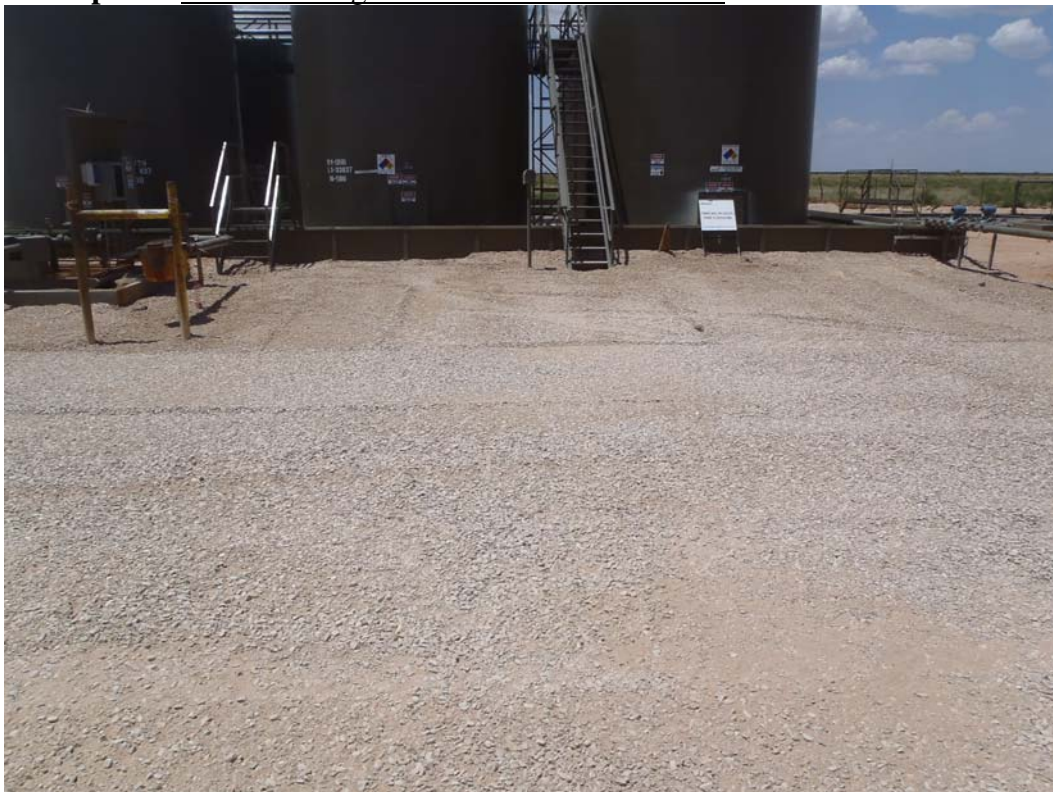
Photograph: 8

Description: View showing site after backfill activities.

landfill in Carlsbad, NM. Upon approval, D&H arrived to site on July 31, 2015, to backfill excavated area.
