RE: Remediation Progress Report and Closure Proposal
Chevron – WDDU #42
UL-A, Section 32, Township 24 South, Range 38 East
Lea County, New Mexico
NMOCD Reference # 1RP-3535

The following *Remediation Progress Report and Closure Proposal* serves as a condensed update on remedial activities undertaken and proposed closure for the above referenced Site.

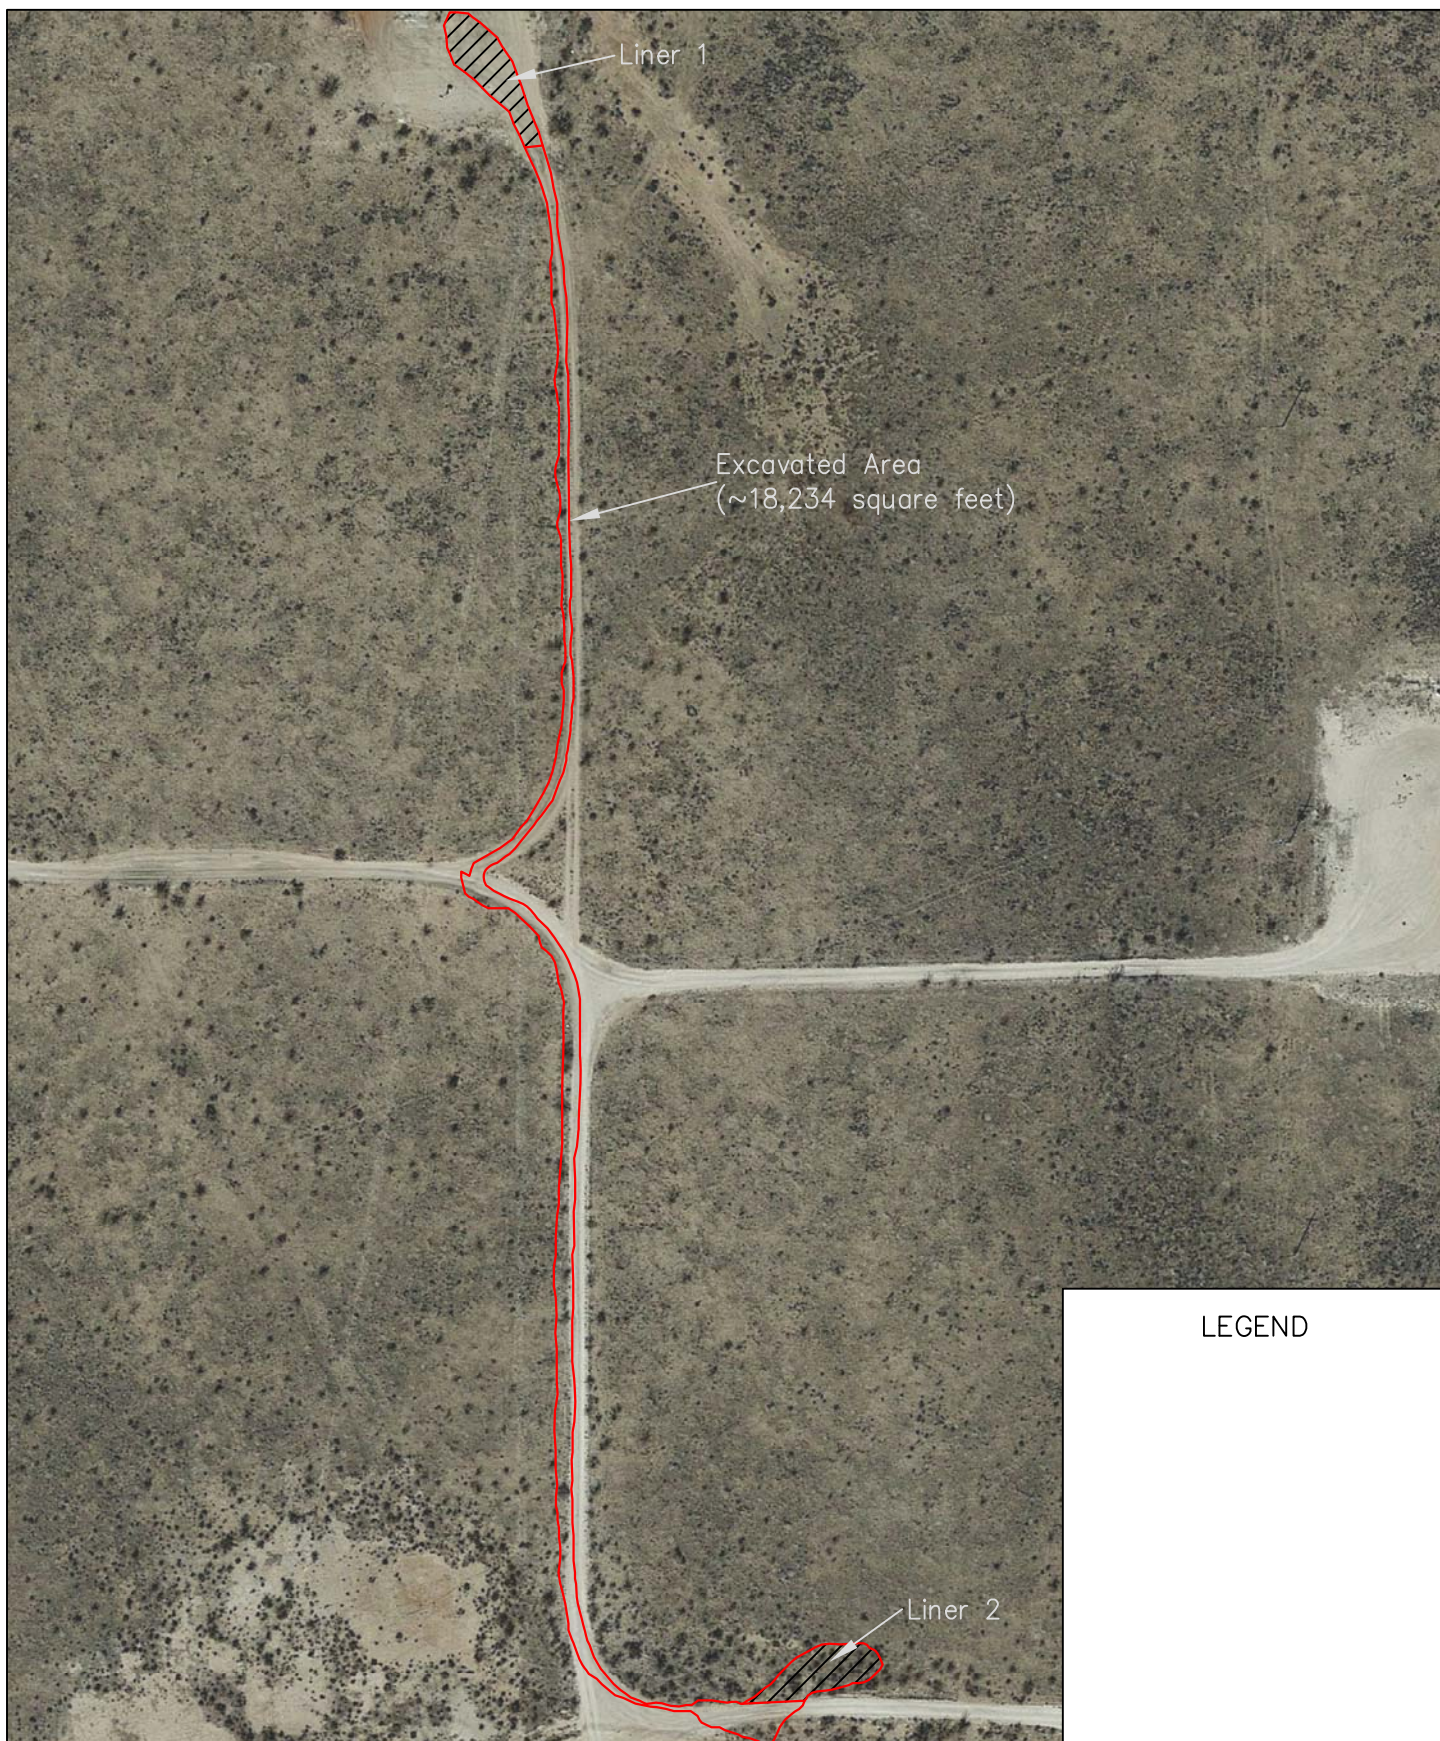
Figure 6 Proposed Liner Chevron WDDU #42	Lea County, New Mexico NE 1/4 of NE 1/4, Sec. 32, T24S, R38E N 32° 10' 44.36" W 103° 4' 32.23" Elevation: 3,209 feet amsl	DWG By: D Dominguez August 2015	REVISED:

Taking into consideration that the excavation extends several hundred feet down a lease road from the north excavation to the south excavation, EPI proposes to backfill the excavated area on the lease road between the excavations with clean caliche and place a twenty (20) mil thick polyethylene liner in the bottom of the north and south excavations (reference *Figure 6*). The polyethylene liner will lay on a one (1) foot thick layer of clean soil. Remainder of the excavations will be backfilled with selected top soil to finish grade. Top soil will be free of deleterious material or rocks or large clumps.

Backfilling will continue until the entire excavation is closed. Upon completion of backfill activities, the entire disturbed area will be contoured to blend with existing lease road, pad location, and pasture area and protected against wind/water erosion.

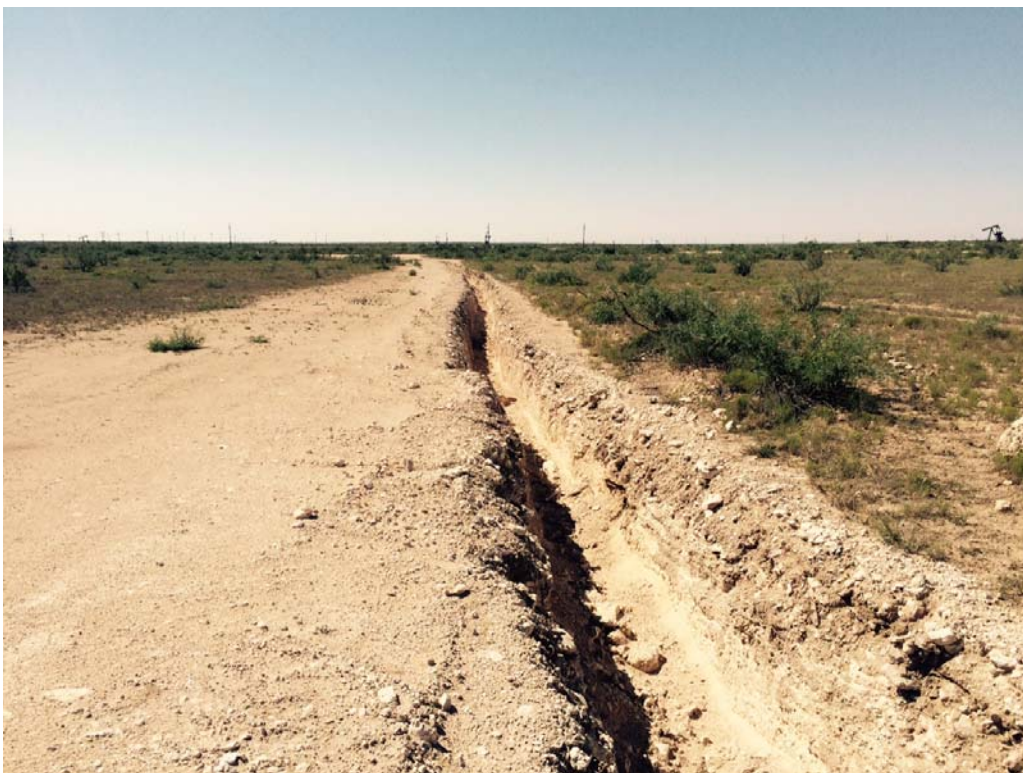
Photograph #4 – Looking south across excavation in road
