RE: Final Closure Report
Legacy LP – Cooper Jal Main Injection Line
UL-N, Section 18, Township 24 South, Range 37 East
Lea County, New Mexico
NMOCD Reference # 1RP 3464

The following *Final Closure Report* serves as a condensed update on closure activities for the above referenced Site.

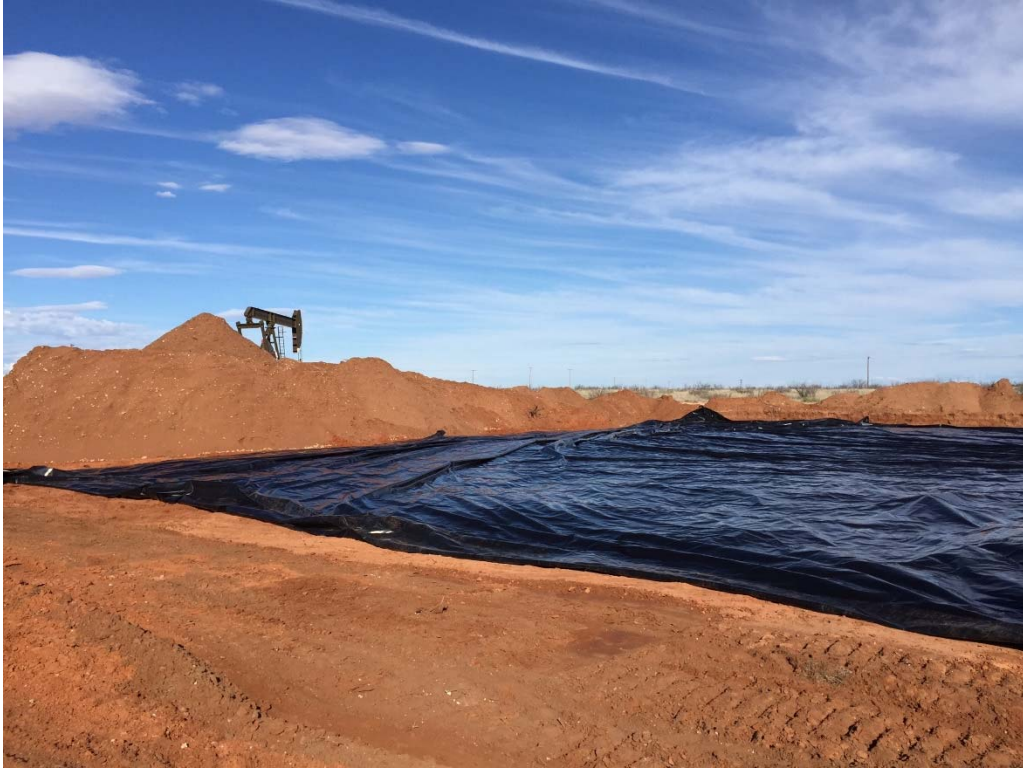
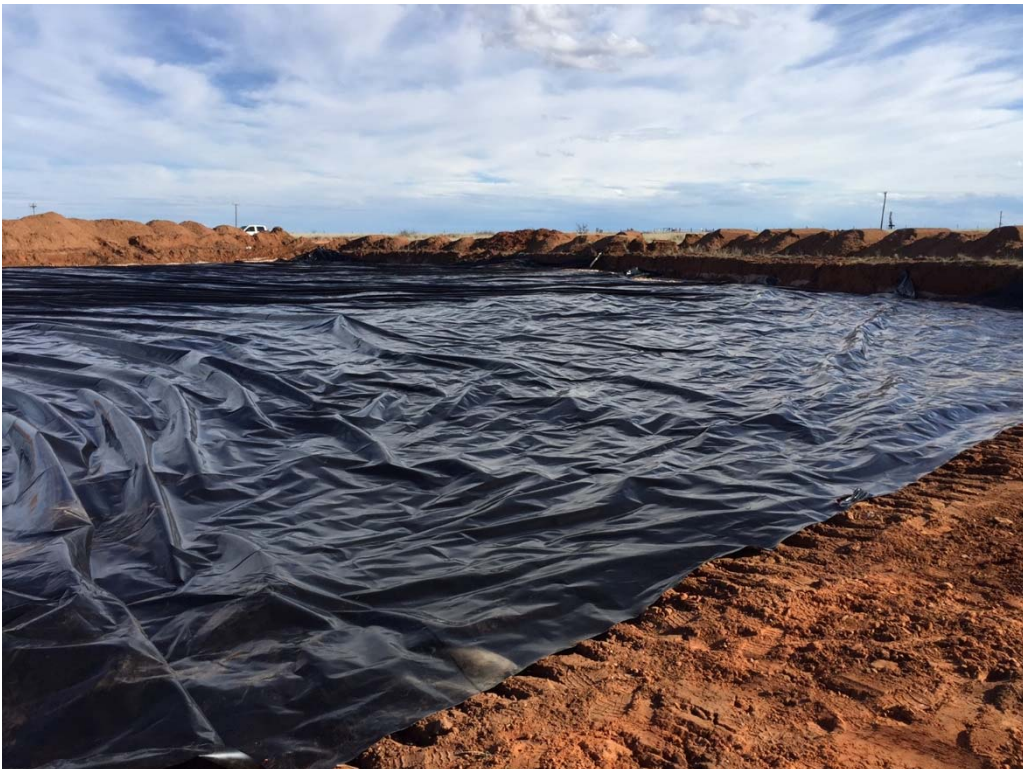
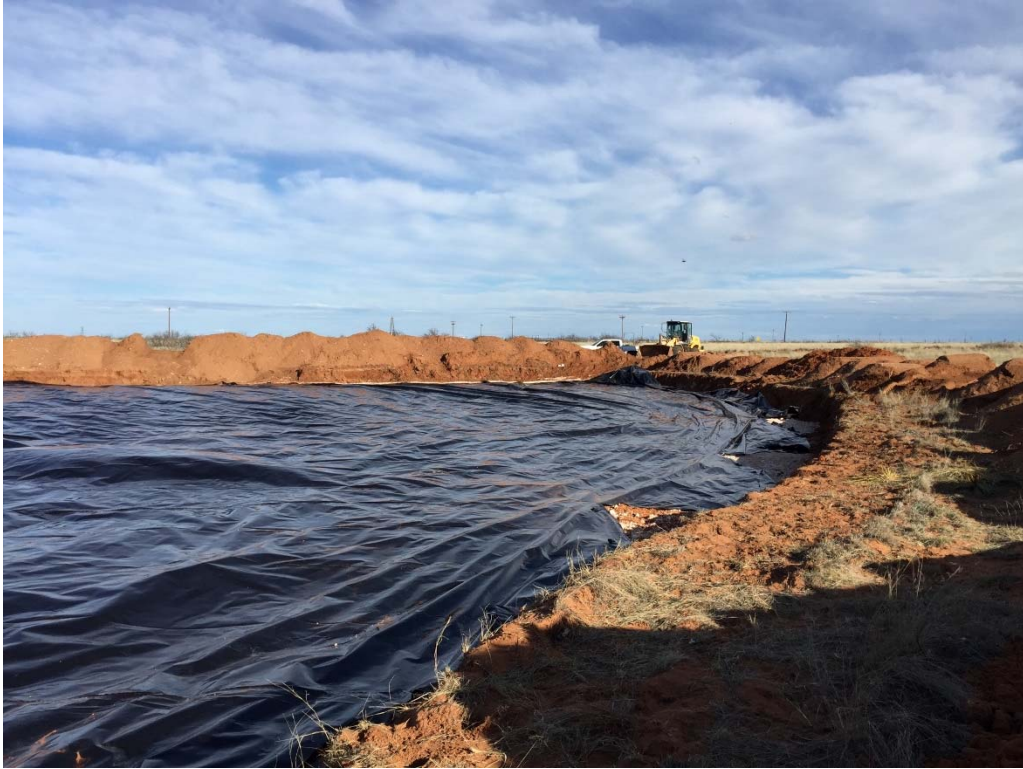
Photograph #1 – South liner installation

Photograph #2 – South liner installation

Photograph #3 – South liner installation

On March 19 – 23, 2015 separate twenty (20) mil thick polyethylene liners were placed on the excavation floor in the areas of BH2/BH3, North Liner is approximately 27,500 sq. ft., and BH6, South Liner is approximately 34,500 sq. ft. (reference *Figure 5*). Bottom of the polyethylene liners lay on a one (1) foot thick layer of clean top soil. Remainder of the excavation has been backfilled with selected top soil to finish grade. Top soil was free of deleterious material or rocks or large clumps.

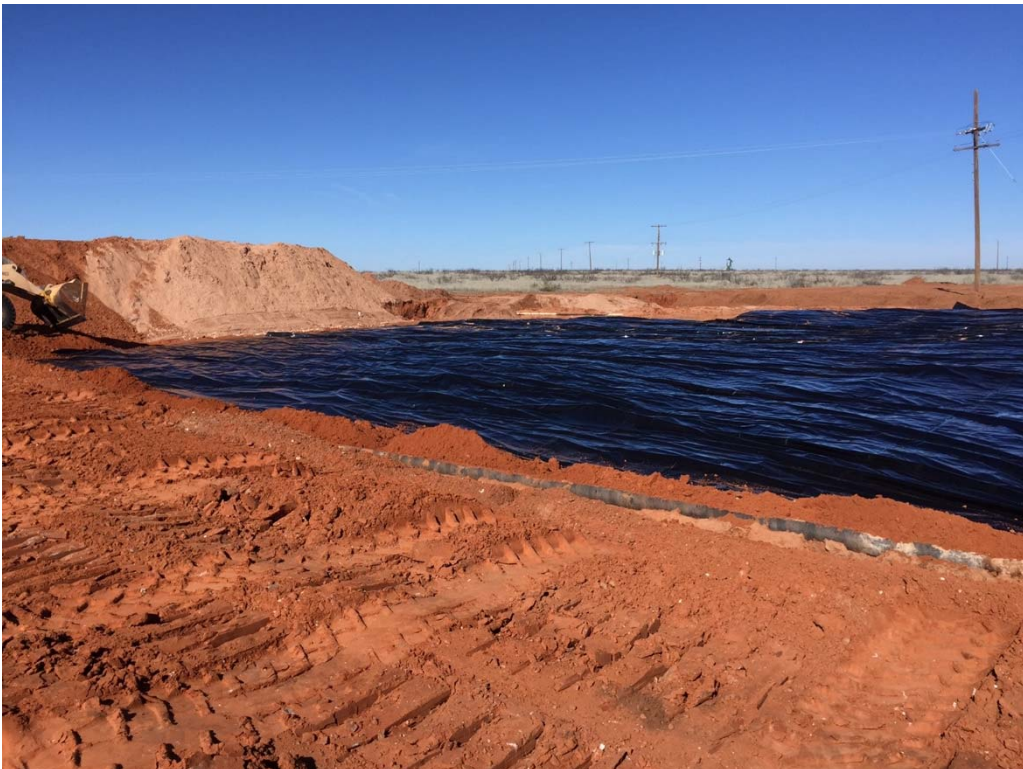
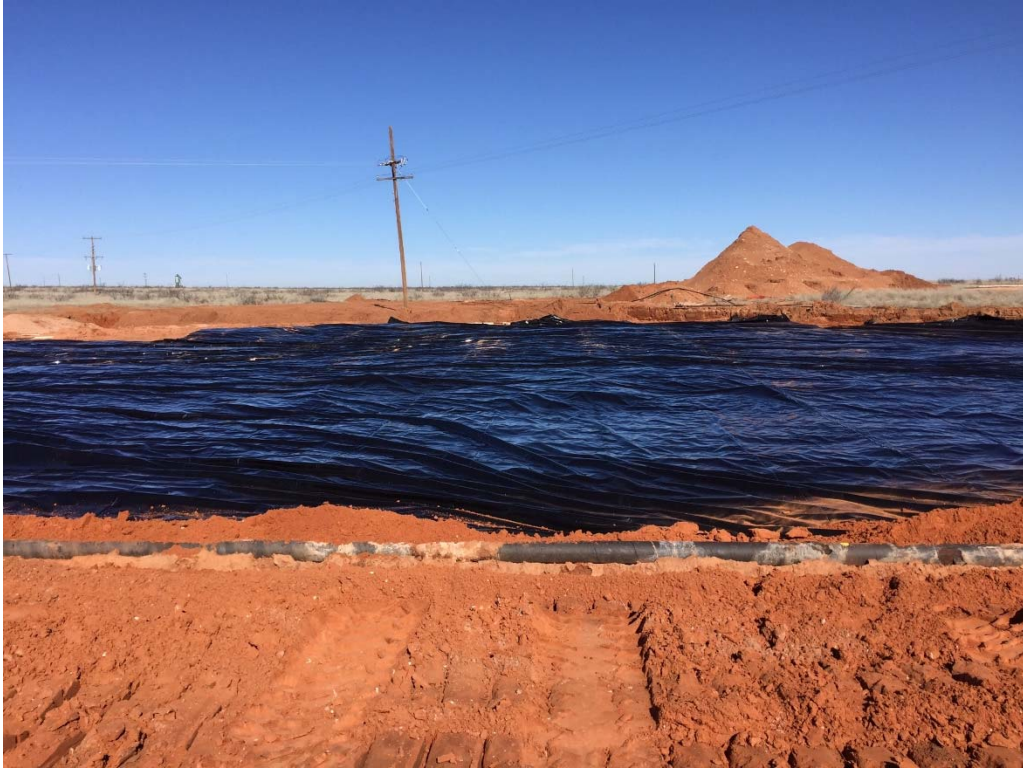
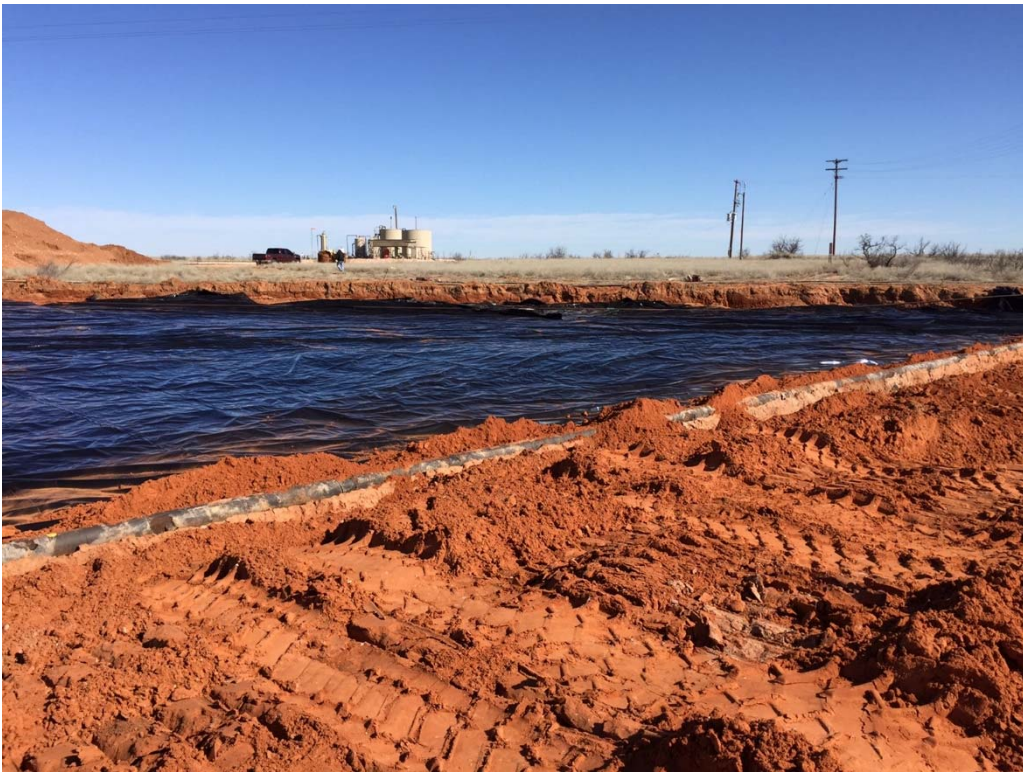
Photograph #4 – North liner installation

Photograph #5 – North liner installation

Photograph #6 – North liner installation

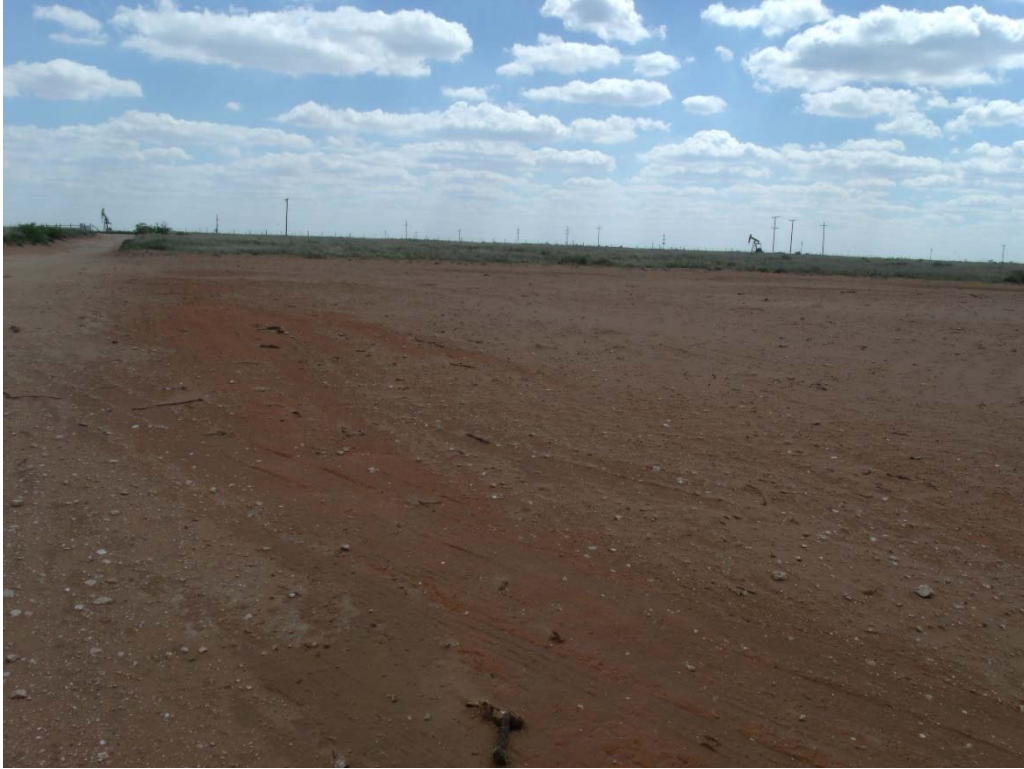
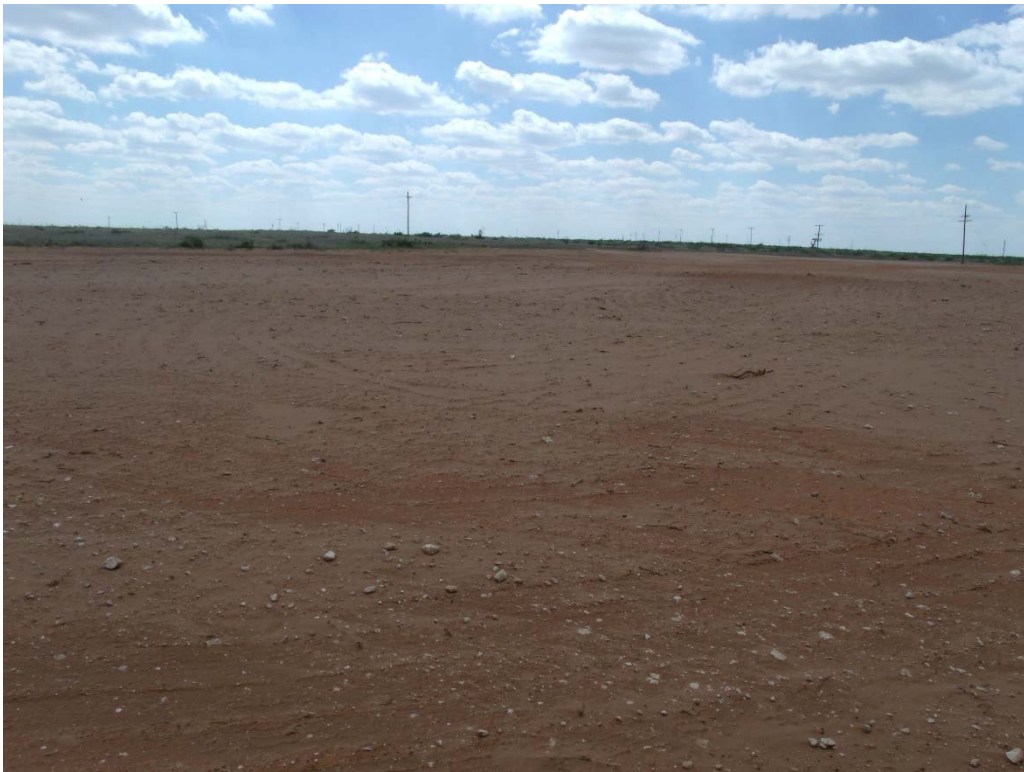
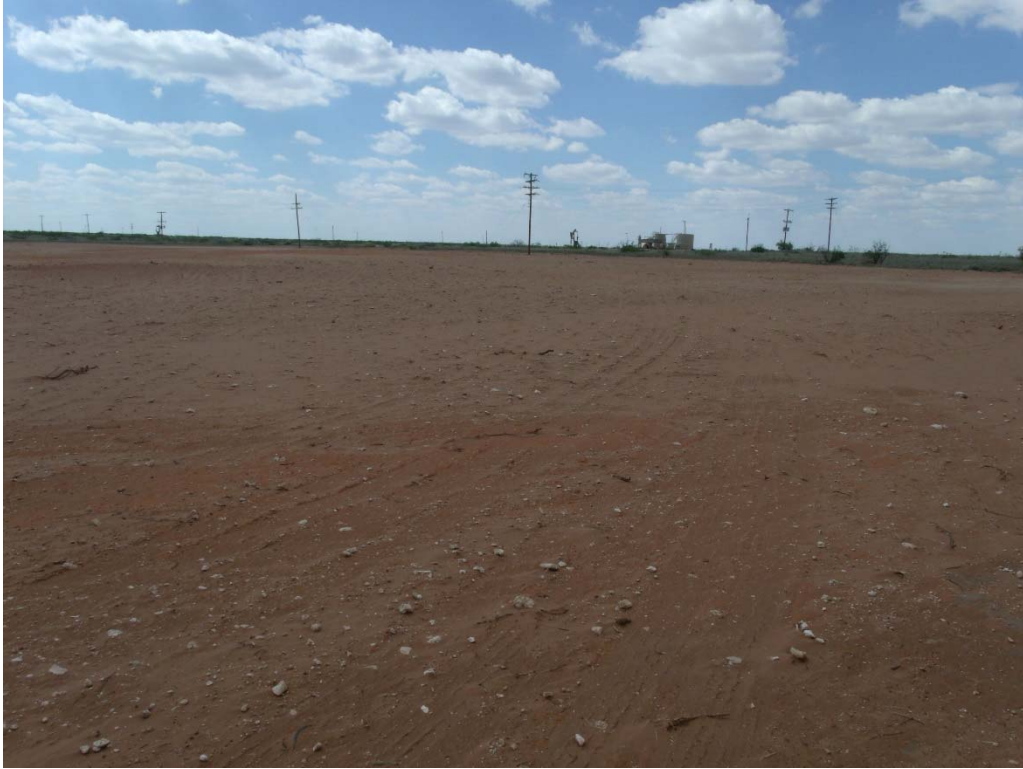
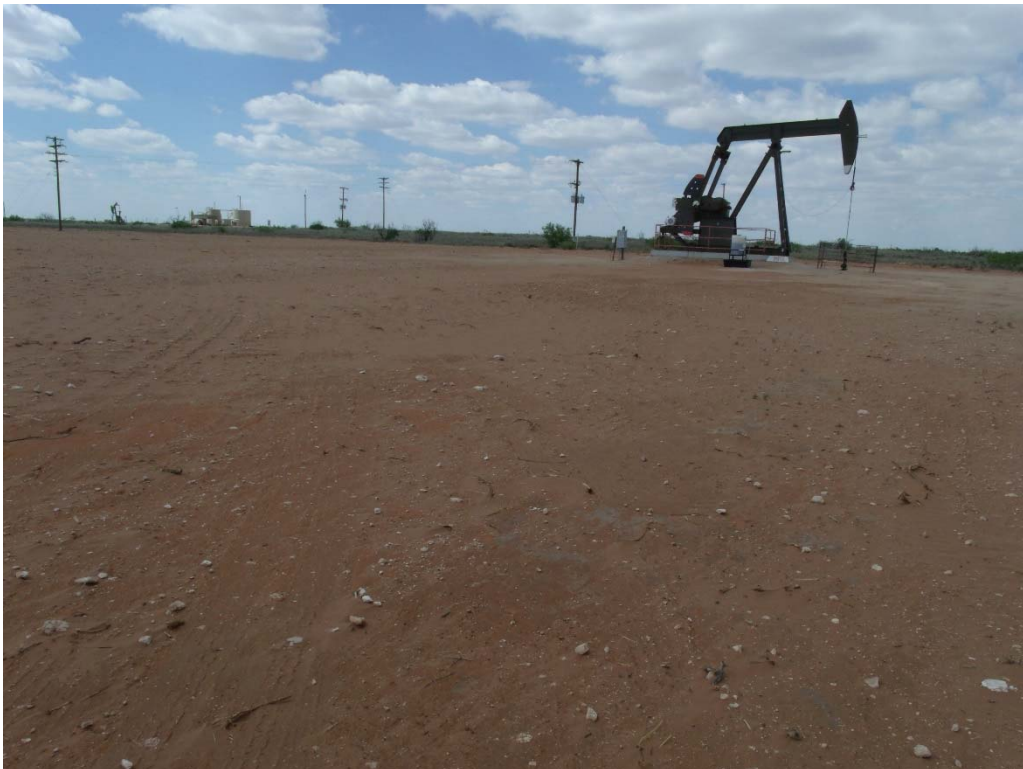
Photograph #7 – Backfilled

Photograph #8 – Backfilled

Photograph #9 – Backfilled

Photograph #10 – Backfilled

Backfilling continued until the entire excavation was closed. Upon completion of backfill activities, the entire disturbed area was contoured to blend with existing pasture area and protected against wind/water erosion. Disturbed areas will be disced and deep drill seeded with a mixture approved by the property owner. However, it is recommended completing this activity in late spring 2015 when ground conditions are more conducive to vegetative growth.
