Subject: **Soil Assessment and Remediation Work Plan**  
Legacy Reserves Operating, LP  
Rock Queen Unit #86  
API #: 30-005-00931

Rock Queen Unit #86  
Legacy Reserves Operating, LP  
Chaves County, New Mexico  
Figure 1 - Site Plan

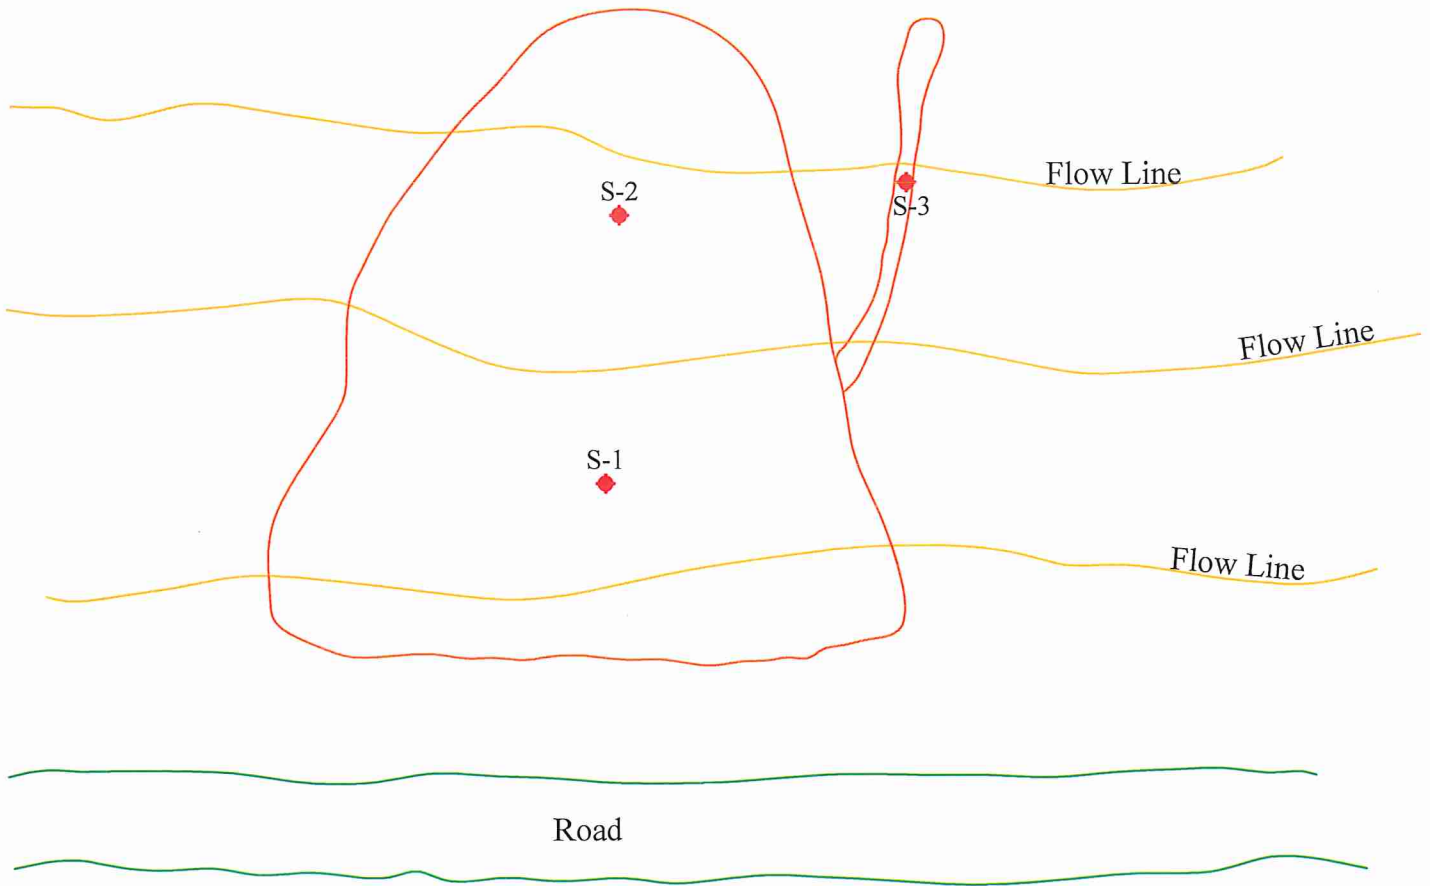
On August 28, 2015 a flow line leak was discovered, the amount of the mixed fluids released was approximately 20 barrels. All wells were shut in and the flow line was repaired. A vacuum truck was called to the location and recovered approximately 5 barrels of fluid. The impacted area is off the well pad and measured approximately 170-feet long by 100-feet wide. A site plan is presented in [Appendix I](#).

- The impacted area in the vicinity of sample location S-2 will be excavated to a depth of 1-foot bgs.
- The impacted areas in the vicinity of sample locations S-1 and S-3 will be excavated to a depth of 4-feet bgs and a 20-mil liner will be installed.
- All impacted soil will be transported to an NMOCD approved solid waste disposal facility.
- The excavated areas will be backfilled with top soil and contoured to match the surround terrain.
- A final closure report documenting all remedial actions will be provided to the NMOCD office in Hobbs along with the Final Form C-141.
