Release Notification and Corrective Action**OPERATOR**
☐ Initial Report ☒ Final Report

Name of Company: Southern Union Gas Services	Contact: Rose Slade
Address: P.O. Box 1226 Jal, NM 88252	Telephone No.: 210-403-6525 or 432.940.5147
Facility Name: Lea County Field Dept.	Facility Type: Natural Gas Gathering
Surface Owner: Rubert Madera Trust	Mineral Owner: Federal
IRP No. 1116

Site Closure Report
Regency Field Services LLC
A-14 6-Inch Pipeline Release Site
 Unit Letter A, Section 3, Township 24 South,
 Range 34 East
 Lea County, New Mexico
 32.252566N; 103.452315W
 Project No. 7250715006-001

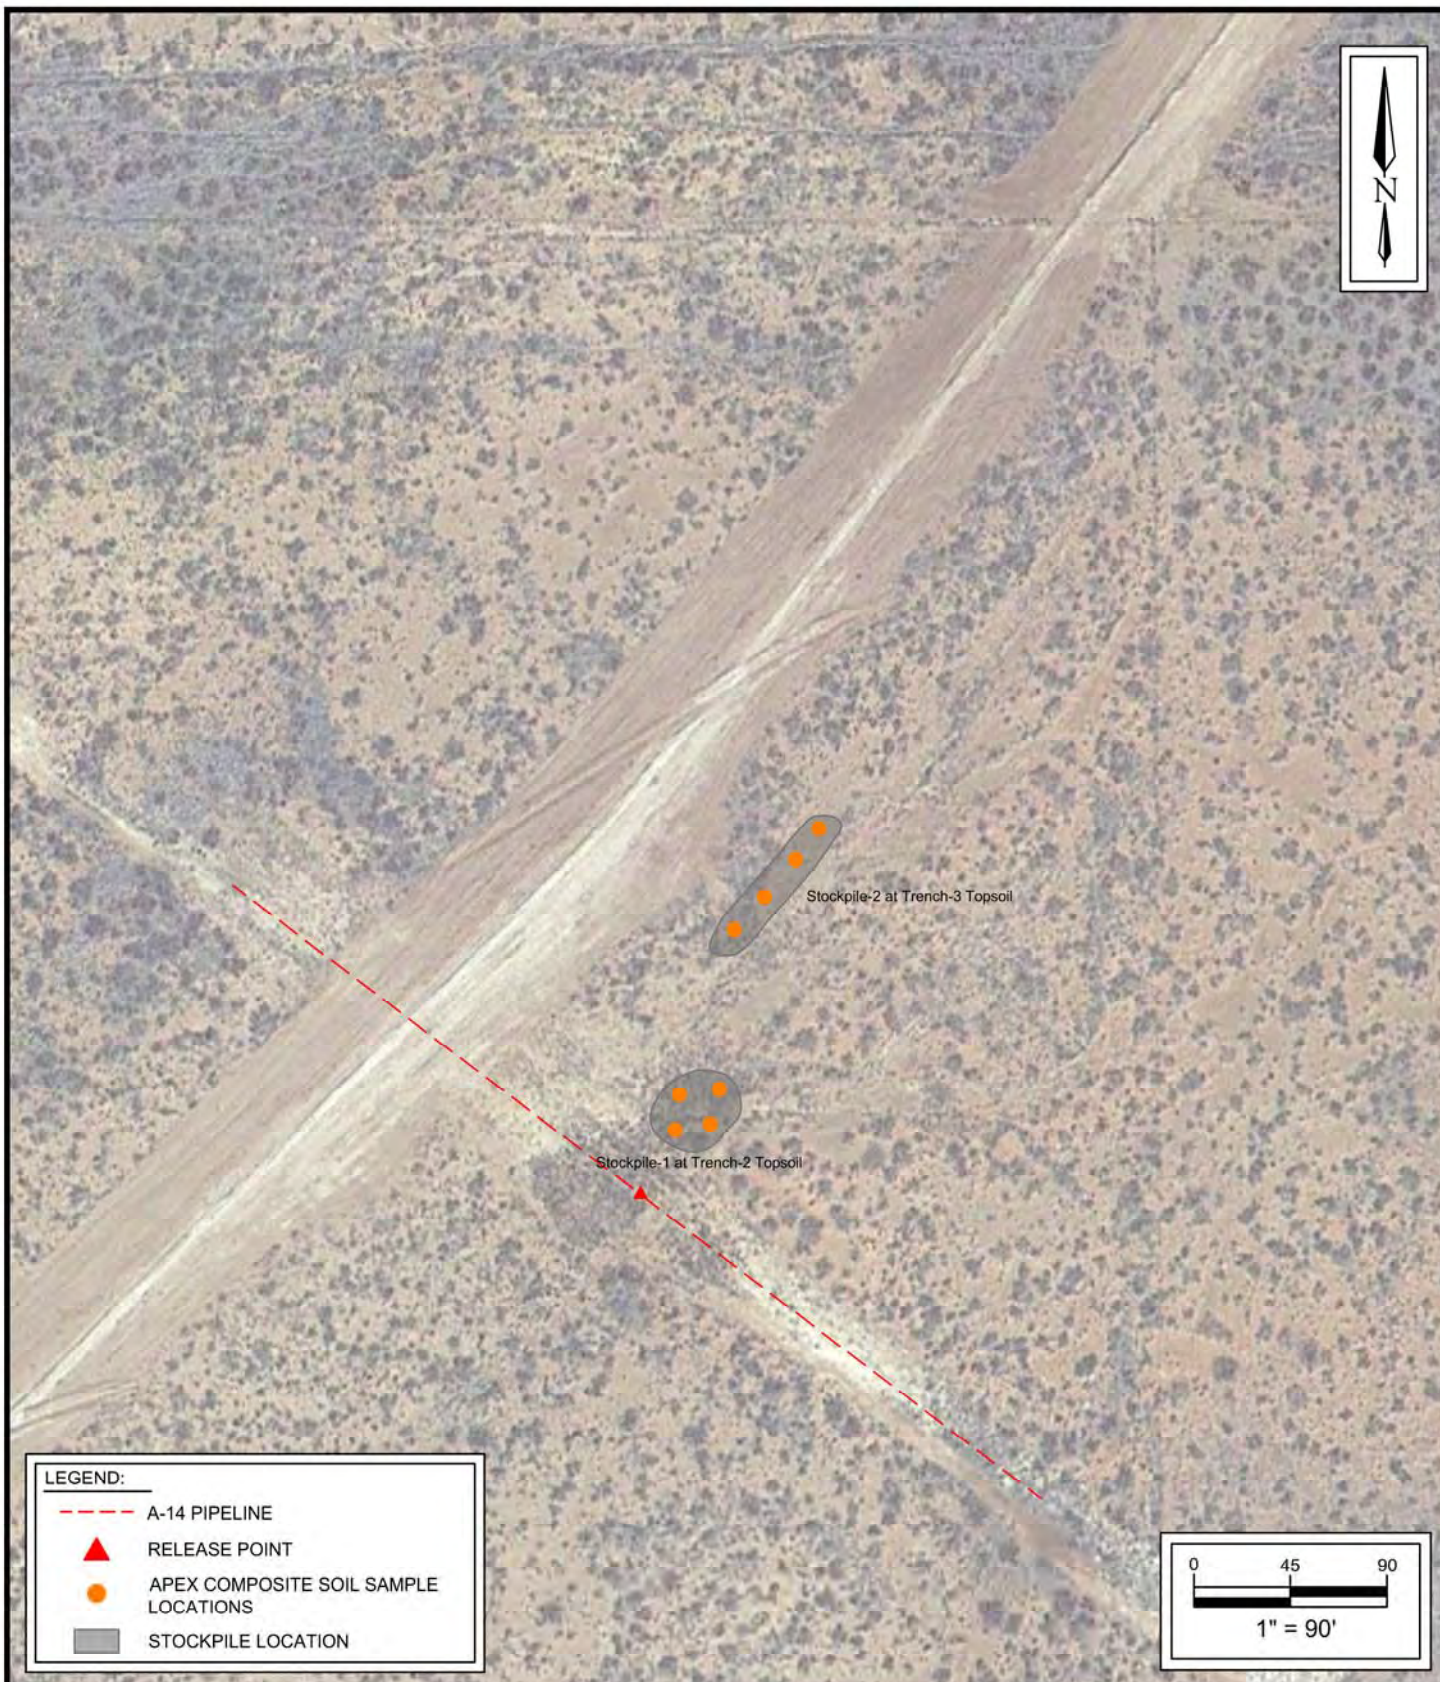
FIGURE 3B

Site Plan
NOVA 2013

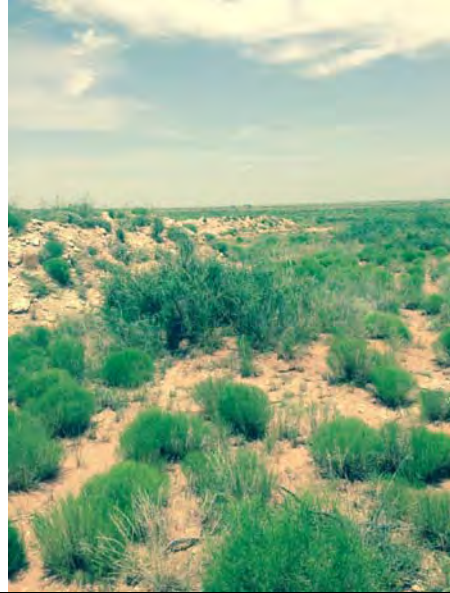
Photograph 1

View of vegetative overgrowth on former crude oil flow path near Trench 3.

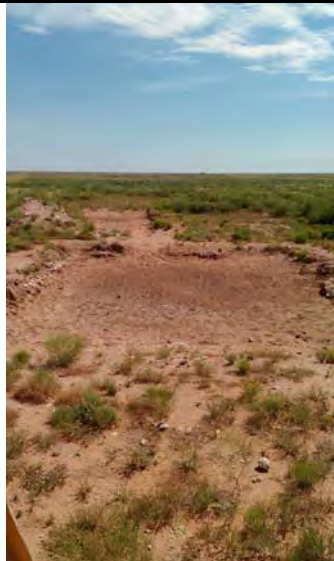
Photograph 2

View of Trench 2 excavation prior to backfill activities.

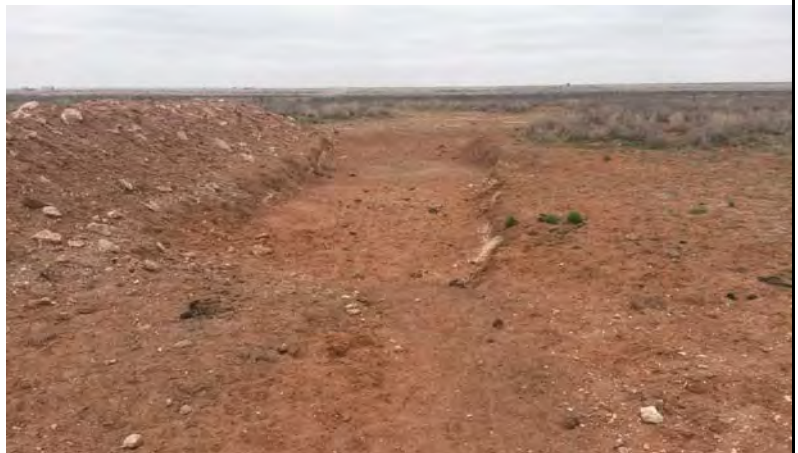
Photograph 3

View of Trench 3 excavation prior to backfill activities.

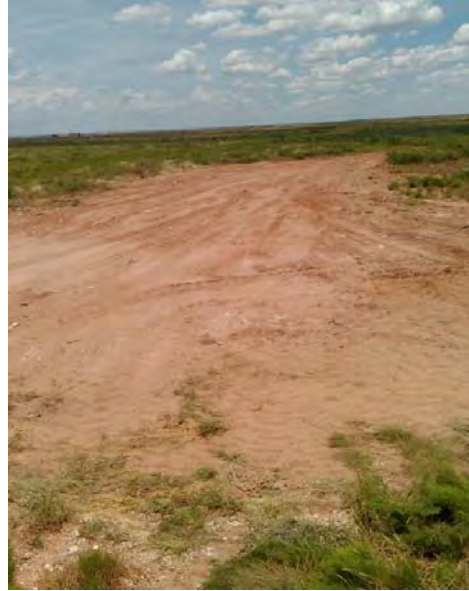
Photograph 4

View of Trench 3 excavation
subsequent to backfill activities.
