RE: Final Closure Report
Chevron – Mittie Weatherly #2
UL-E, Section 17, Township 21 South, Range 37 East
Lea County, New Mexico

The following *Final Closure Report* serves as a condensed update on closure activities undertaken for the above referenced Site.

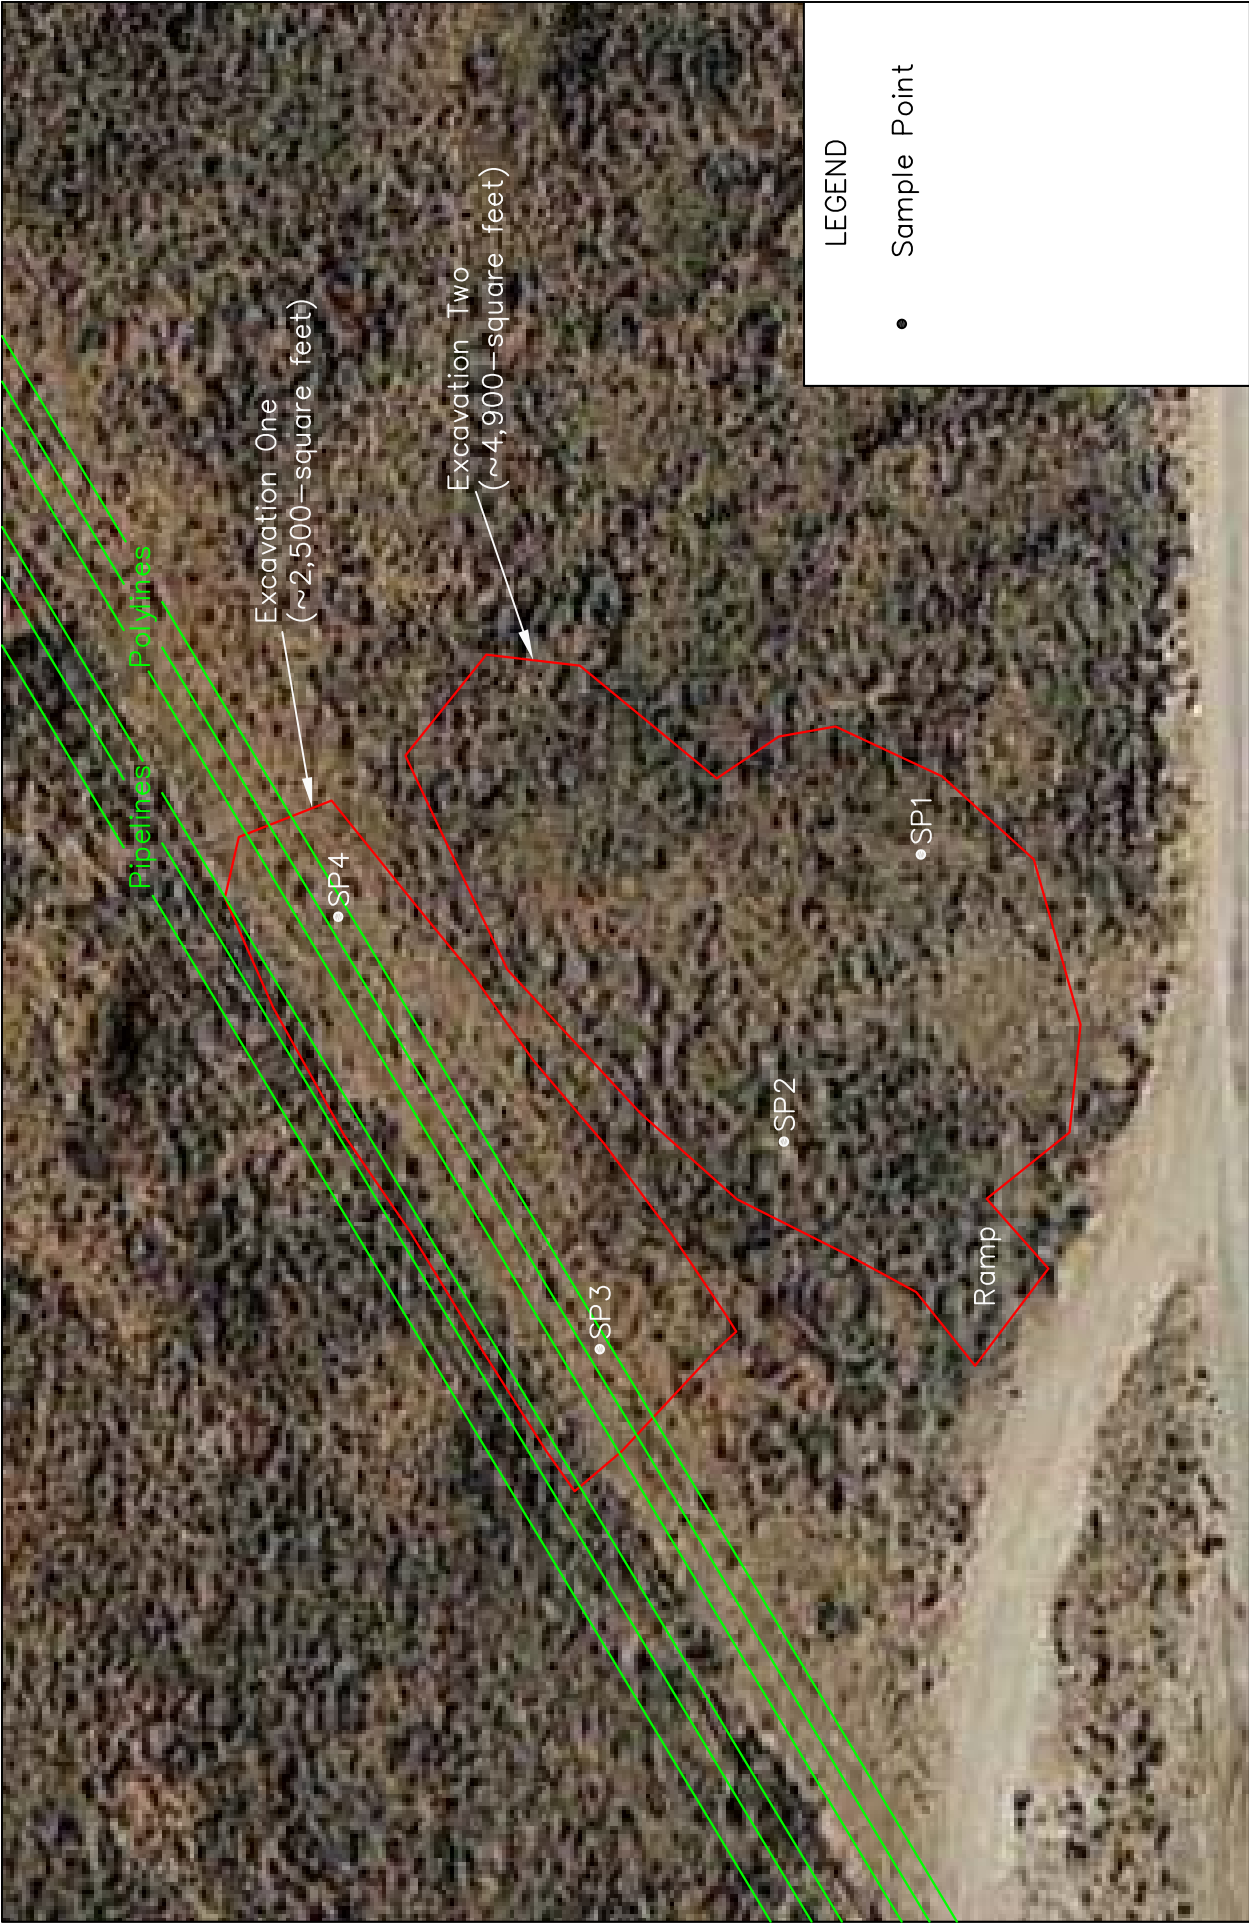
From May 21 – June 18, 2014 approximately 972 cubic yards of contaminated material were excavated and transported to a state approved facility for disposal. The release area was excavated into two areas. Excavation one was excavated using a hydro-excavator as three (3) buried flowlines were identified through one-call. Excavation two was excavated using a backhoe as no lines were identified through one-call. Both excavations are approximately four (4) feet deep with excavation one covering approximately 2,500 square feet and excavation two covering approximately 4,900 square feet (reference *Figure 4*).

In order to determine the vertical extent of contamination, on June 6, 2014 a test trench (SP1) was dug on the south east side of excavation two and samples collected at two (2) foot intervals to a depth of twelve (12) feet bgs. On June 10, 2014 excavation continued on SP1 to a depth of twenty four (24) feet bgs and samples again collected at two (2) foot intervals. On June 11, 2014 a second test trench (SP2) was dug on the south west side of excavation two and samples collected at two (2) foot intervals to a depth of sixteen (16) feet bgs. On June 16, 2014 two samples were collected from the north (SP4) and south (SP3) ends of excavation one. Due to the presence of buried flowlines in the excavation only one (1) sample was collected at each end at a depth of five (5) feet bgs (reference *Figure 4*). All samples were immediately jarred, put in plastic bags and placed on ice until the crew returned to the EPI yard where the samples were placed in the refrigerator. All twenty two (22) samples were sent to Cardinal Labs in Hobbs, New Mexico and analyzed for Chloride contaminant concentrations.

Laboratory analytical data indicates Chloride concentrations are in excess of NMOCD Recommended Remedial Action Levels (RRALs) of 500 mg/Kg to a depth of twenty two (22) feet bgs at SP1 and twelve (12) feet bgs at SP2. Chloride concentrations at SP3 were in excess of NMOCD RRALs at five (5) bgs; SP4 did not exceed NMOCD RRALs (reference *Figure 4* and *Table 2*).

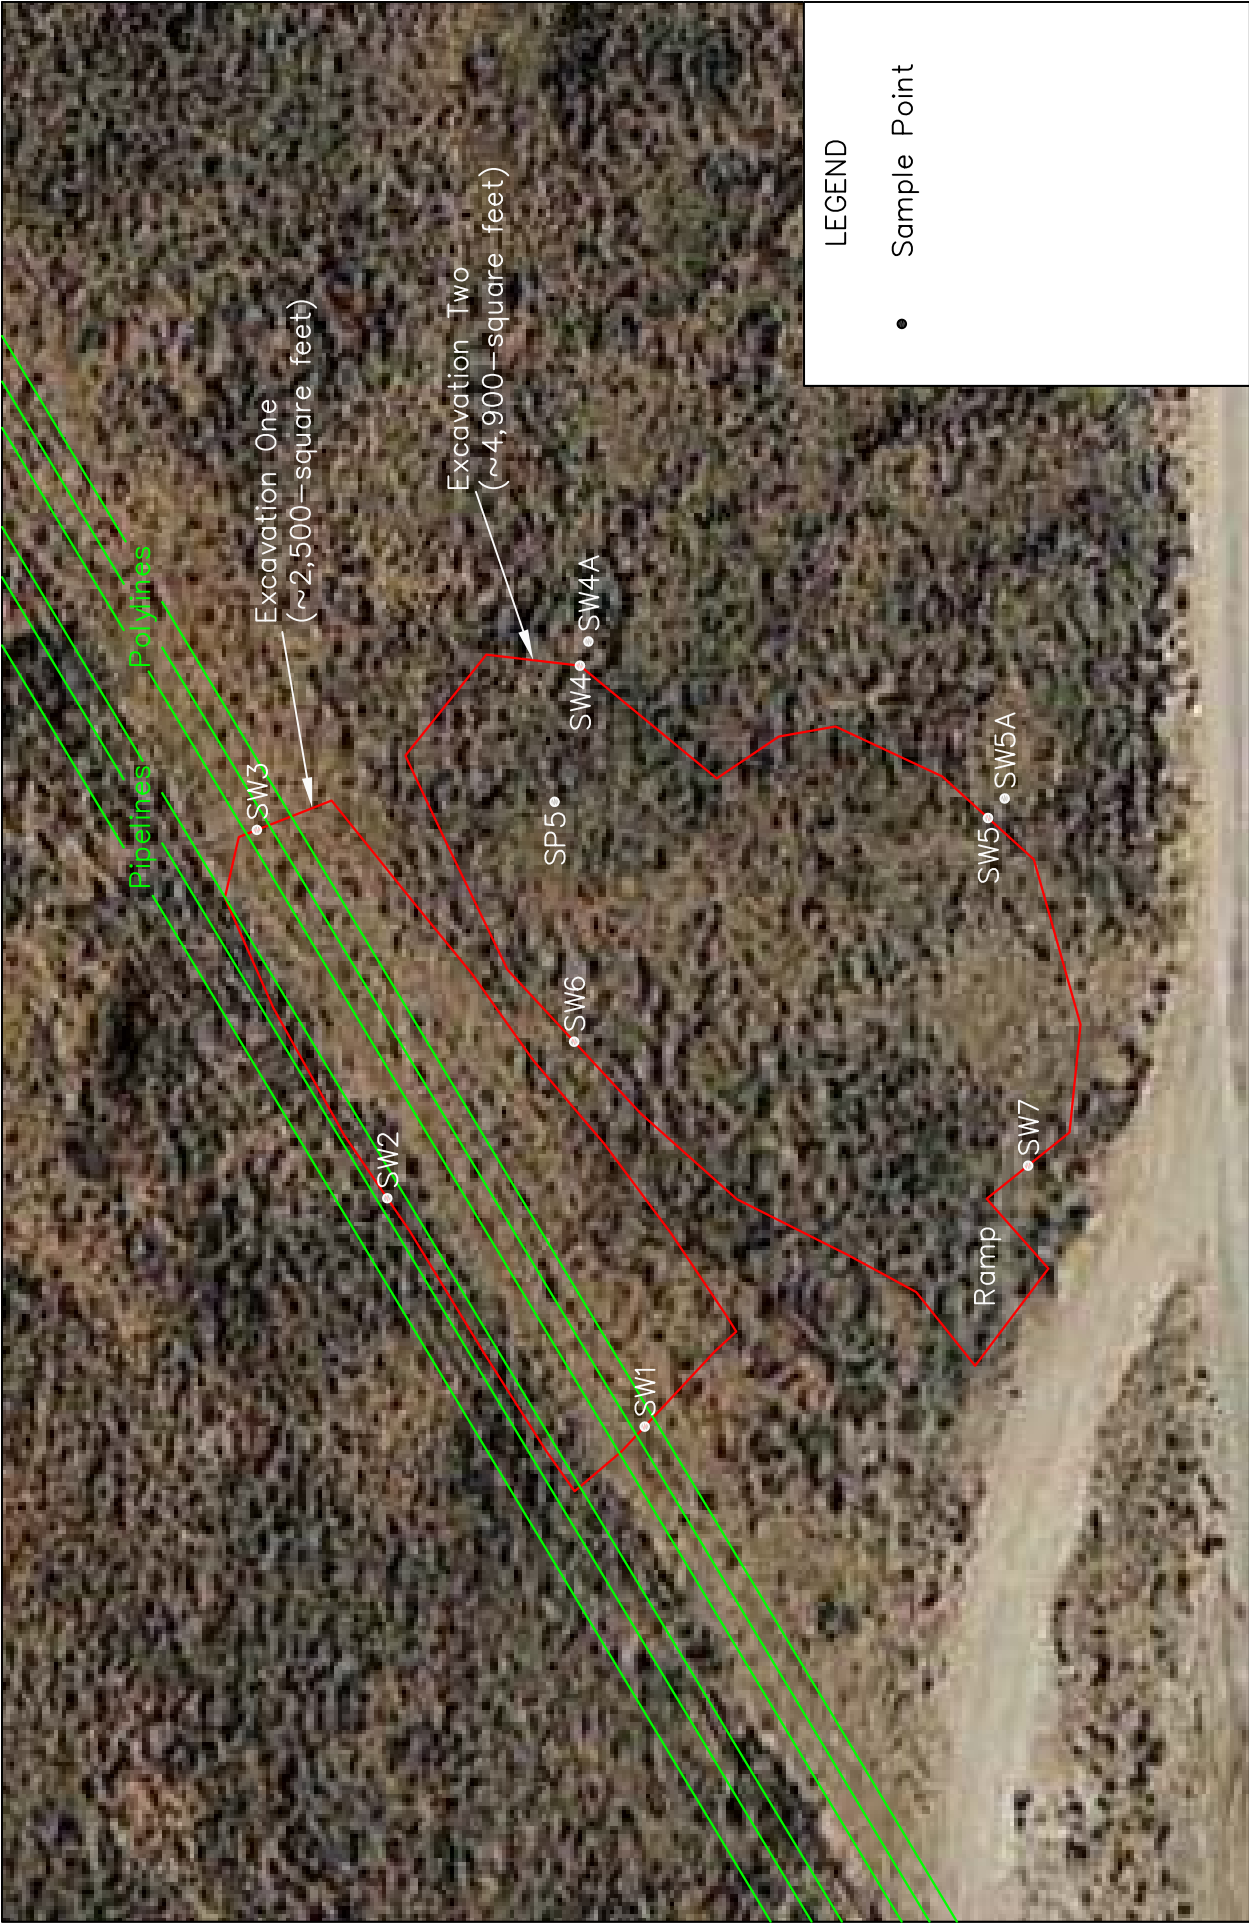
Figure 5 Sample Map – 5–11–15 Chevron Mittie Weatherly #2	Lea County, New Mexico SW 1/4 of NW 1/4, Sec. 17, T21S, R37E N 32° 28' 52.42" W 103° 11' 24.46" Elevation: 3,481 feet amsl	DWG By: D Dominguez May 2014	REVISED: June 2015

On May 11, 2015 EPI personnel mobilized on site to collect soil samples to determine sidewall contaminant concentrations as well as collect one (1) additional sample from excavation floor. Ten (10) soil samples we collected from eight (8) sample locations; SW1 – SW7, SP5. Eight (8) of the ten (10) soil samples were sent to Cardinal Labs in Hobbs, NM and analyzed for Chloride contaminant concentrations. Sample locations SW4 and SW5 field tested high for Chlorides so additional samples were collected approximately four (4) feet further out from the sidewall and field tested. These samples were sent the lab (reference *Figure 5* and *Table 2*).

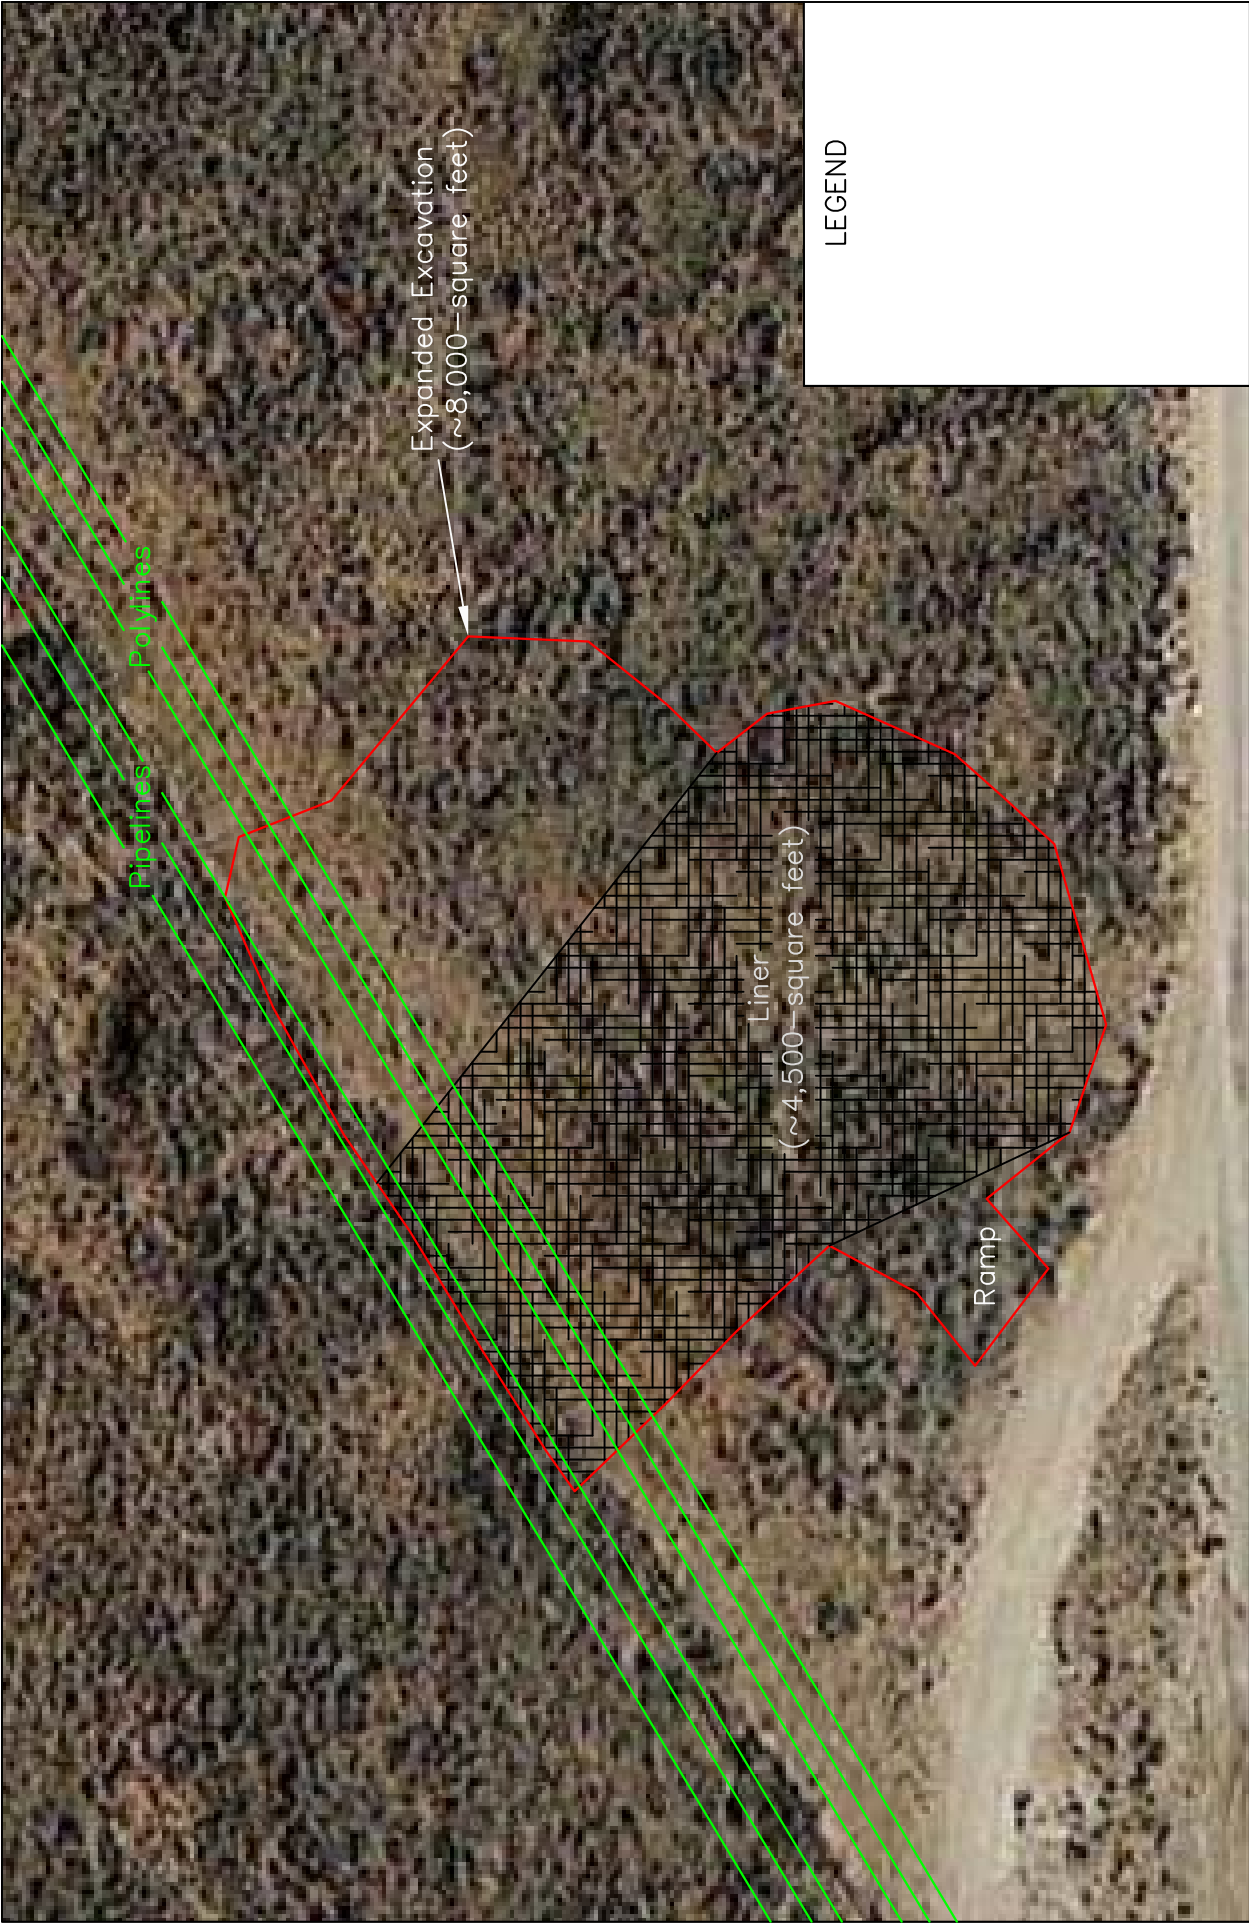
Figure 6 Liner Map Chevron Mittie Weatherly #2	Lea County, New Mexico SW 1/4 of NW 1/4, Sec. 17, T21S, R37E N 32° 28' 52.42" W 103° 11' 24.46" Elevation: 3,481 feet amsl	DWG By: D Dominguez May 2014	REVISED: July 2015	 	
		 			SHEET 1 of 1

Laboratory analytical data indicates the excavation is void of Chloride concentrations in excess of NMOCD RRALs in all samples with the exception of SW6. However, sample point SW6 was located on the wall separating the two excavations and was excavated (reference *Figure 6* and *Table 2*).

Based on laboratory data and with NMOCD approval, the soil separating the excavations was removed and an additional two (2) feet excavated from the floor of the excavation. As the flowlines running through the excavation do not belong to Chevron the soil was not removed from under the flowlines, but left to support the flowlines. In total, approximately 1,472 cubic yards of contaminated soil were excavated and transported to a state approved facility for disposal. When excavation activities were completed a twenty (20) mil thick polyethylene liner was placed in the bottom of the excavation and under the flowlines (reference *Figure 7*). The polyethylene liner was placed on a one (1) foot thick layer of clean soil. The excavation was backfilled with approximately 1,472 cubic yards of selected top soil to finish grade. Top soil was free of deleterious material or rocks or large clumps.

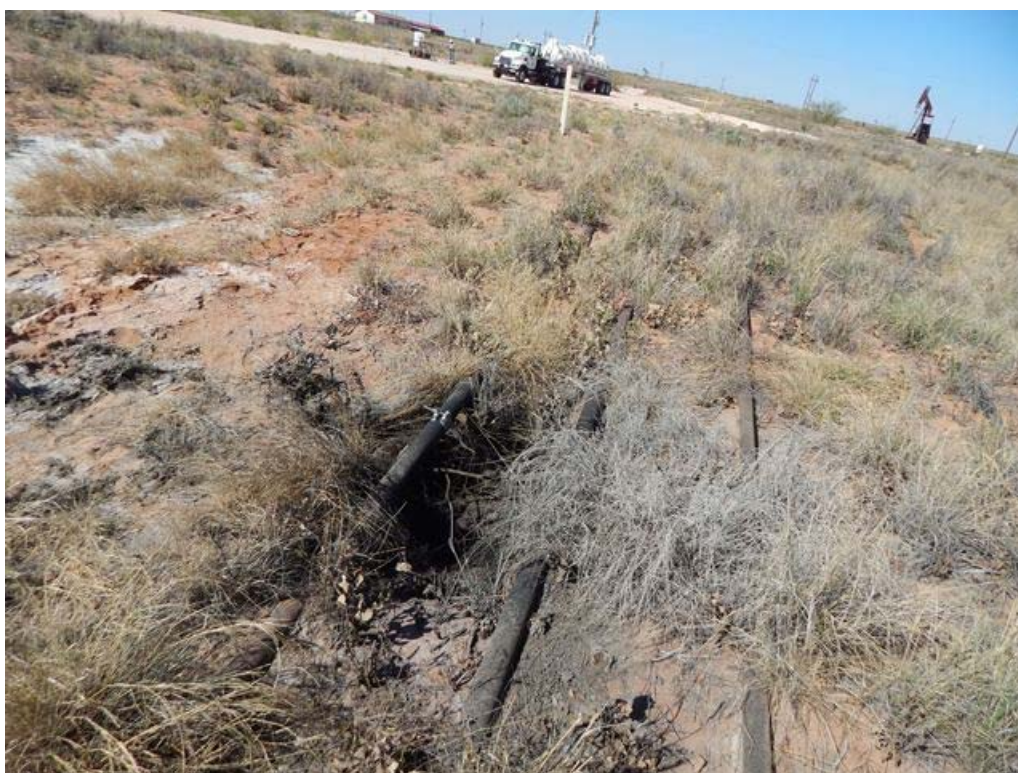
Photograph #2 – Looking across release point

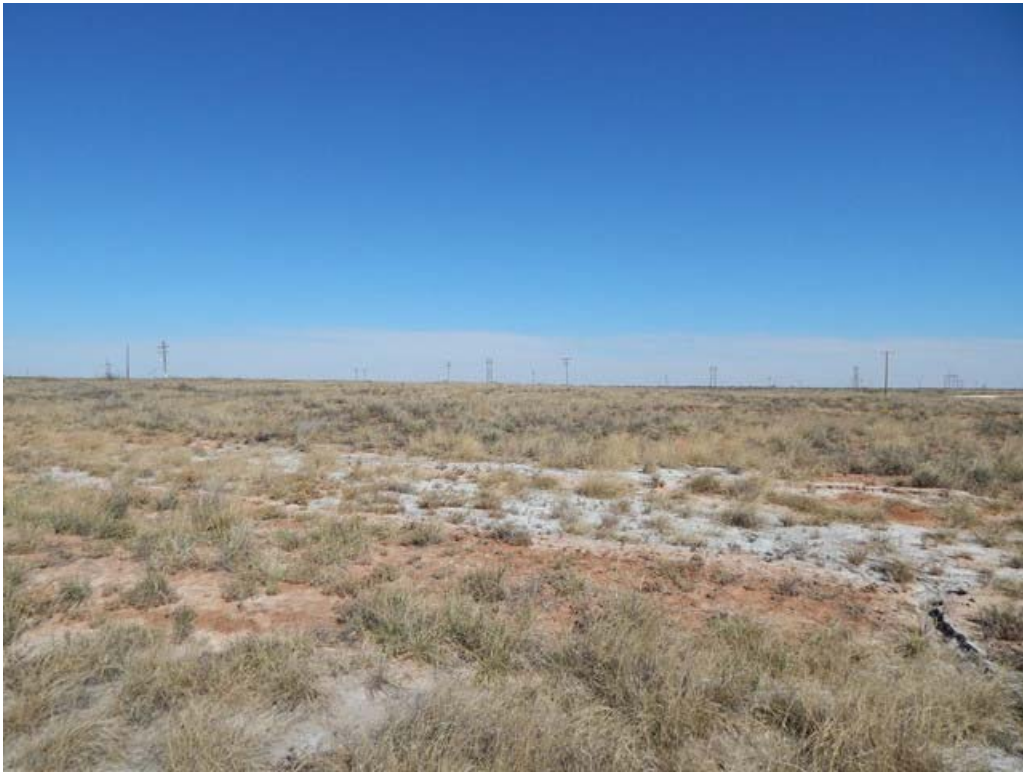
Photograph #3 – Looking northerly across release area

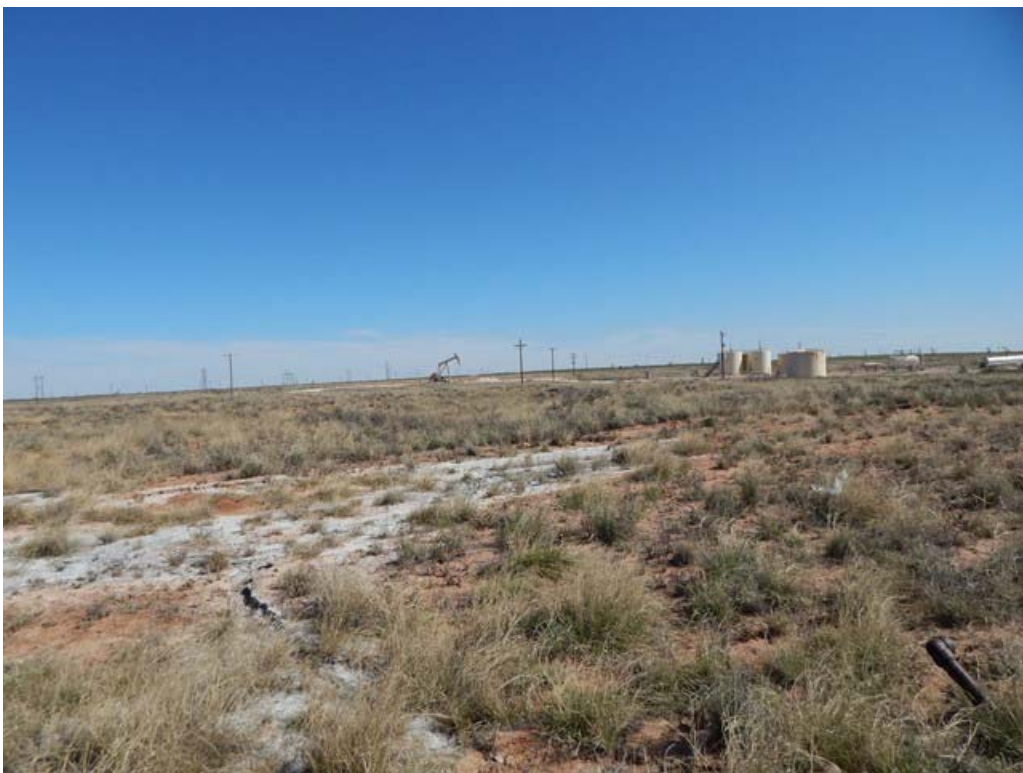
Photograph #4 – Looking northerly across release area

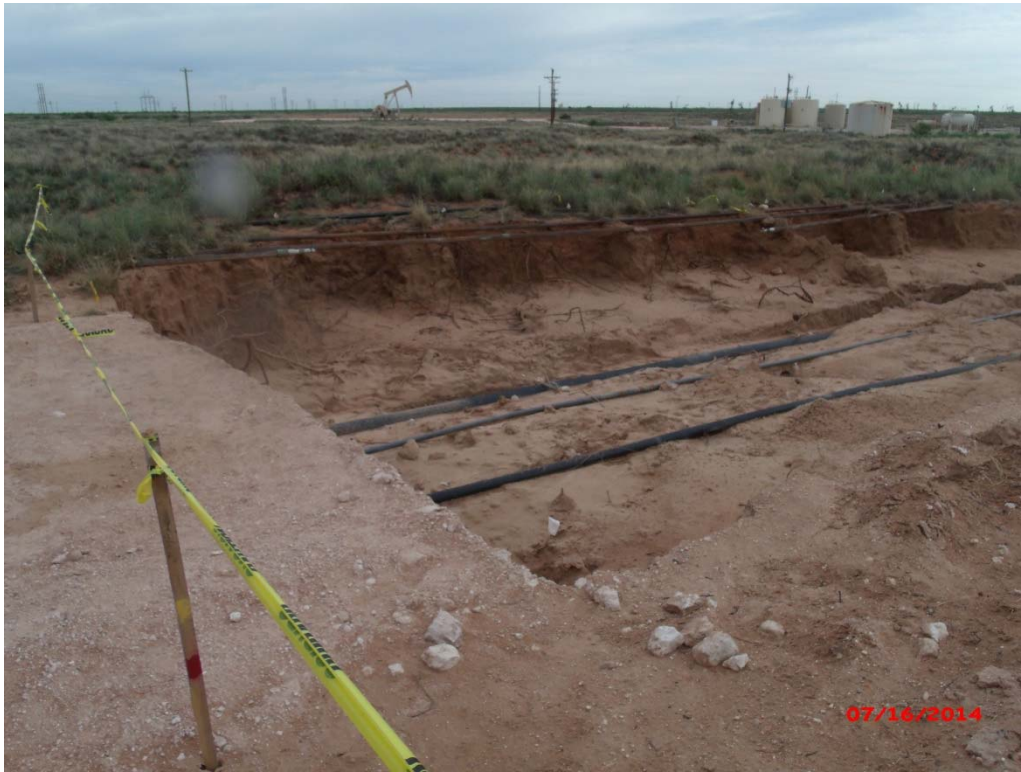
Photograph #5 – Looking northerly across excavation one

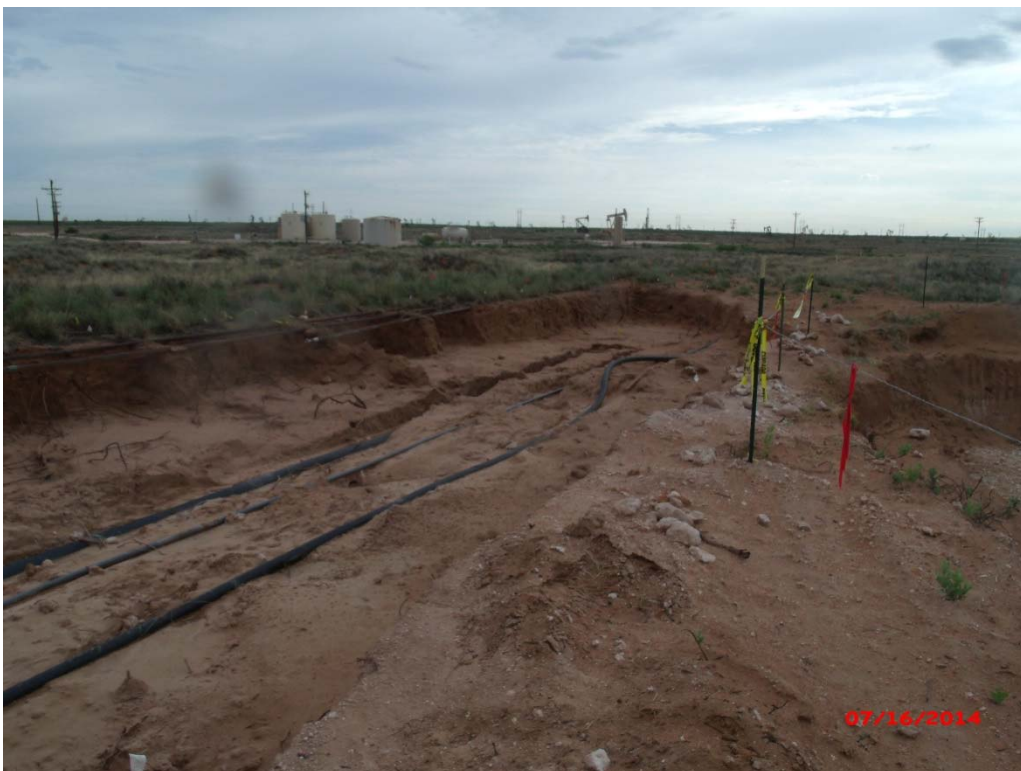
Photograph #6 – Looking north easterly across excavation one

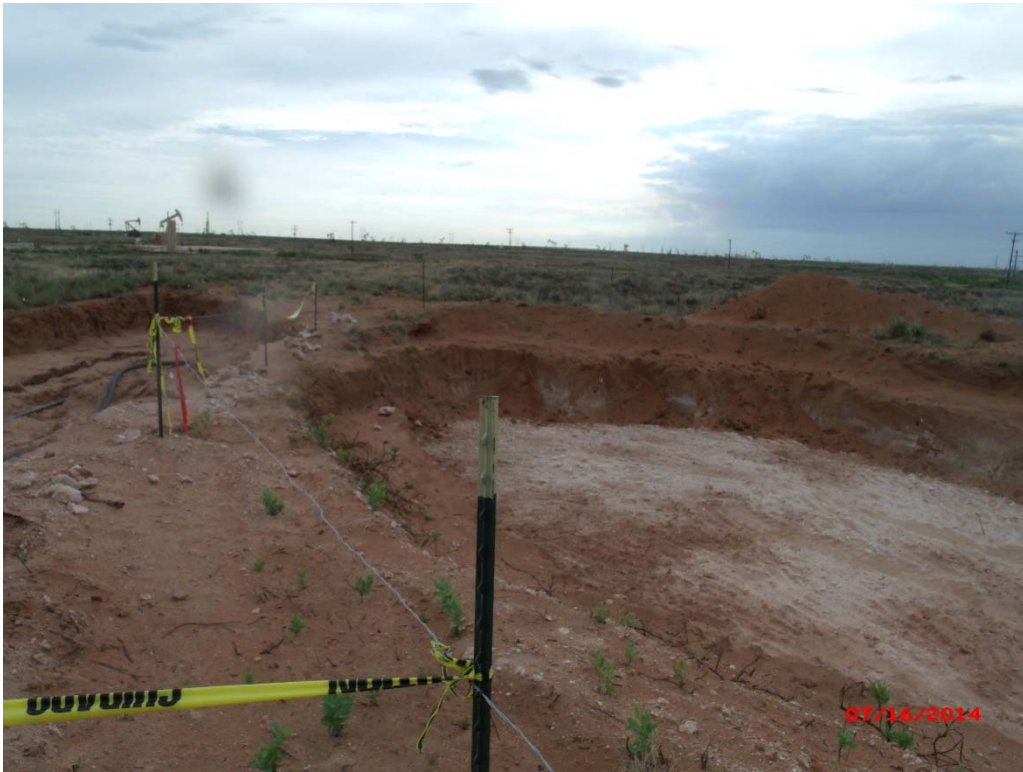
Photograph #7 – Looking easterly across excavation two

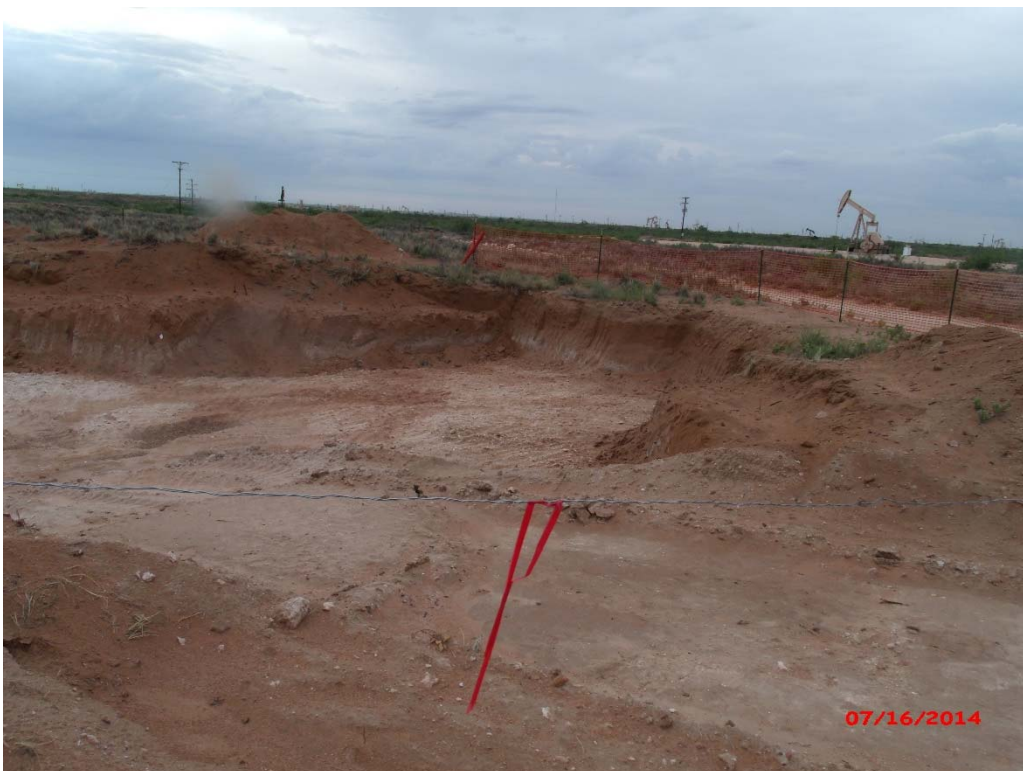
Photograph #8 – Looking easterly across excavation two

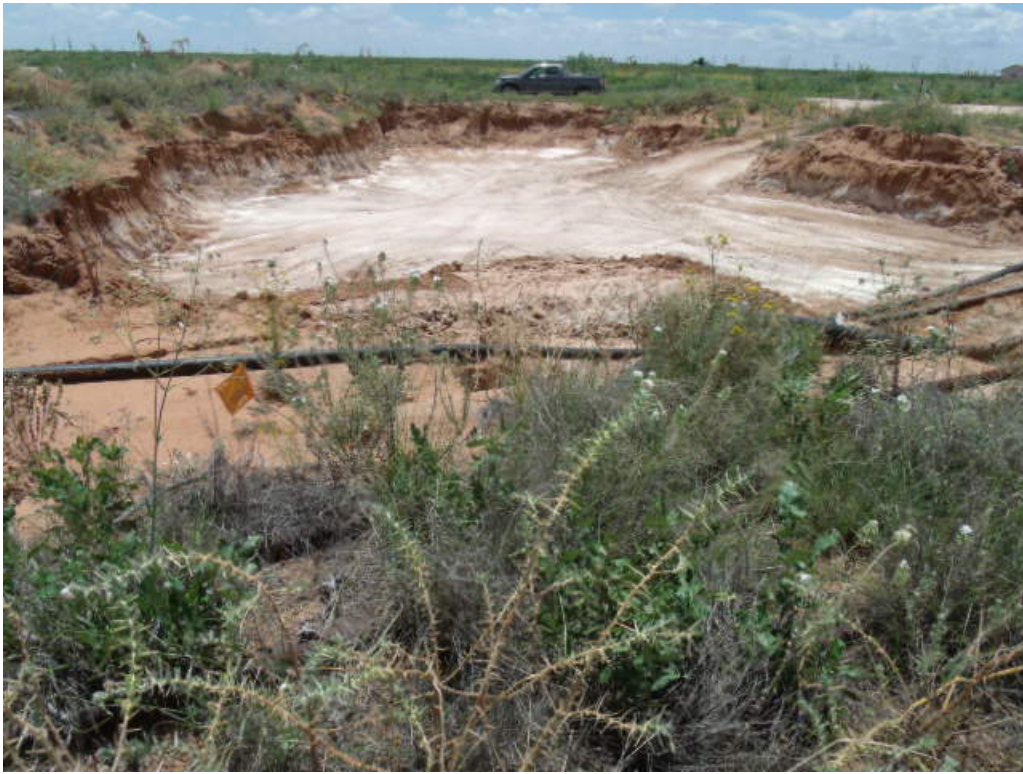
Photograph #9 – Looking across expanded excavation

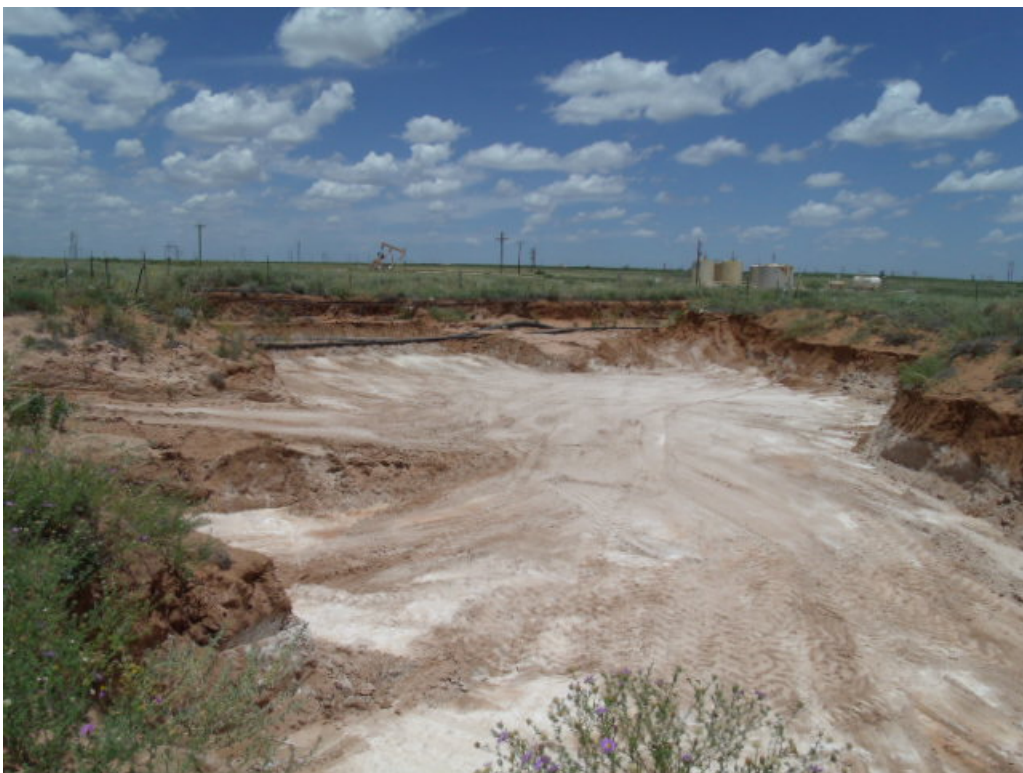
Photograph #10 – Looking across expanded excavation

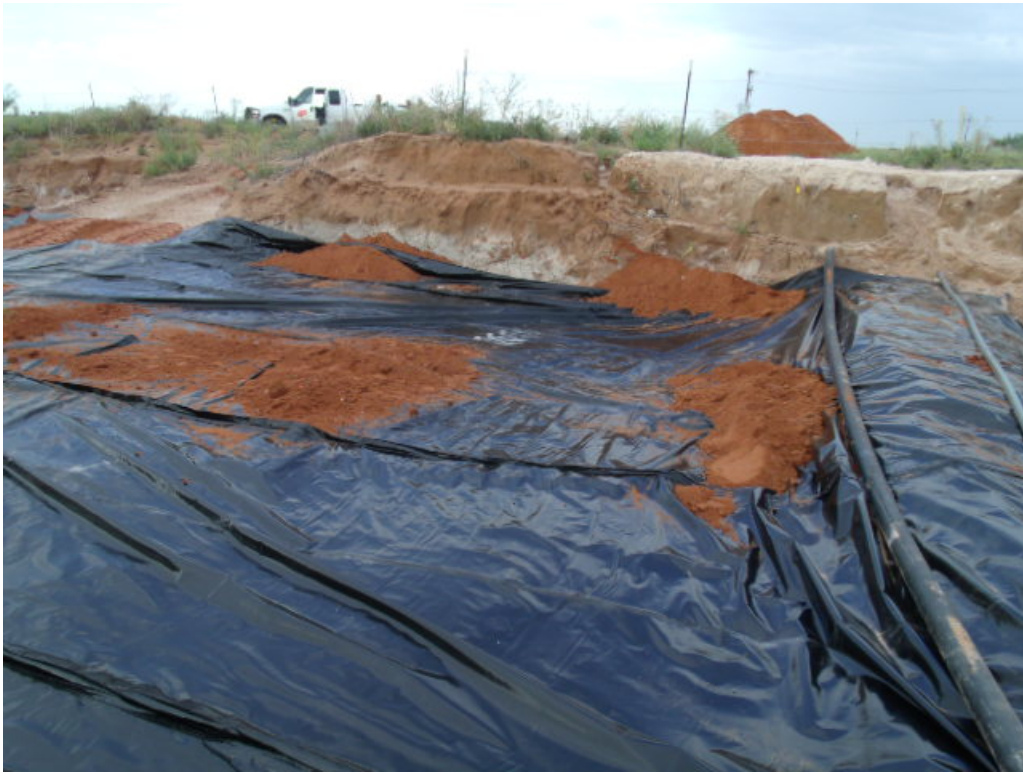
Photograph #11 – Liner installed

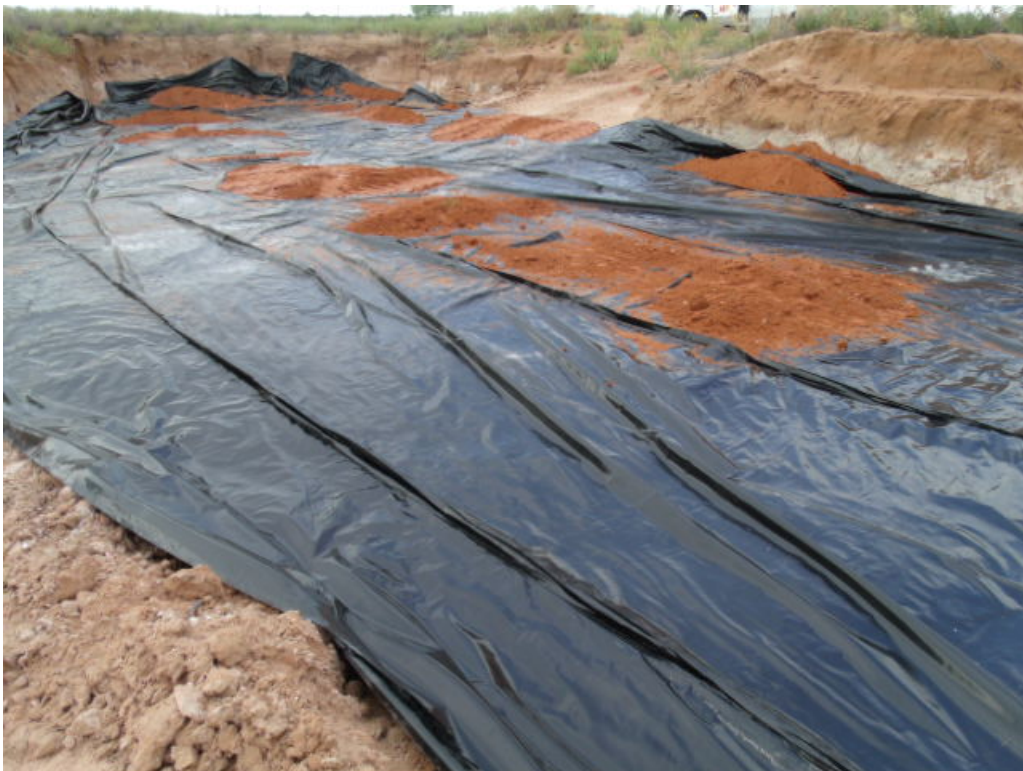
Photograph #12 – Liner installed

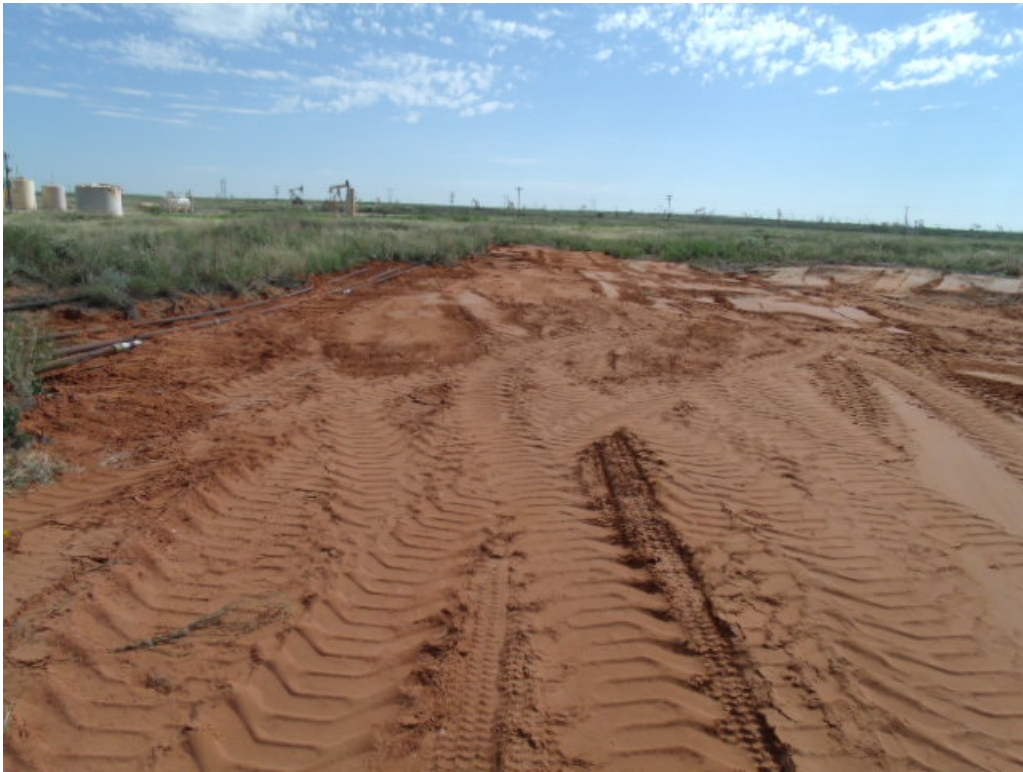
Photograph #13 – Backfilled

Backfilling continued until the entire excavation was closed. Upon completion of backfill activities, the entire disturbed area was contoured to blend with existing pasture area and protected against wind/water erosion. Disturbed areas will be disced and deep drill seeded with a mixture approved by the property owner. However, it is recommended completing this activity in late spring 2016 when ground conditions are more conducive to vegetative growth.

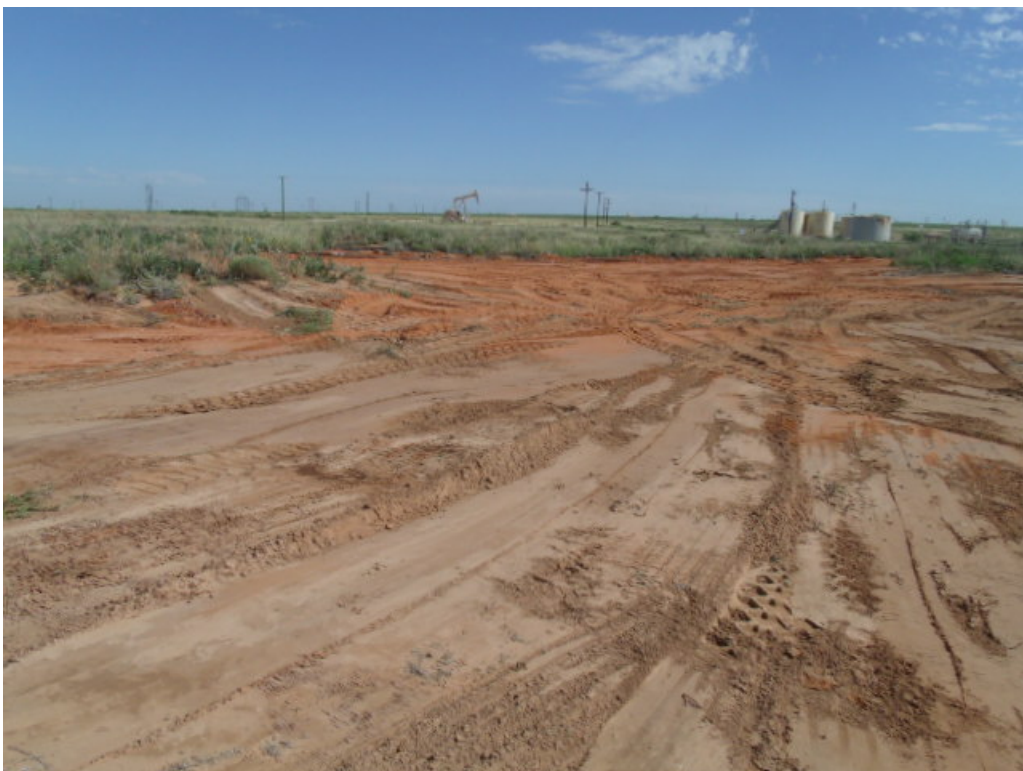
Photograph #14 – Backfilled
