Philmex 04

(1RP-3210)

Termination Request

**RE: Termination Request
ConocoPhillips Philmex 04 (1RP-3210)
UL/N sec. 26 T17S R33E
API No. 30-025-30394**

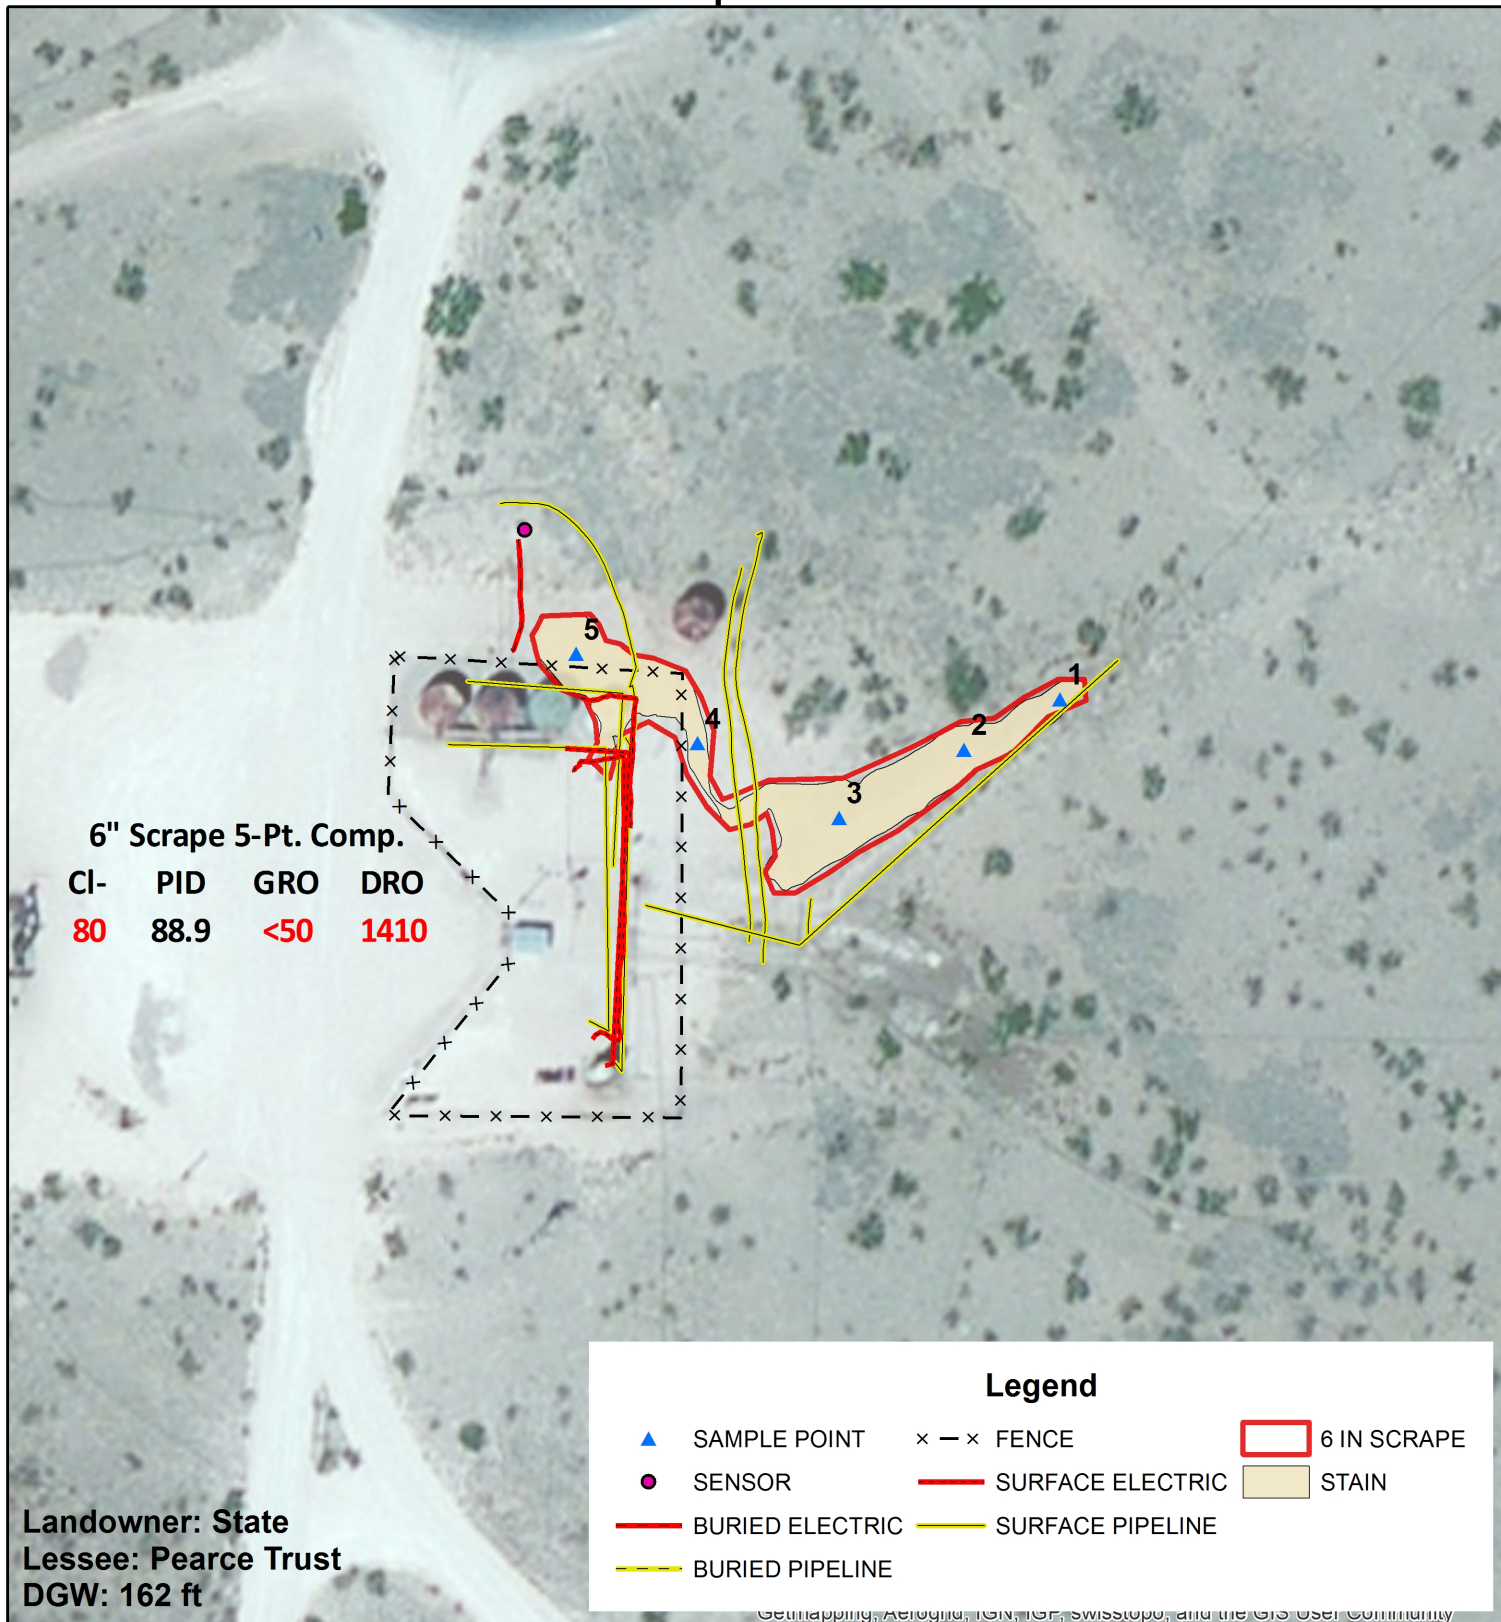
Figure 1

CAP activities began June 3rd, 2015. The area was scraped to 6 inches bgs and a 5 Pt. Composite was taken and sent to a commercial laboratory for analysis (Figure 1). Laboratory analysis returned a chloride level of 80 mg/kg, a Gasoline Range Organics (GRO) reading of non-detect and a Diesel Range Organics (DRO) reading of 1410 mg/kg (Appendix B). A total of 115 yards of contaminated soil were exported and disposed of at a NMOCD approved facility. Approximately 120 yards of top soil were imported for backfill. A sample of the imported soil was taken and sent to a commercial laboratory for analysis. Laboratory analysis returned a chloride level of non-detect. A request to backfill the site was sent to NMOCD June 10th, 2015 and was approved the same day. The site was then backfilled with the clean, imported soil and contoured to the surrounding location.

Scrape Data

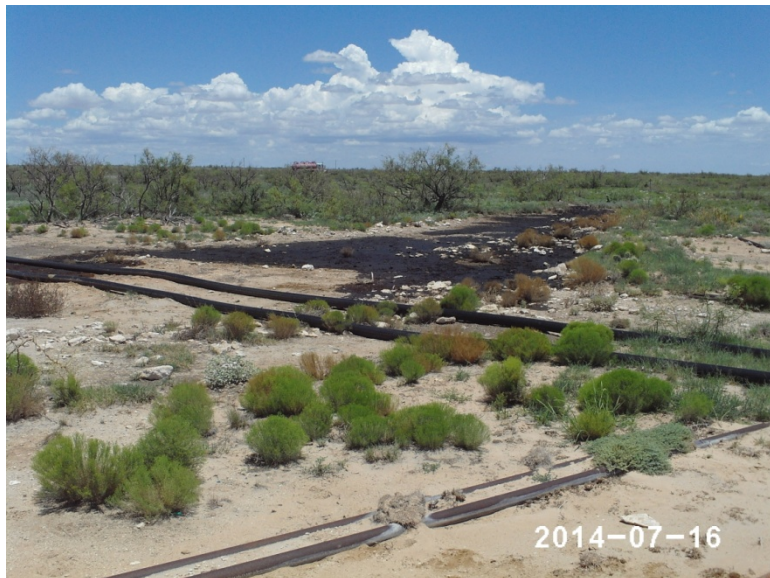
Initial release area, facing northeast

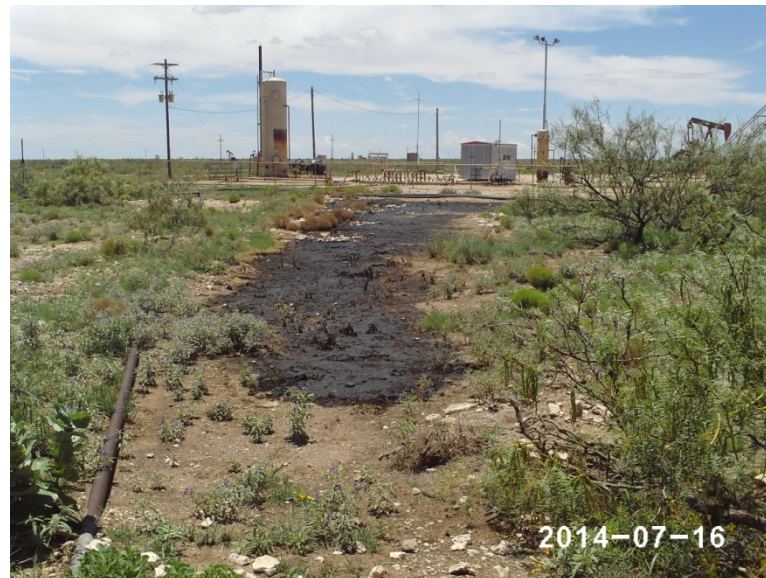
Initial release area, facing southwest

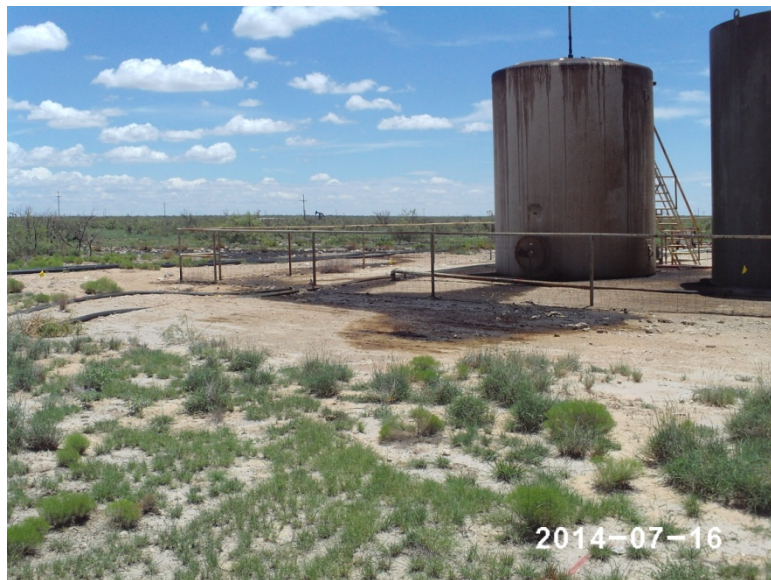
Initial release area, facing southeast

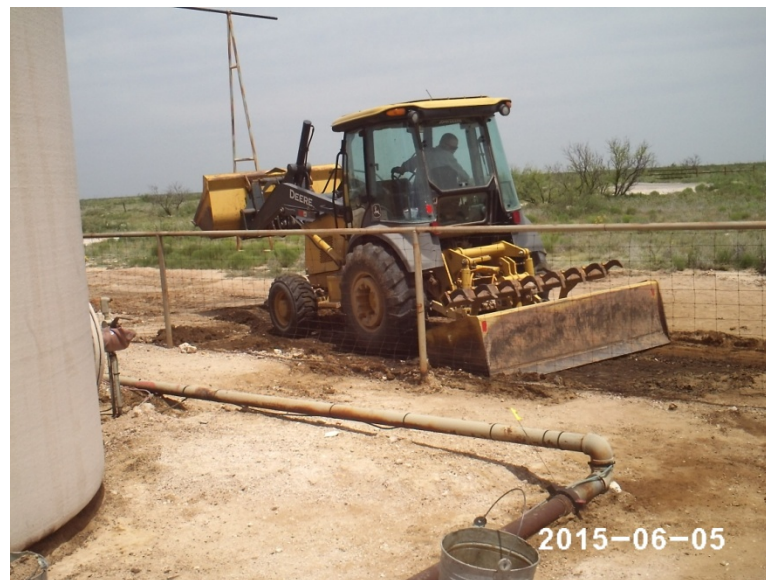
Beginning 6 inch scrape, facing north

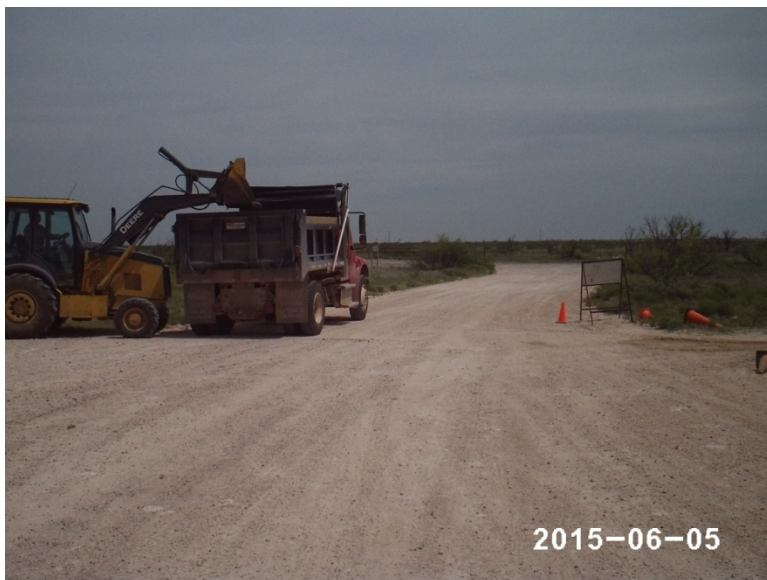
Exporting soil, facing north

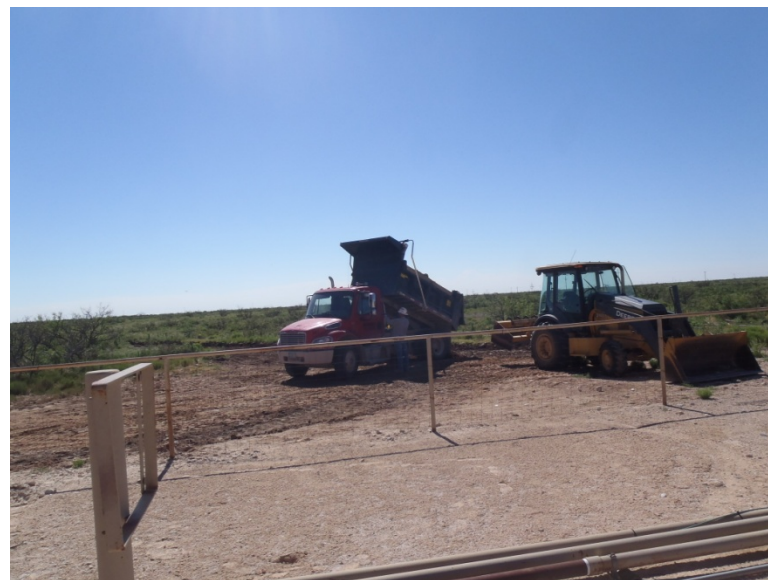
Importing soil, facing east

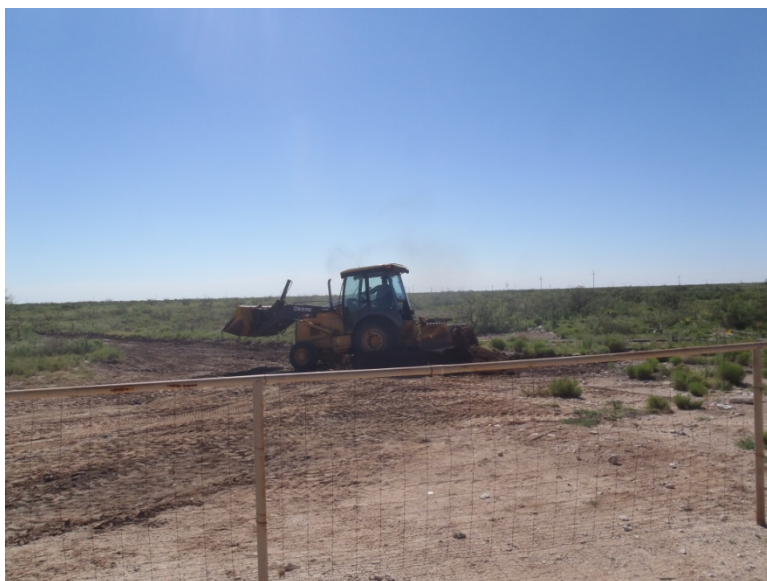
Backfilling scrape, facing southeast

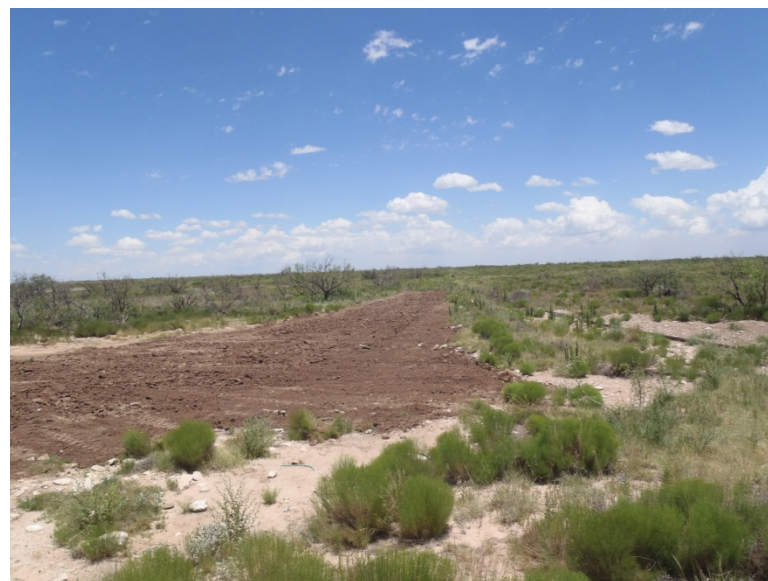
Site completed, facing northeast

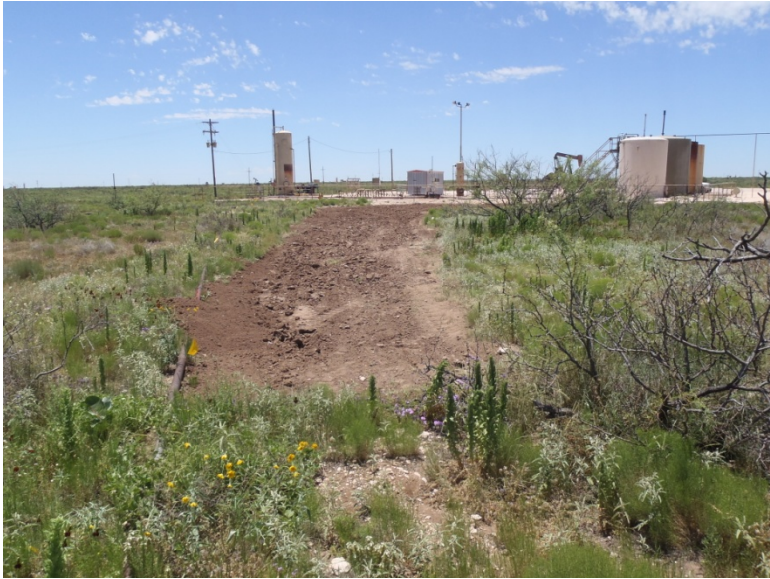
Site completed, facing southwest

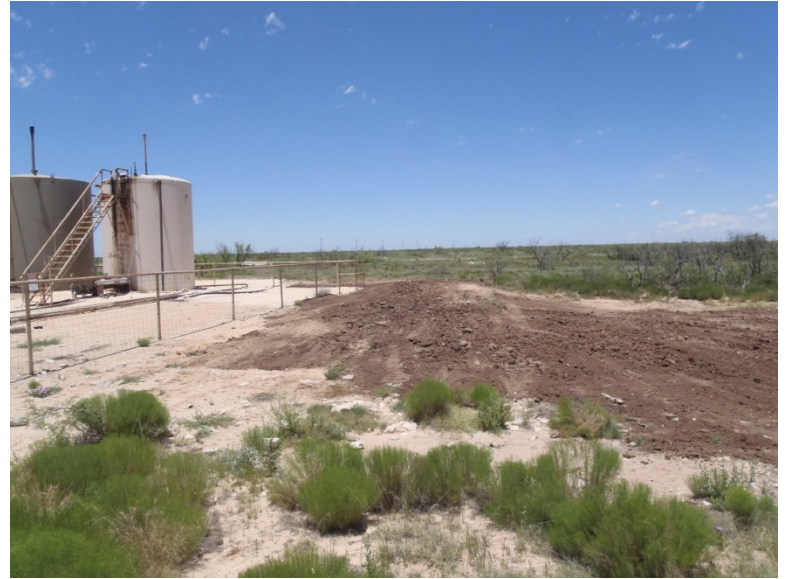
Site completed, facing north
