**XTO Energy, Inc.
Bridges State 120 Battery
Closure Report
Lea County, New Mexico
December 22, 2015**

**XTO Energy, Inc.
200 North Loraine Street, Suite 800
Midland, Texas 79701**

***Safety & Environmental Solutions, Inc.
703 East Clinton Street
Hobbs, New Mexico 88240
(575) 397-0510***

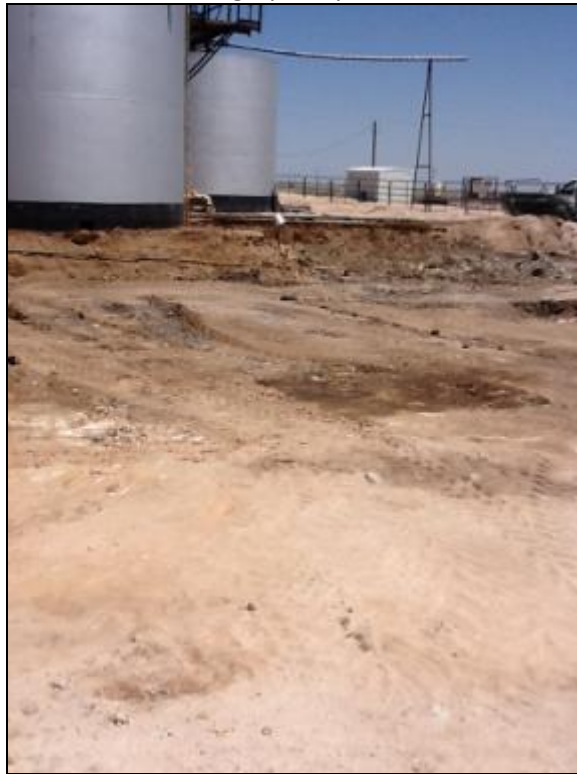
Spill Area

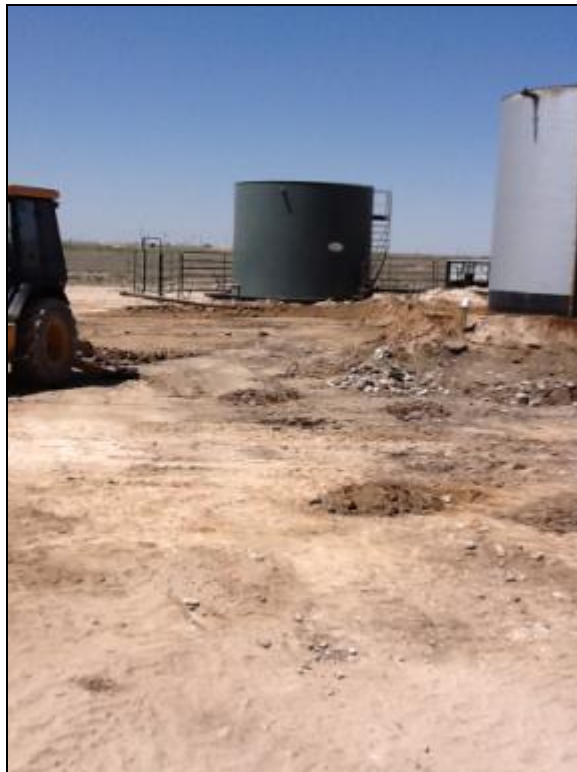
Spill area facing southwest

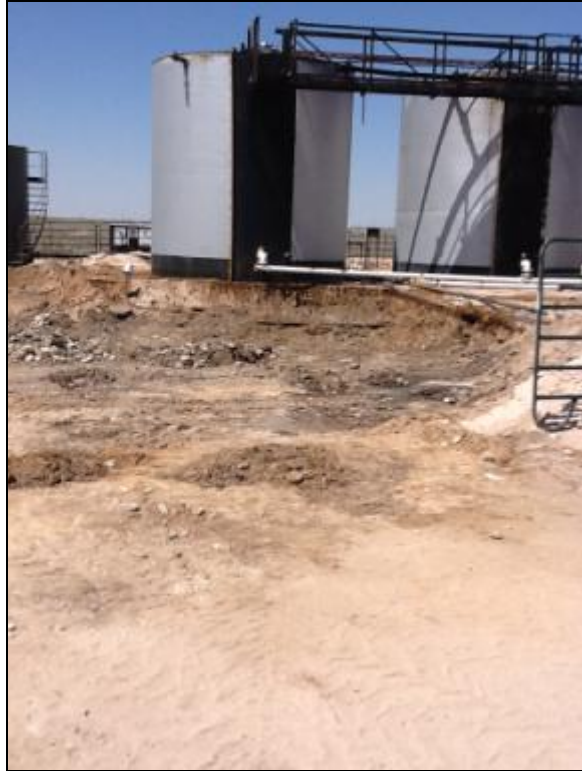
Spill area facing west

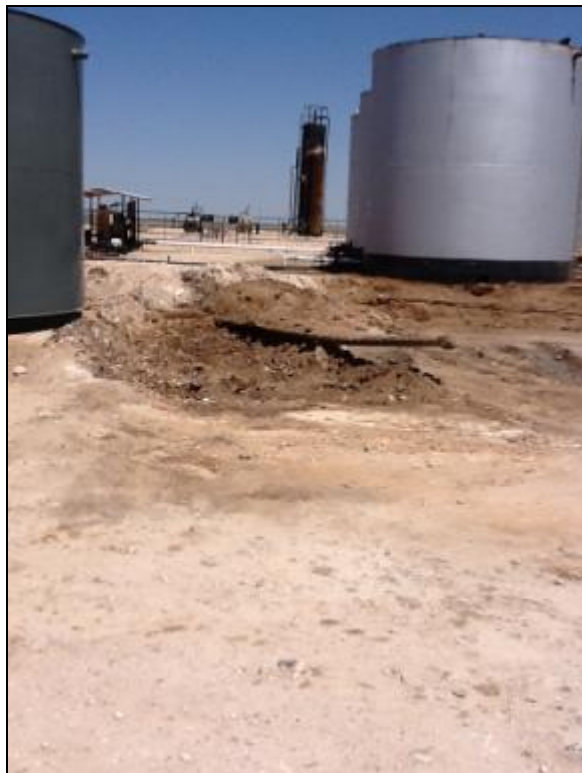
West end of spill area

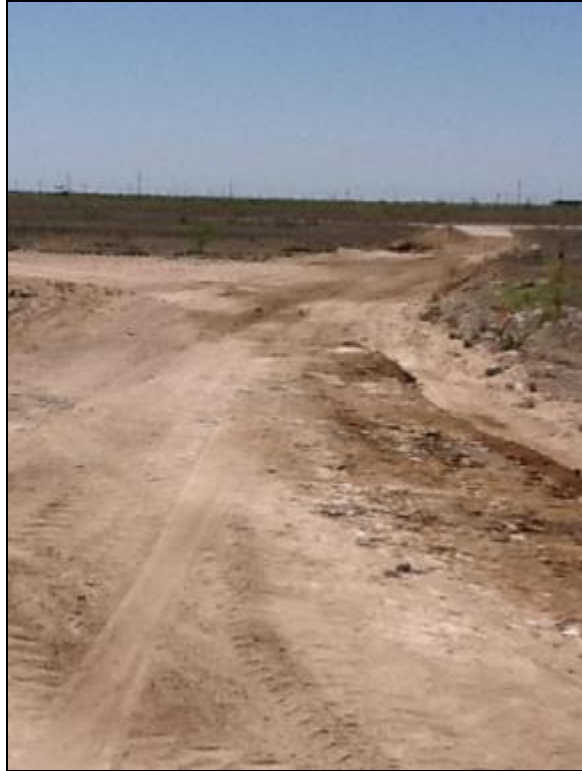
Staining on lease road facing south

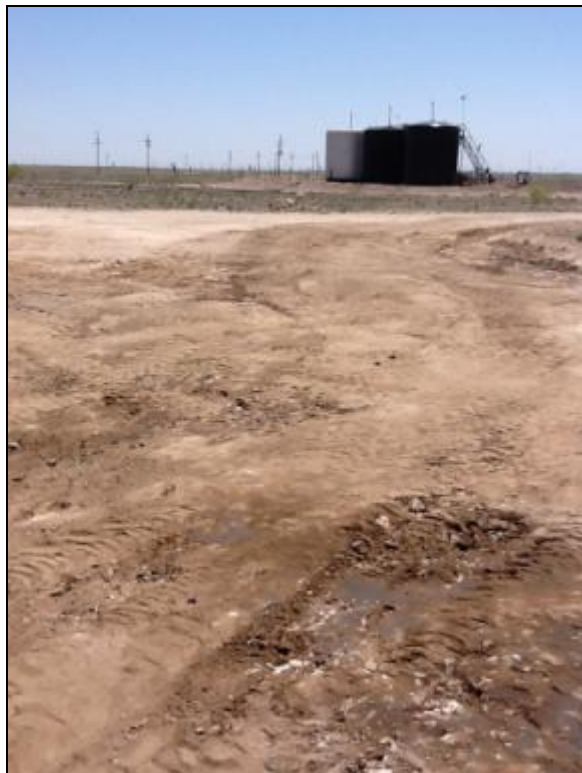
Staining on road facing southeast

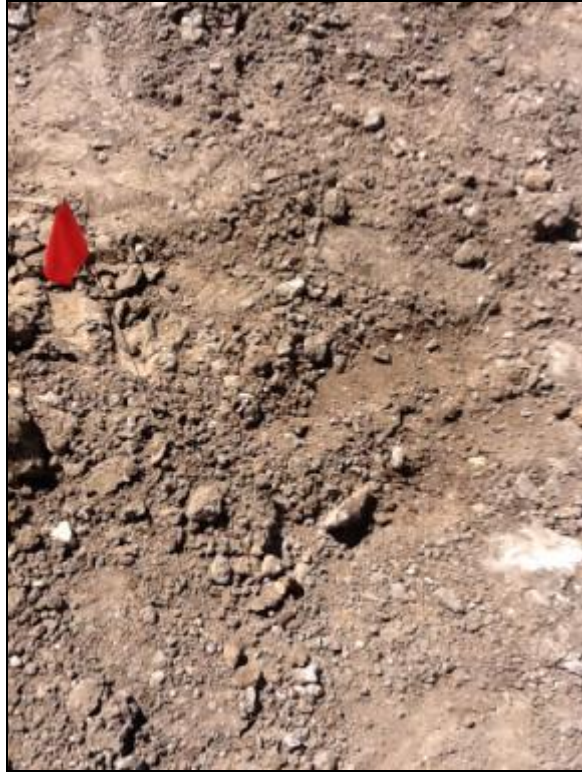
2' of impacted soils were removed from the interior of the bermed area and stockpiled northeast of the location for future removal. Test trenches were excavated before the commencing of delineation efforts in order to determine the vertical extent of the impact. Two test trenches were excavated and representative surface soil samples were retrieved. The backhoe encountered bucket refusal and was not able to penetrate past 6"- 8" bgs. in depth on test trenches #1 and #2. Representative soil samples were not retrieved due to the rock like nature of the soil. However, there was visible staining and odors that remained at this depth in these respective trenches.

Test trench-1: Surface

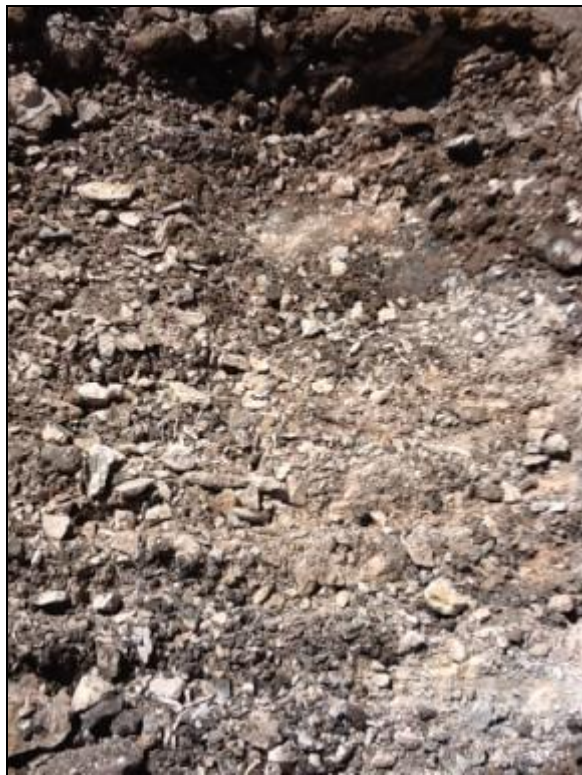
Test trench-1: 6-8 inches

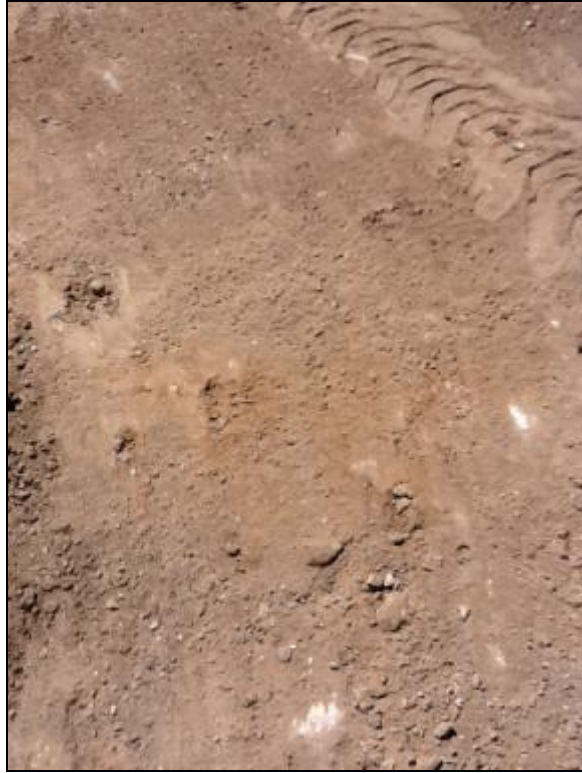
Test trench-2: Surface

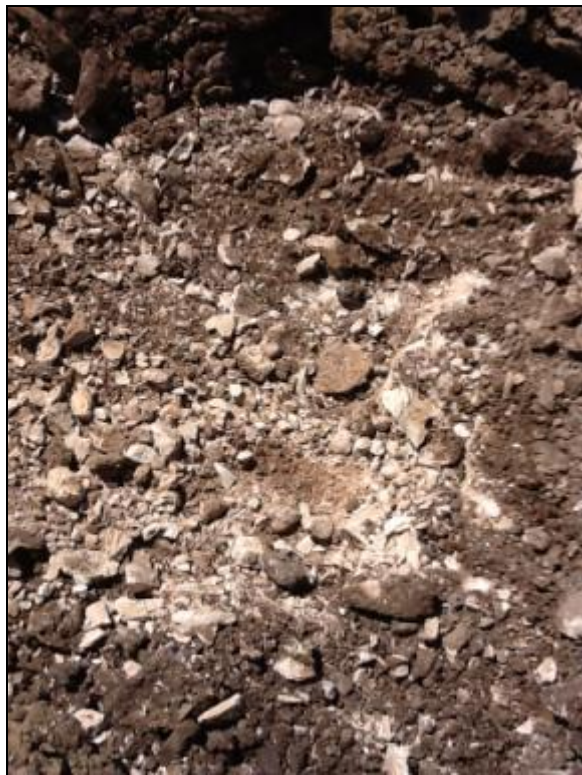
Test trench-2: 6-8 inches

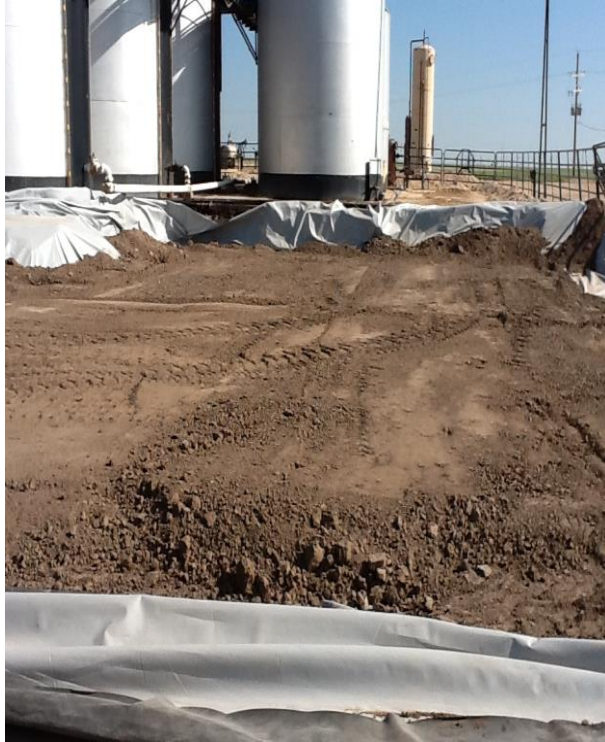
Lined excavation

Based on the above analytical results: SESI personnel returned to the site on July 18, 2012. A layer of fresh topsoil was placed in the excavation and lined. On July 20, 2012 SESI personnel revisited the site and supervised the backfilling of the lined area. The pad area was restored to grade, insuring the pad thickness to be 6"-7" in thickness.

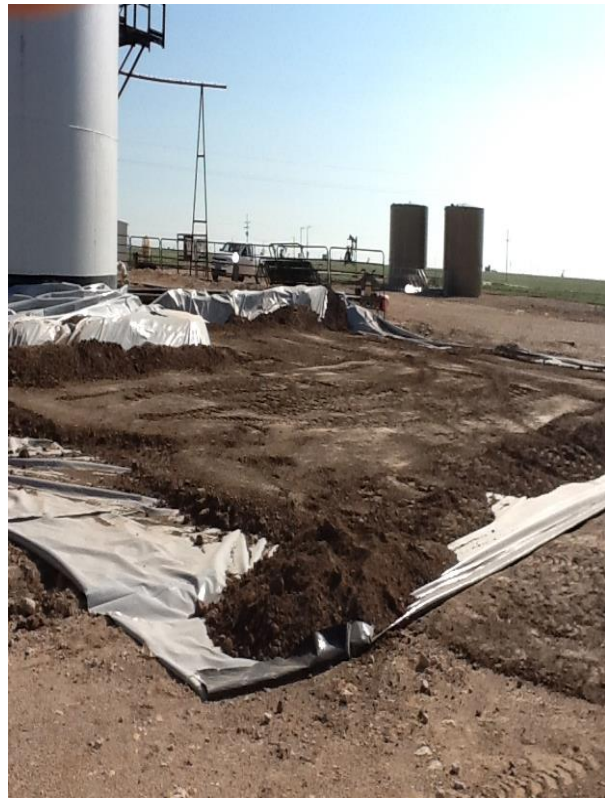
Liner Installation
