RE: Final Closure Report
Chevron – WDDU SE Trunkline
UL-B, Section 32, Township 24 South, Range 38 East
Lea County, New Mexico
NMOCD Reference # 1RP-3649

The following *Final Closure Report* serves as a condensed update on closure activities undertaken for the above referenced Site.

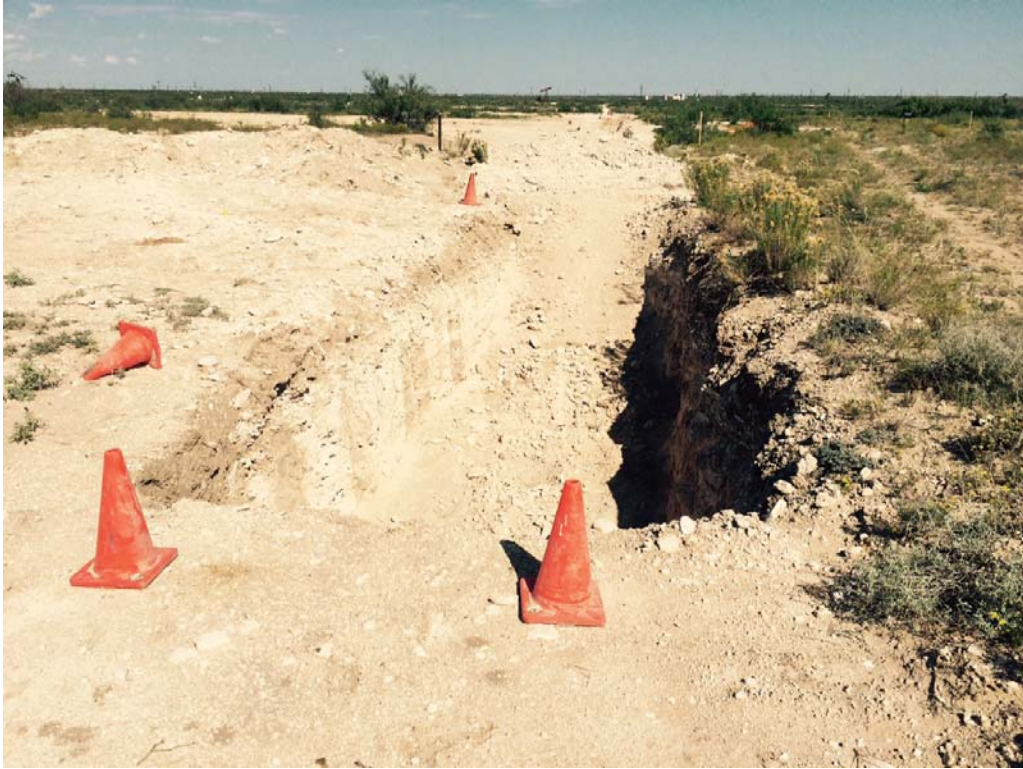
Photograph #1 – Looking east across excavation

Based on laboratory analytical results the excavation was deepened to approximately four (4) feet bgs in an attempt to remove Chloride impacted soil above NMOCD RRALs. To date approximately 680 cubic yards of contaminated soil have been excavated and hauled to a state approved facility for disposal.

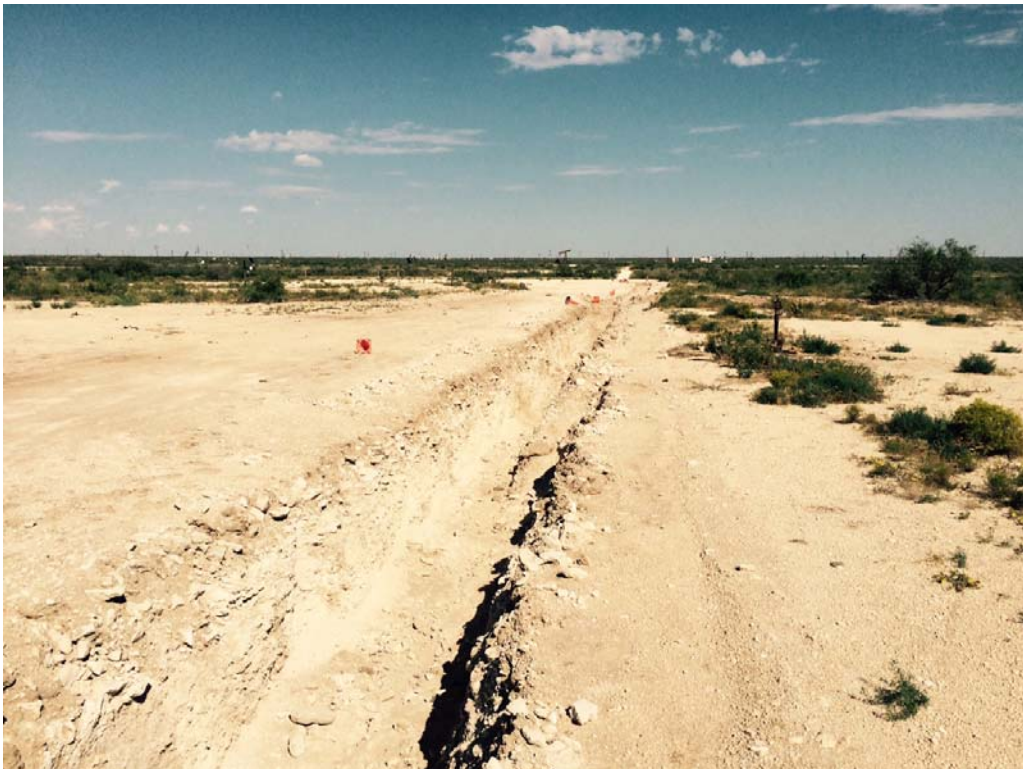
Photograph #2 – Looking east across excavation

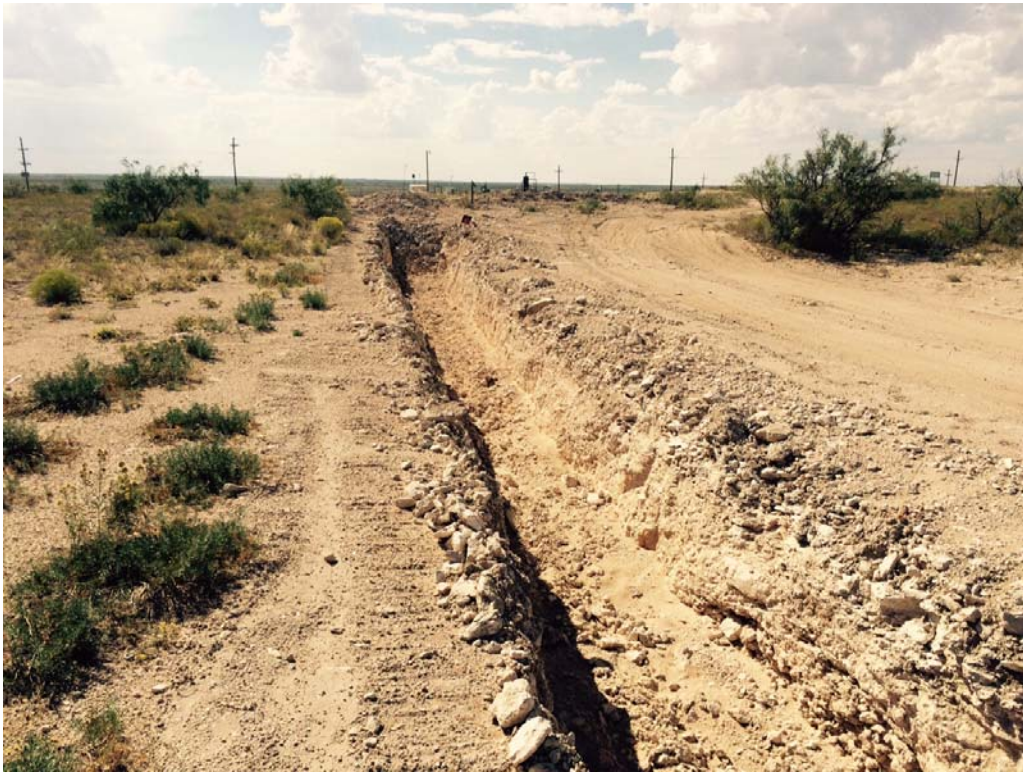
Photograph #3 – Looking east across excavation

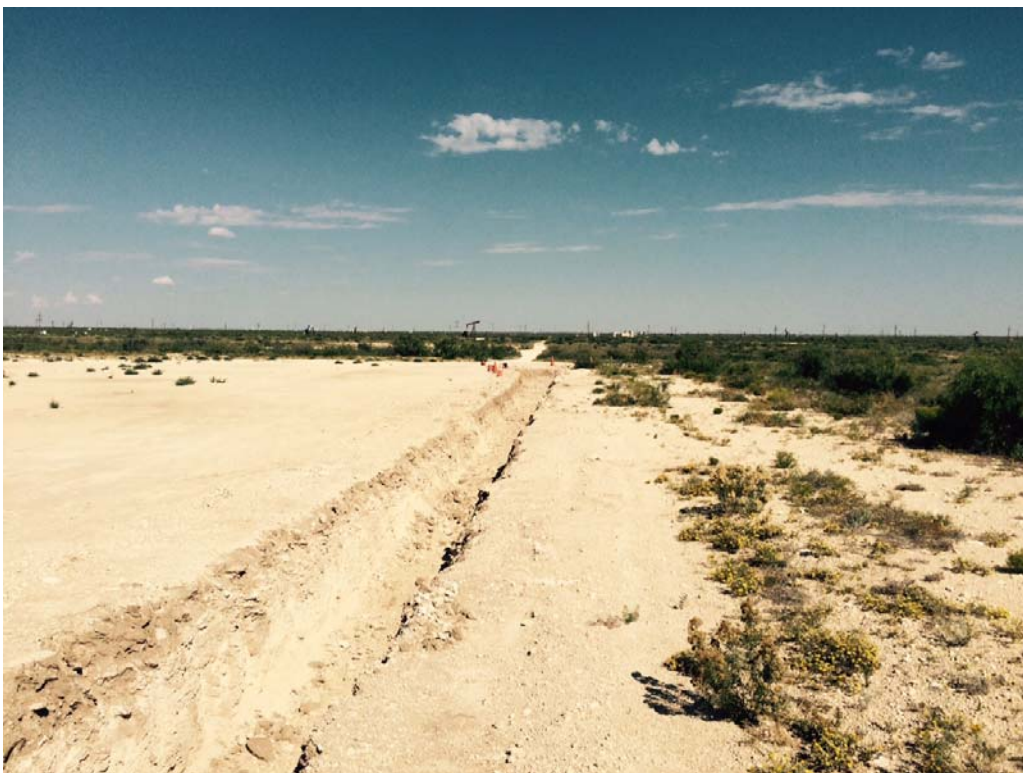
Photograph #4 – Looking east across excavation

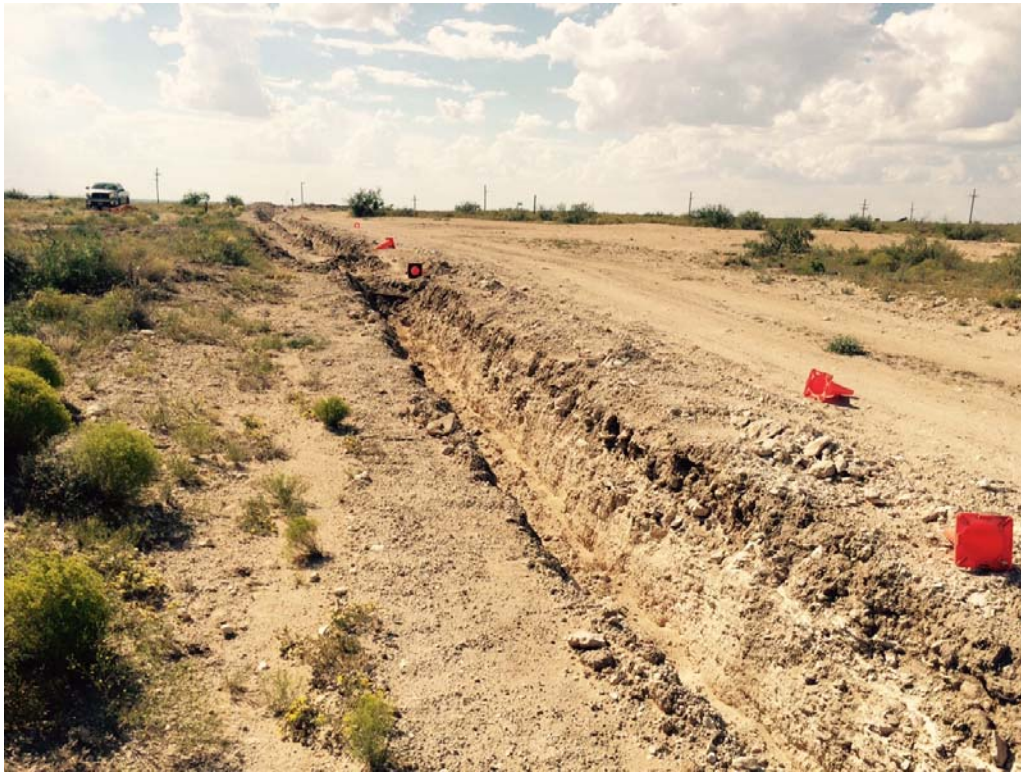
Photograph #5 – Looking west across excavation

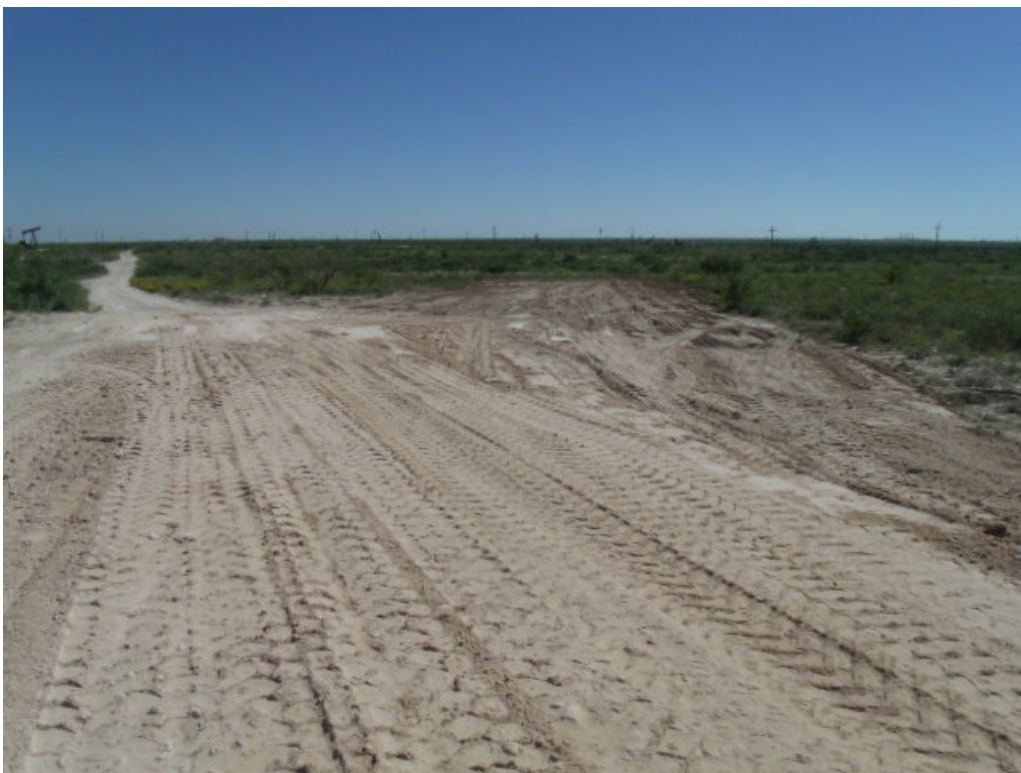
Photograph #6 – Backfilled

Based on laboratory analytical results indicating Chloride concentrations in the excavation were below NMOCD RRALs, the excavation has been backfilled with approximately 680 cubic yards of clean soil; soil was free of deleterious material or rocks or large clumps.

Backfilling continued until the entire excavation was closed. Upon completion of backfill activities, the entire disturbed area was contoured to blend with existing lease road and protected against wind/water erosion.

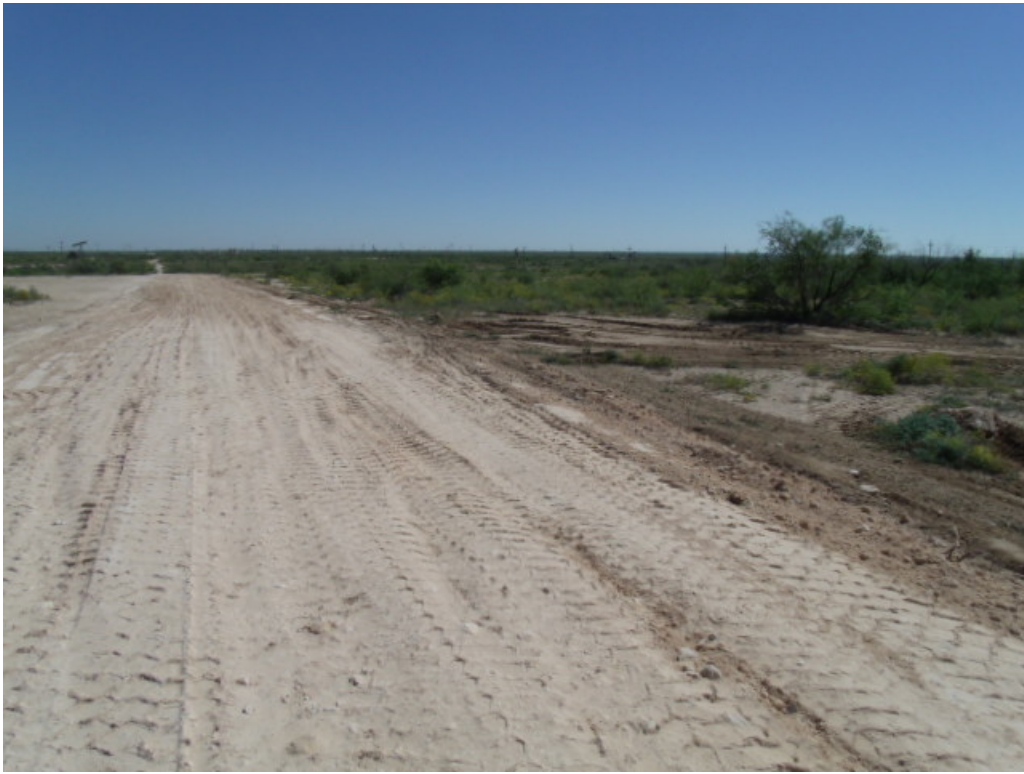
Photograph #7 – Backfilled

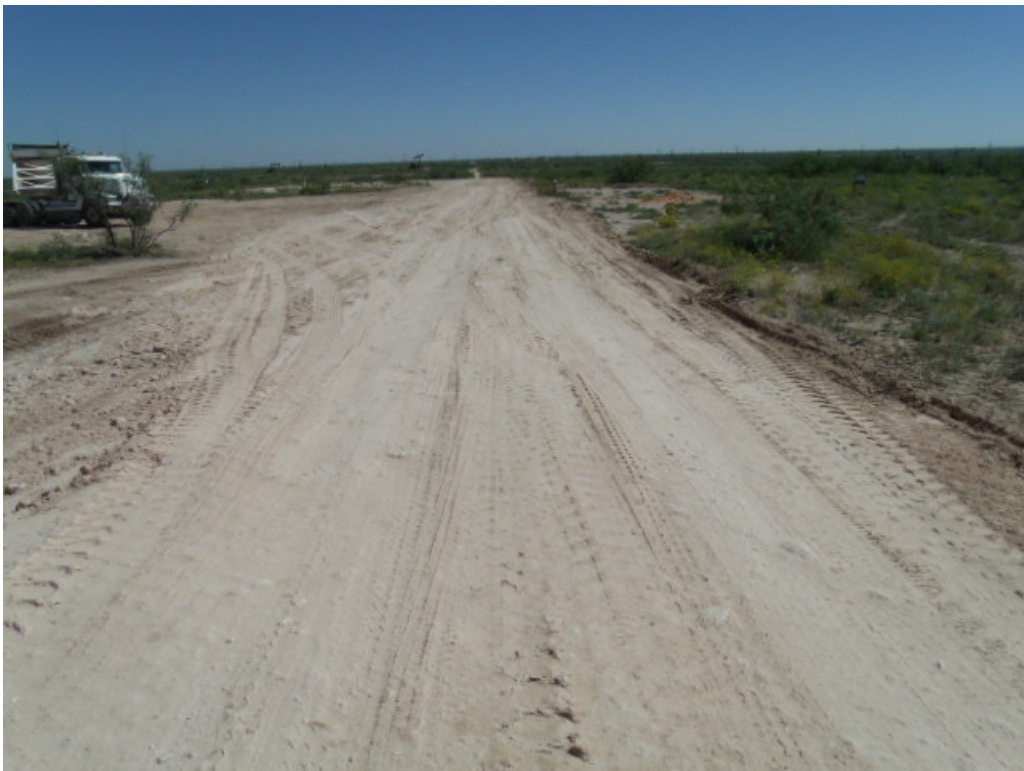
Photograph #8 – Backfilled

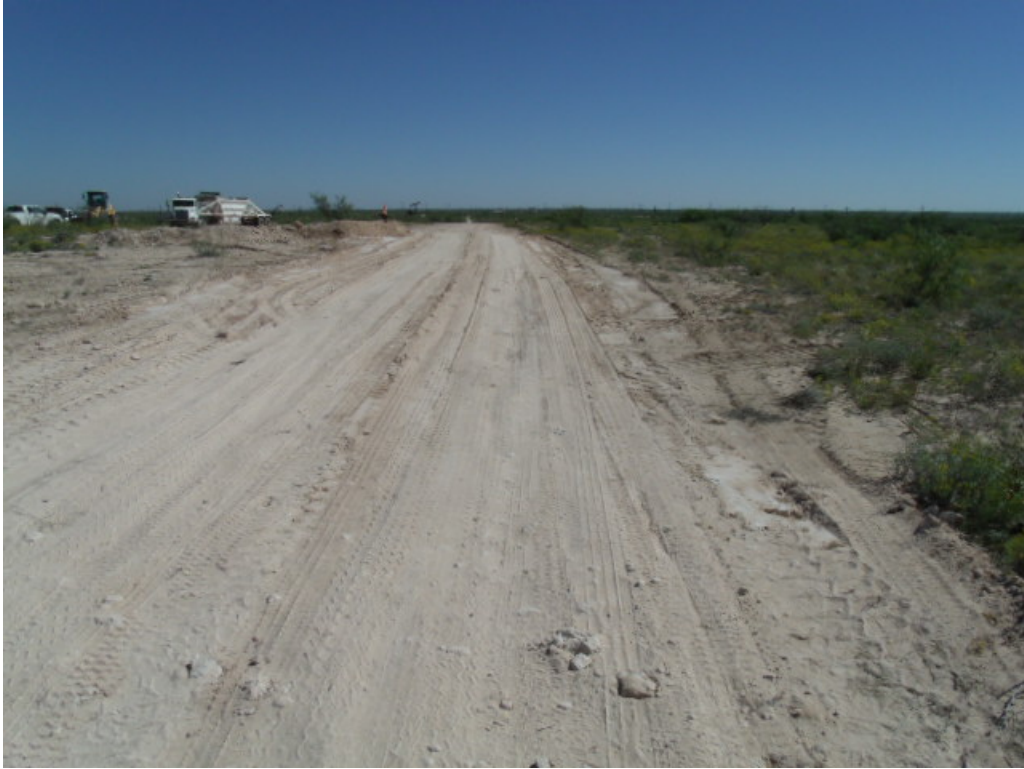
Photograph #9 – Backfilled

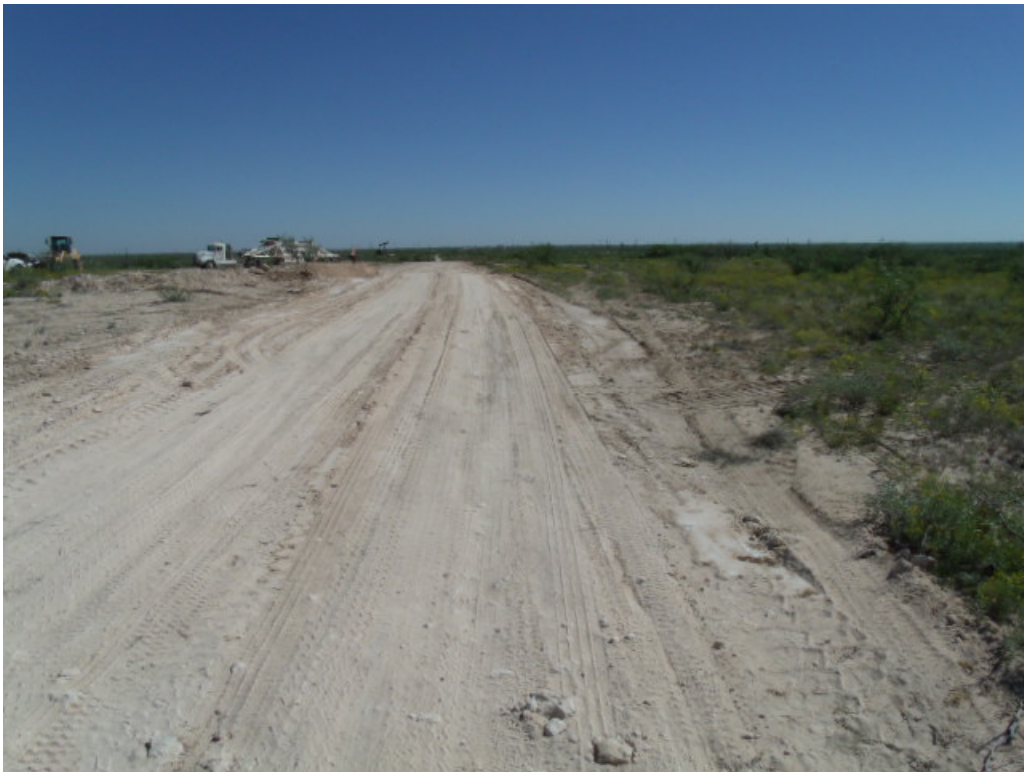
Photograph #10 – Backfilled
