Warren Unit #17 (1RP-3134)

Termination Request

**RE: Termination Request
ConocoPhillips Warren Unit #17 (1RP-3134)
UL/I sec. 33 T20S R38E
API No. 30-025-07878**

**CONOCOPHILLIPS
WARREN UNIT #17**

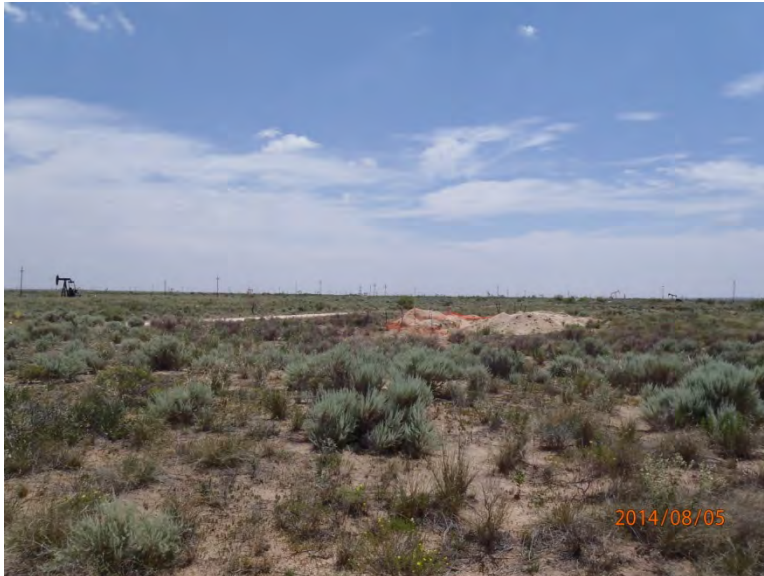
Initial release area, facing southeast

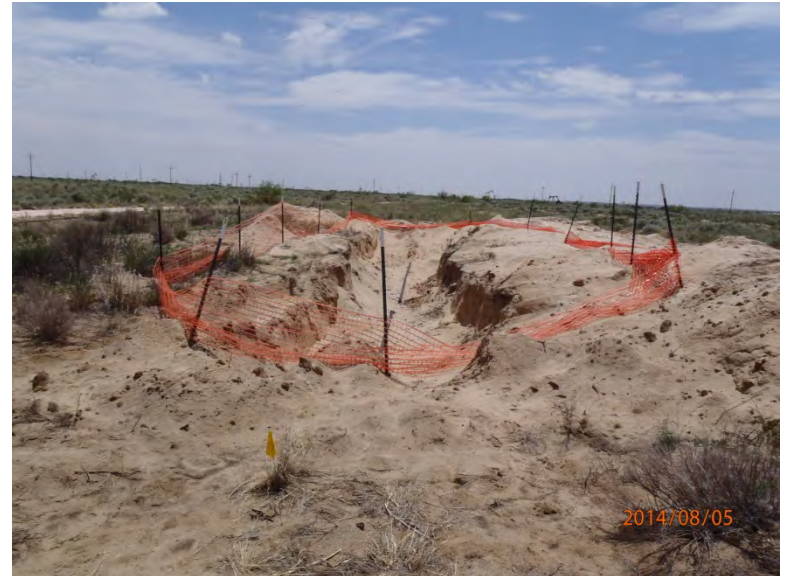
Initial release area, facing south

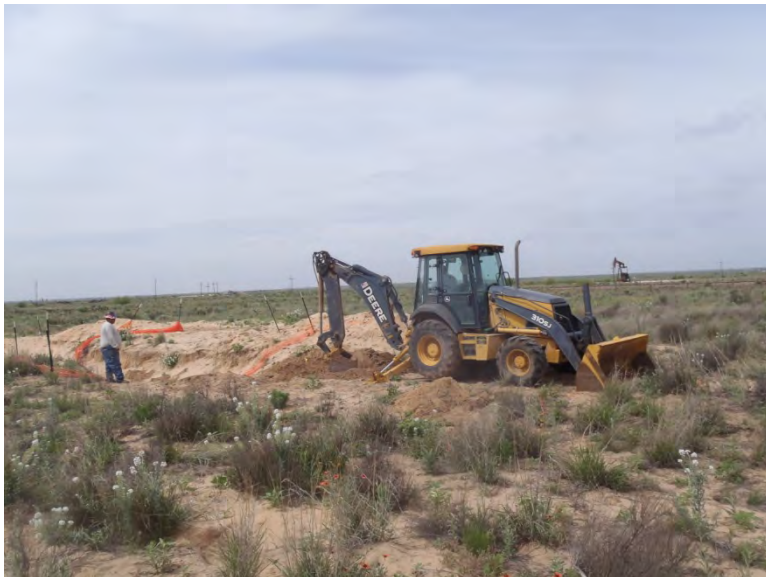
Excavating release, facing southwest

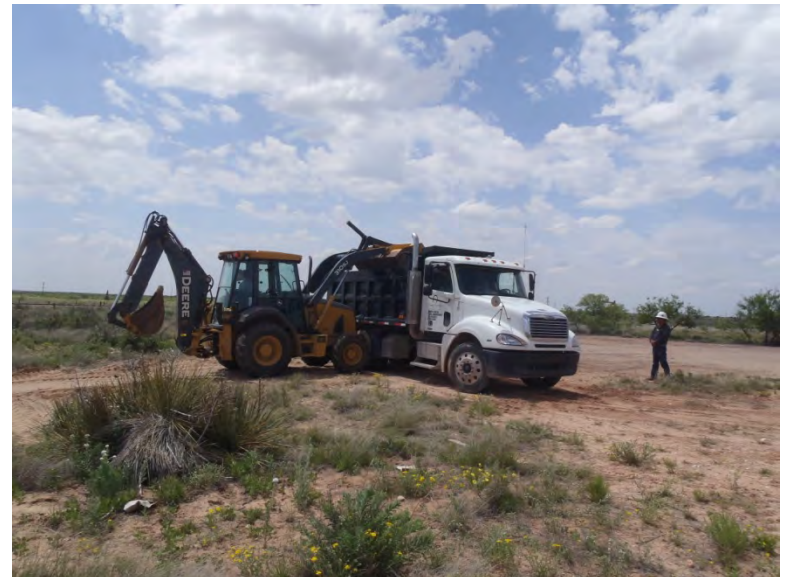
Exporting soil, facing south

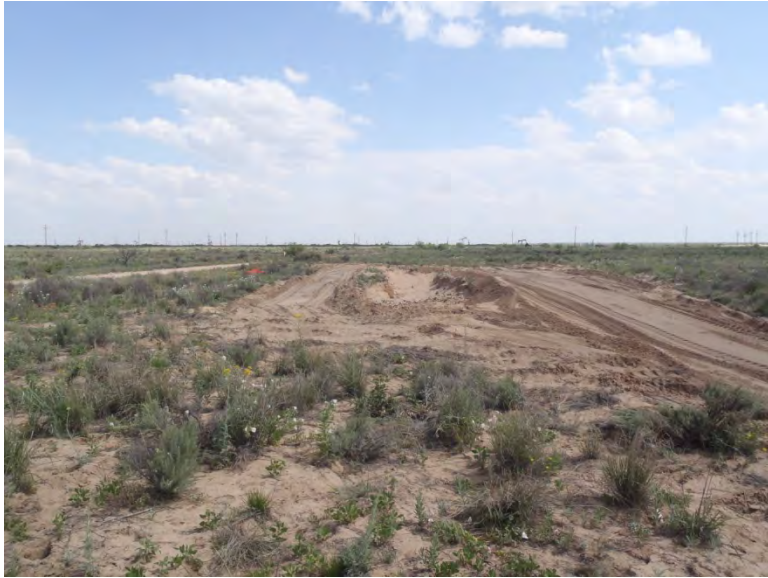
Completed excavation, facing south

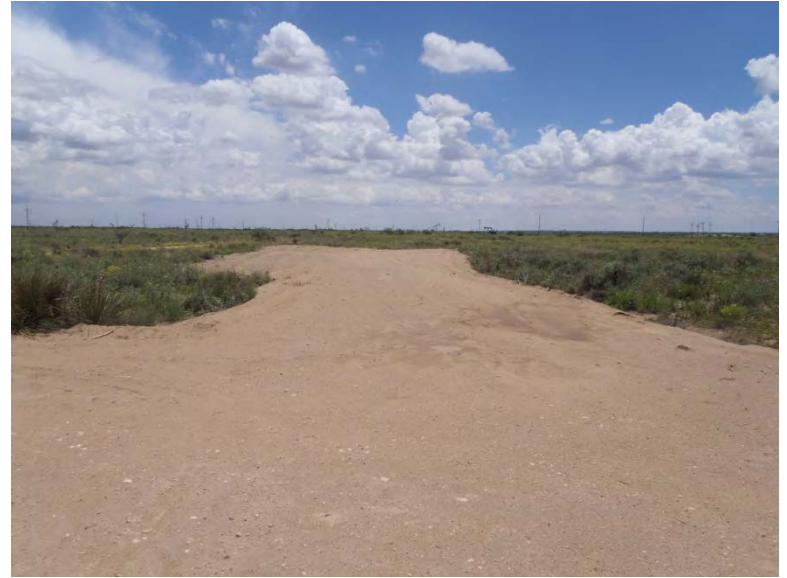
Backfilled excavation, facing south

Photo documentation of the backfilled site can be found in Appendix C.

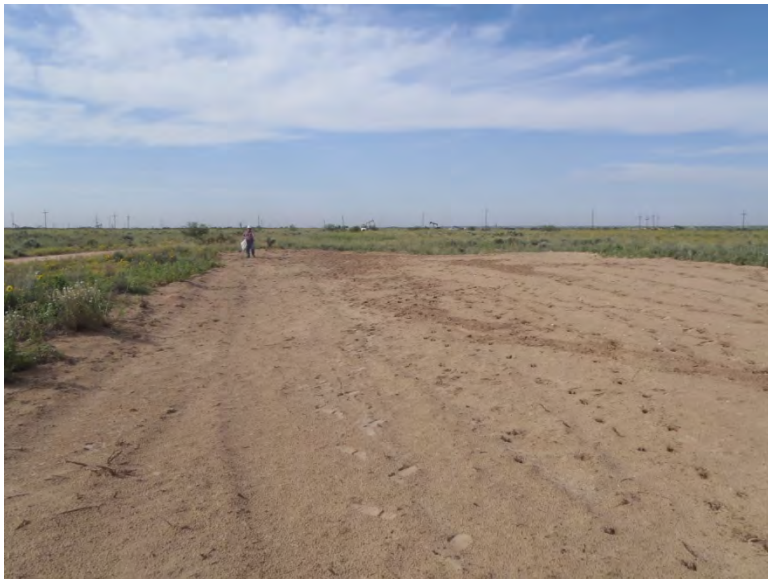
Hand seeding location, facing south

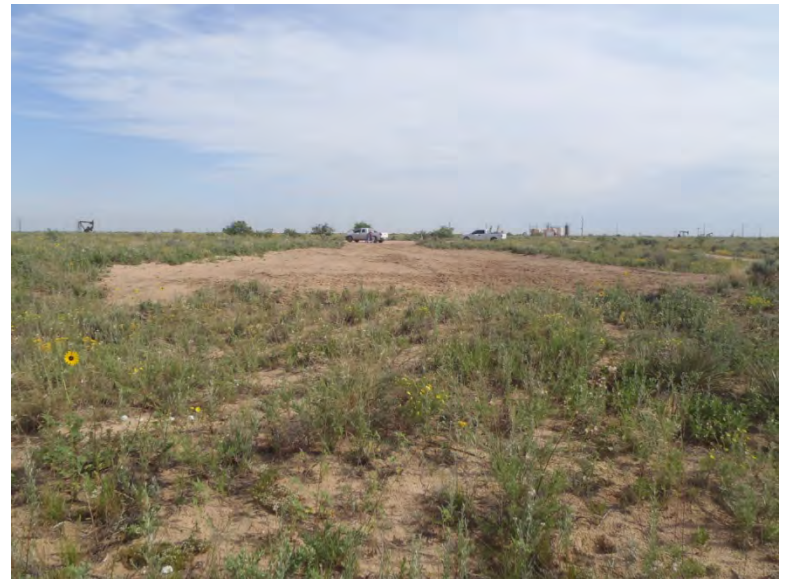
Completed site, facing north
