# **Silver Spike Energy Operating of NM Knowles SWD #002 Closure Report**

**Section 34, T16S, R38E  
Lea County, New Mexico**

**1RP-4000  
January 05, 2016**

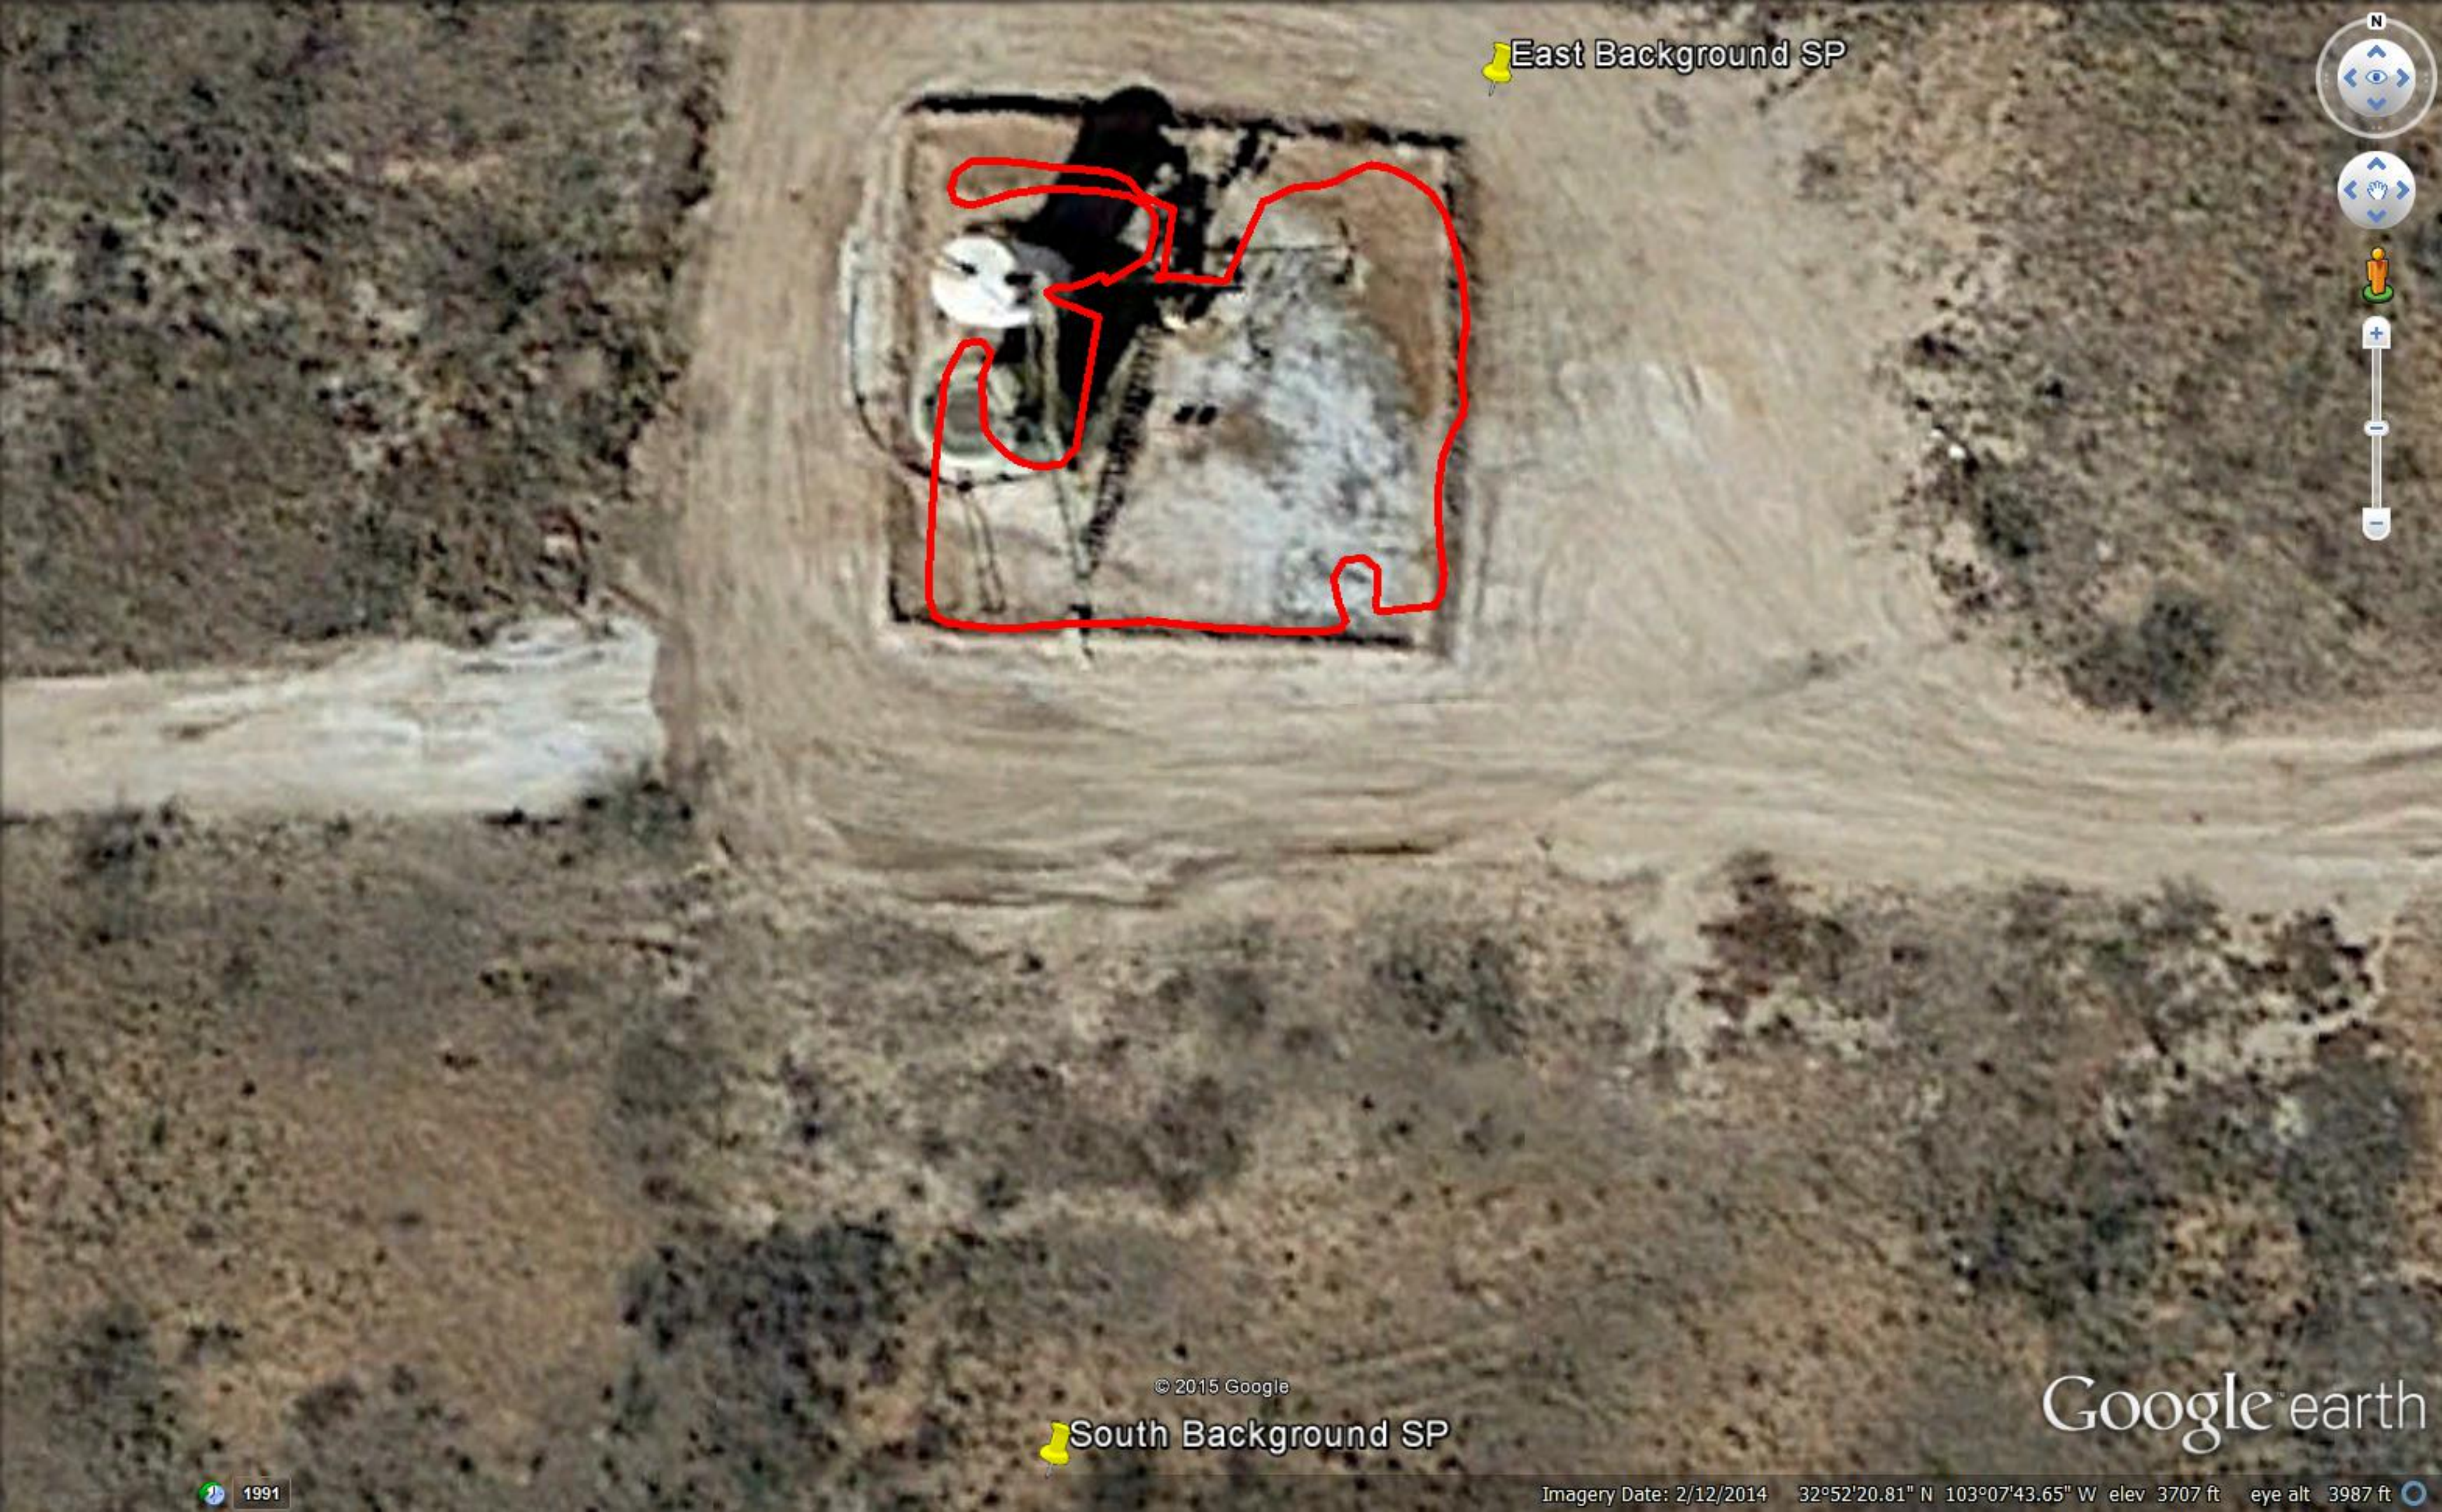
## **Figure 2 Site Plan**

East Background SP

South Background SP

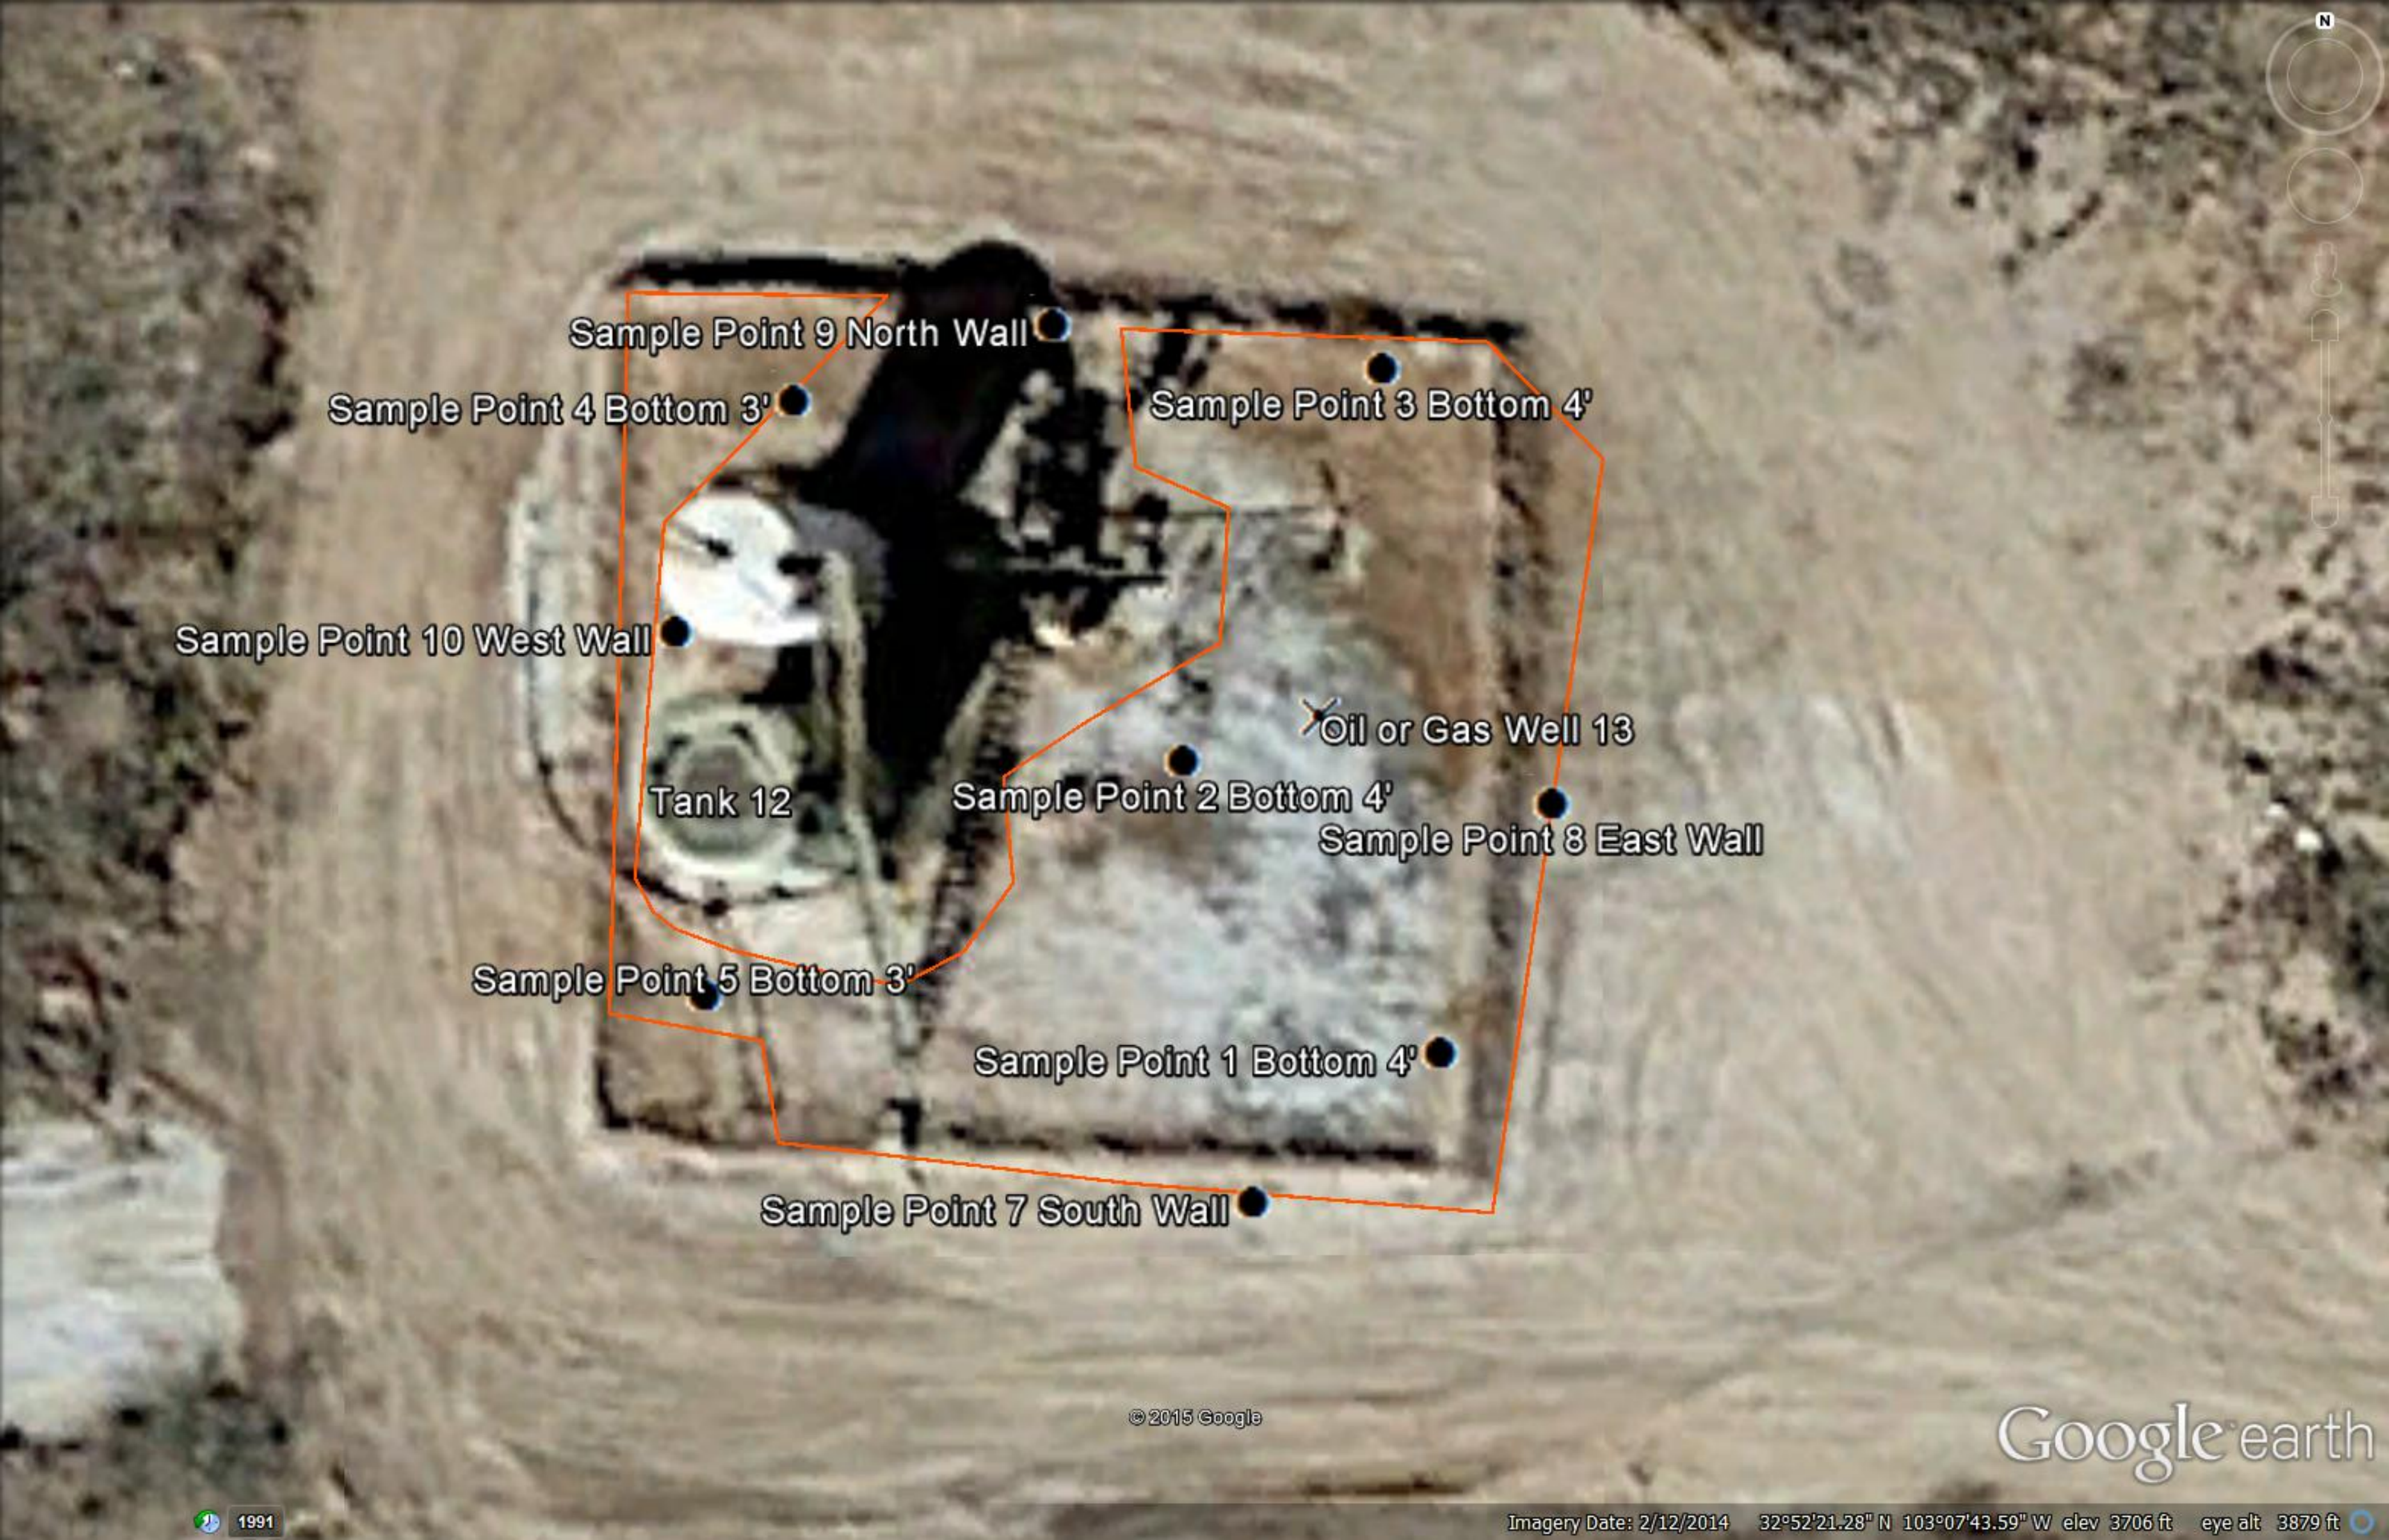
Sample Point 9 North Wall

Sample Point 4 Bottom 3'

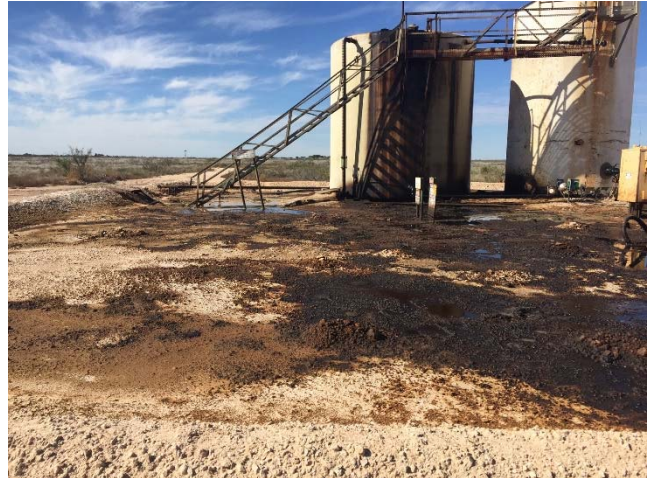
Impacted area facing west

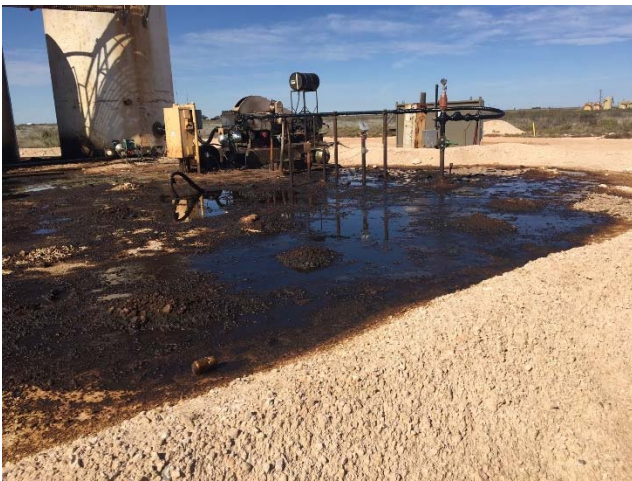
Impacted area facing northwest

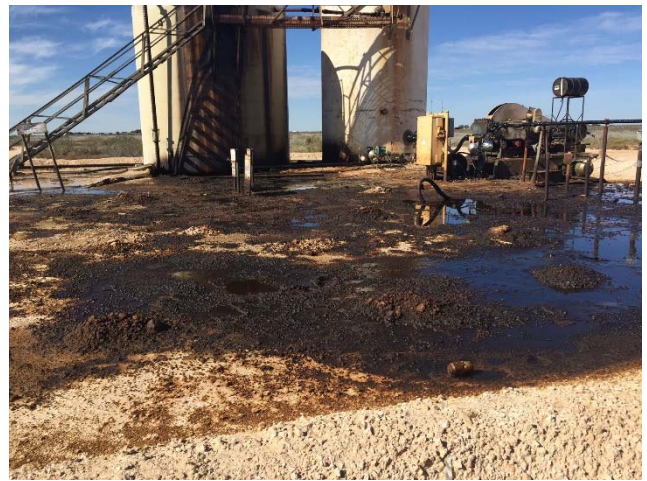
Impacted area facing northwest

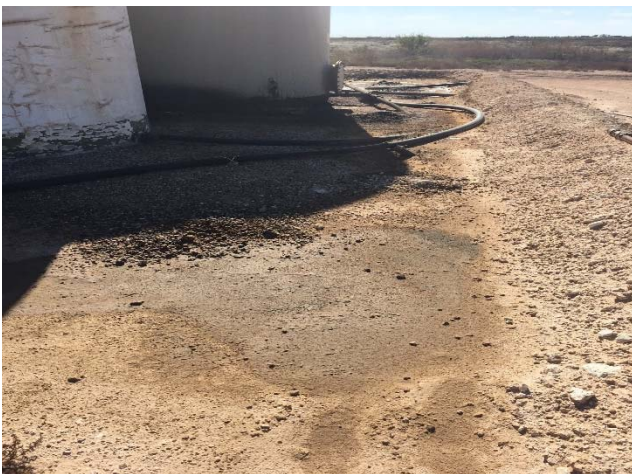
Impacted area west side of tanks

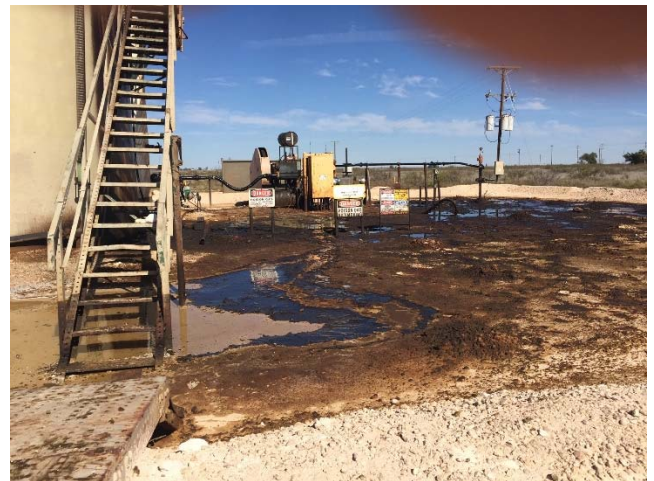
Impacted area facing north

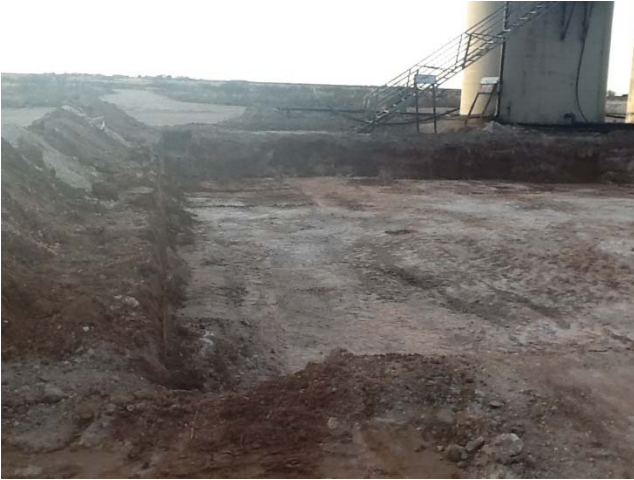
Excavated area facing west

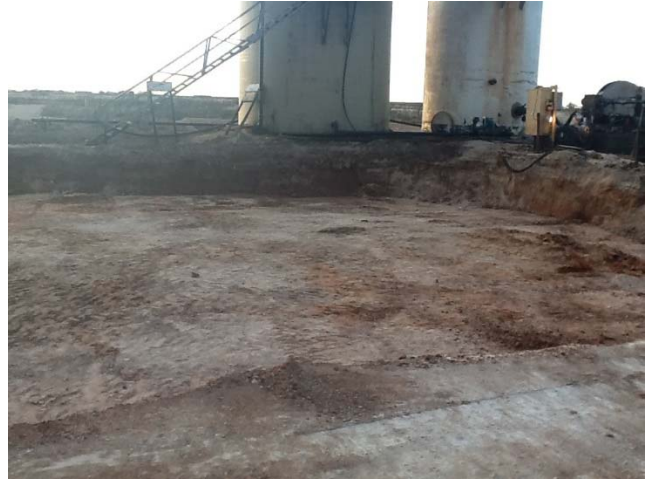
Excavated area facing northwest

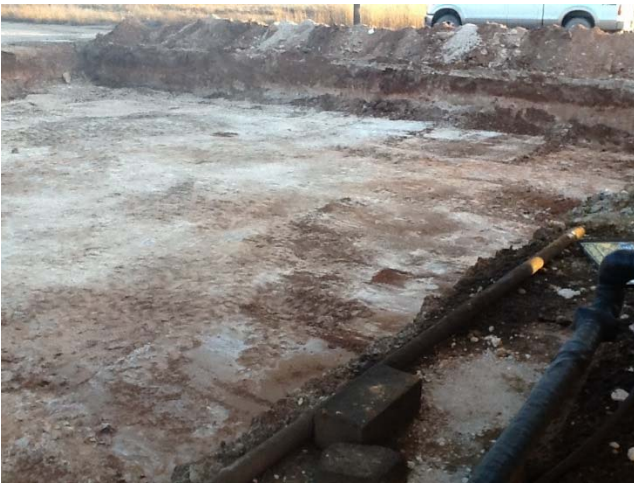
Excavated area South of battery

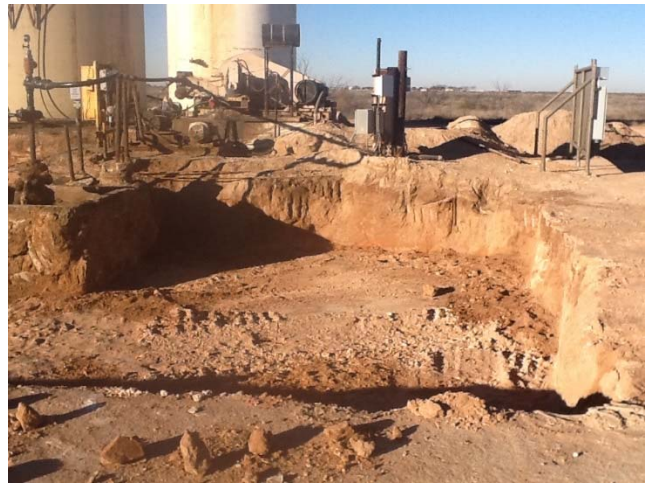
Excavated area northwest

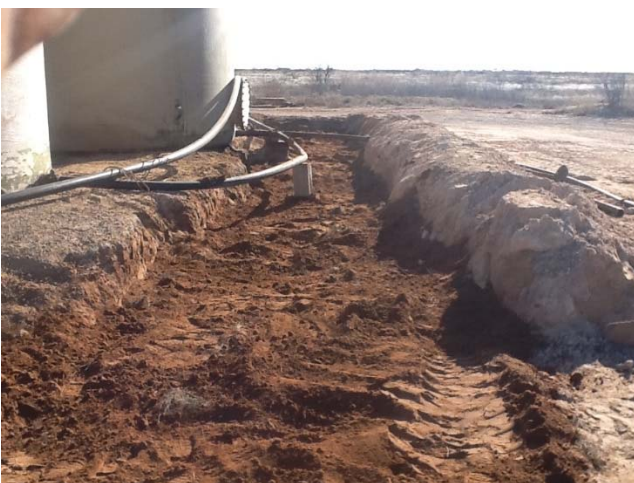
Excavated area west side of tanks

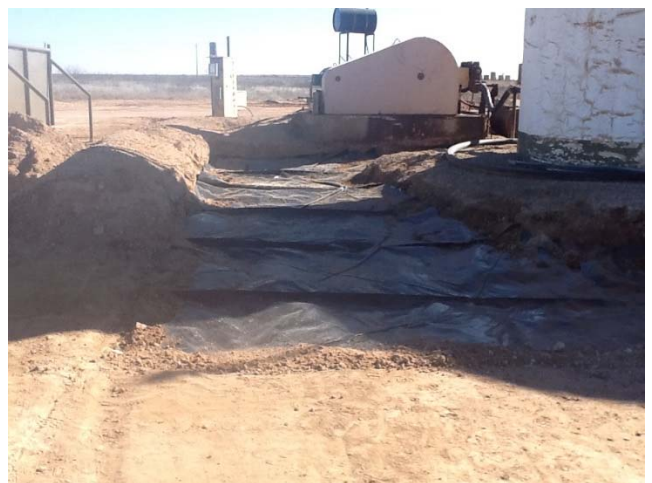
Excavated and lined west side of tanks

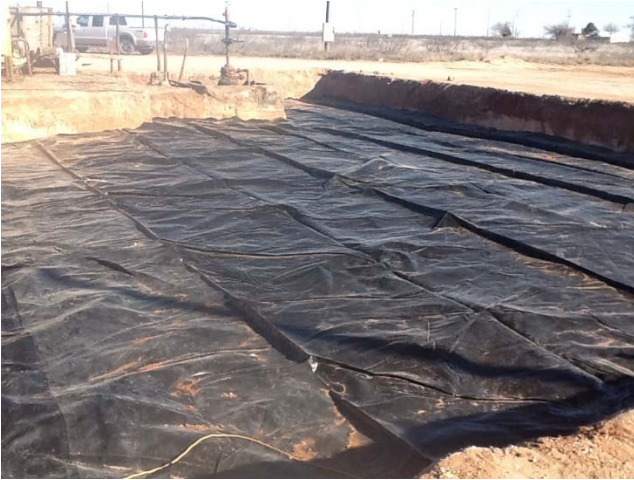
Lined Excavation facing north

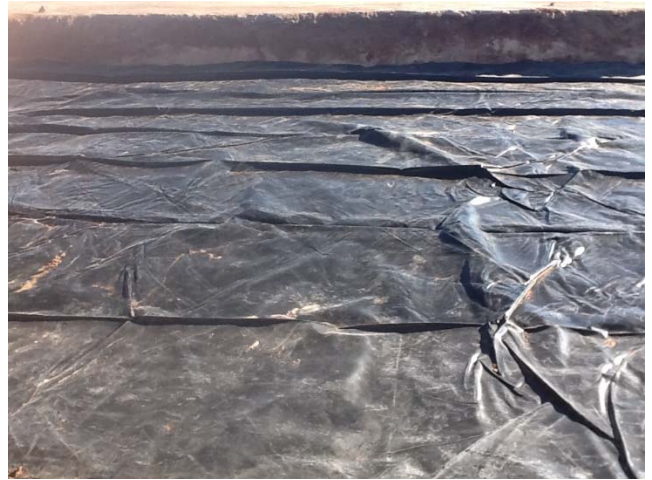
Lined area facing south

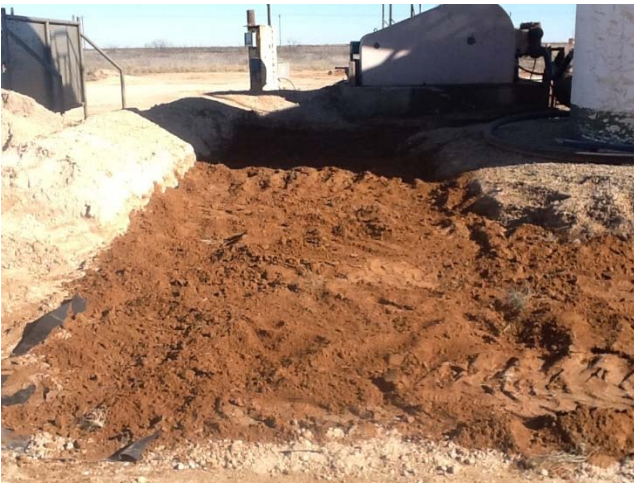
Lined west side of tanks with layered top soil

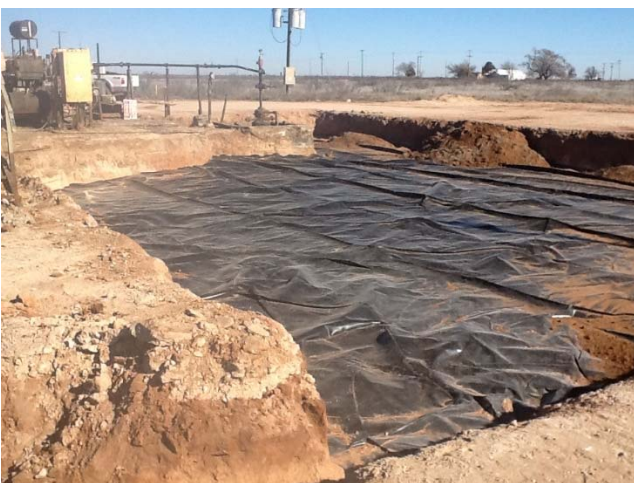
Lined north side layered topsoil

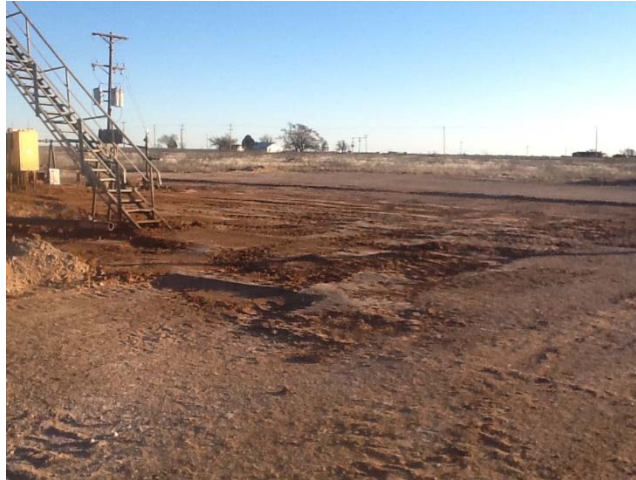
Completion looking northeast

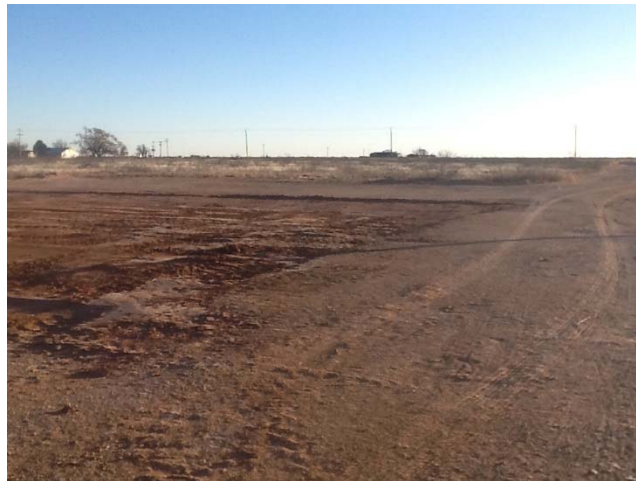
Completion looking east

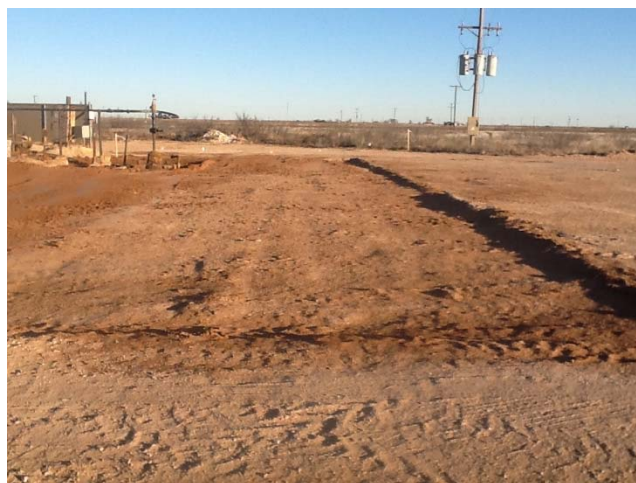
Completion looking north
