**Holly Energy Partners  
Maljamar Park Lact 584  
Section 8, Township 17S, Range 32E  
Lea County, New Mexico**

**Delineation-Closure Report**

**RP-3998  
January 8, 2016**

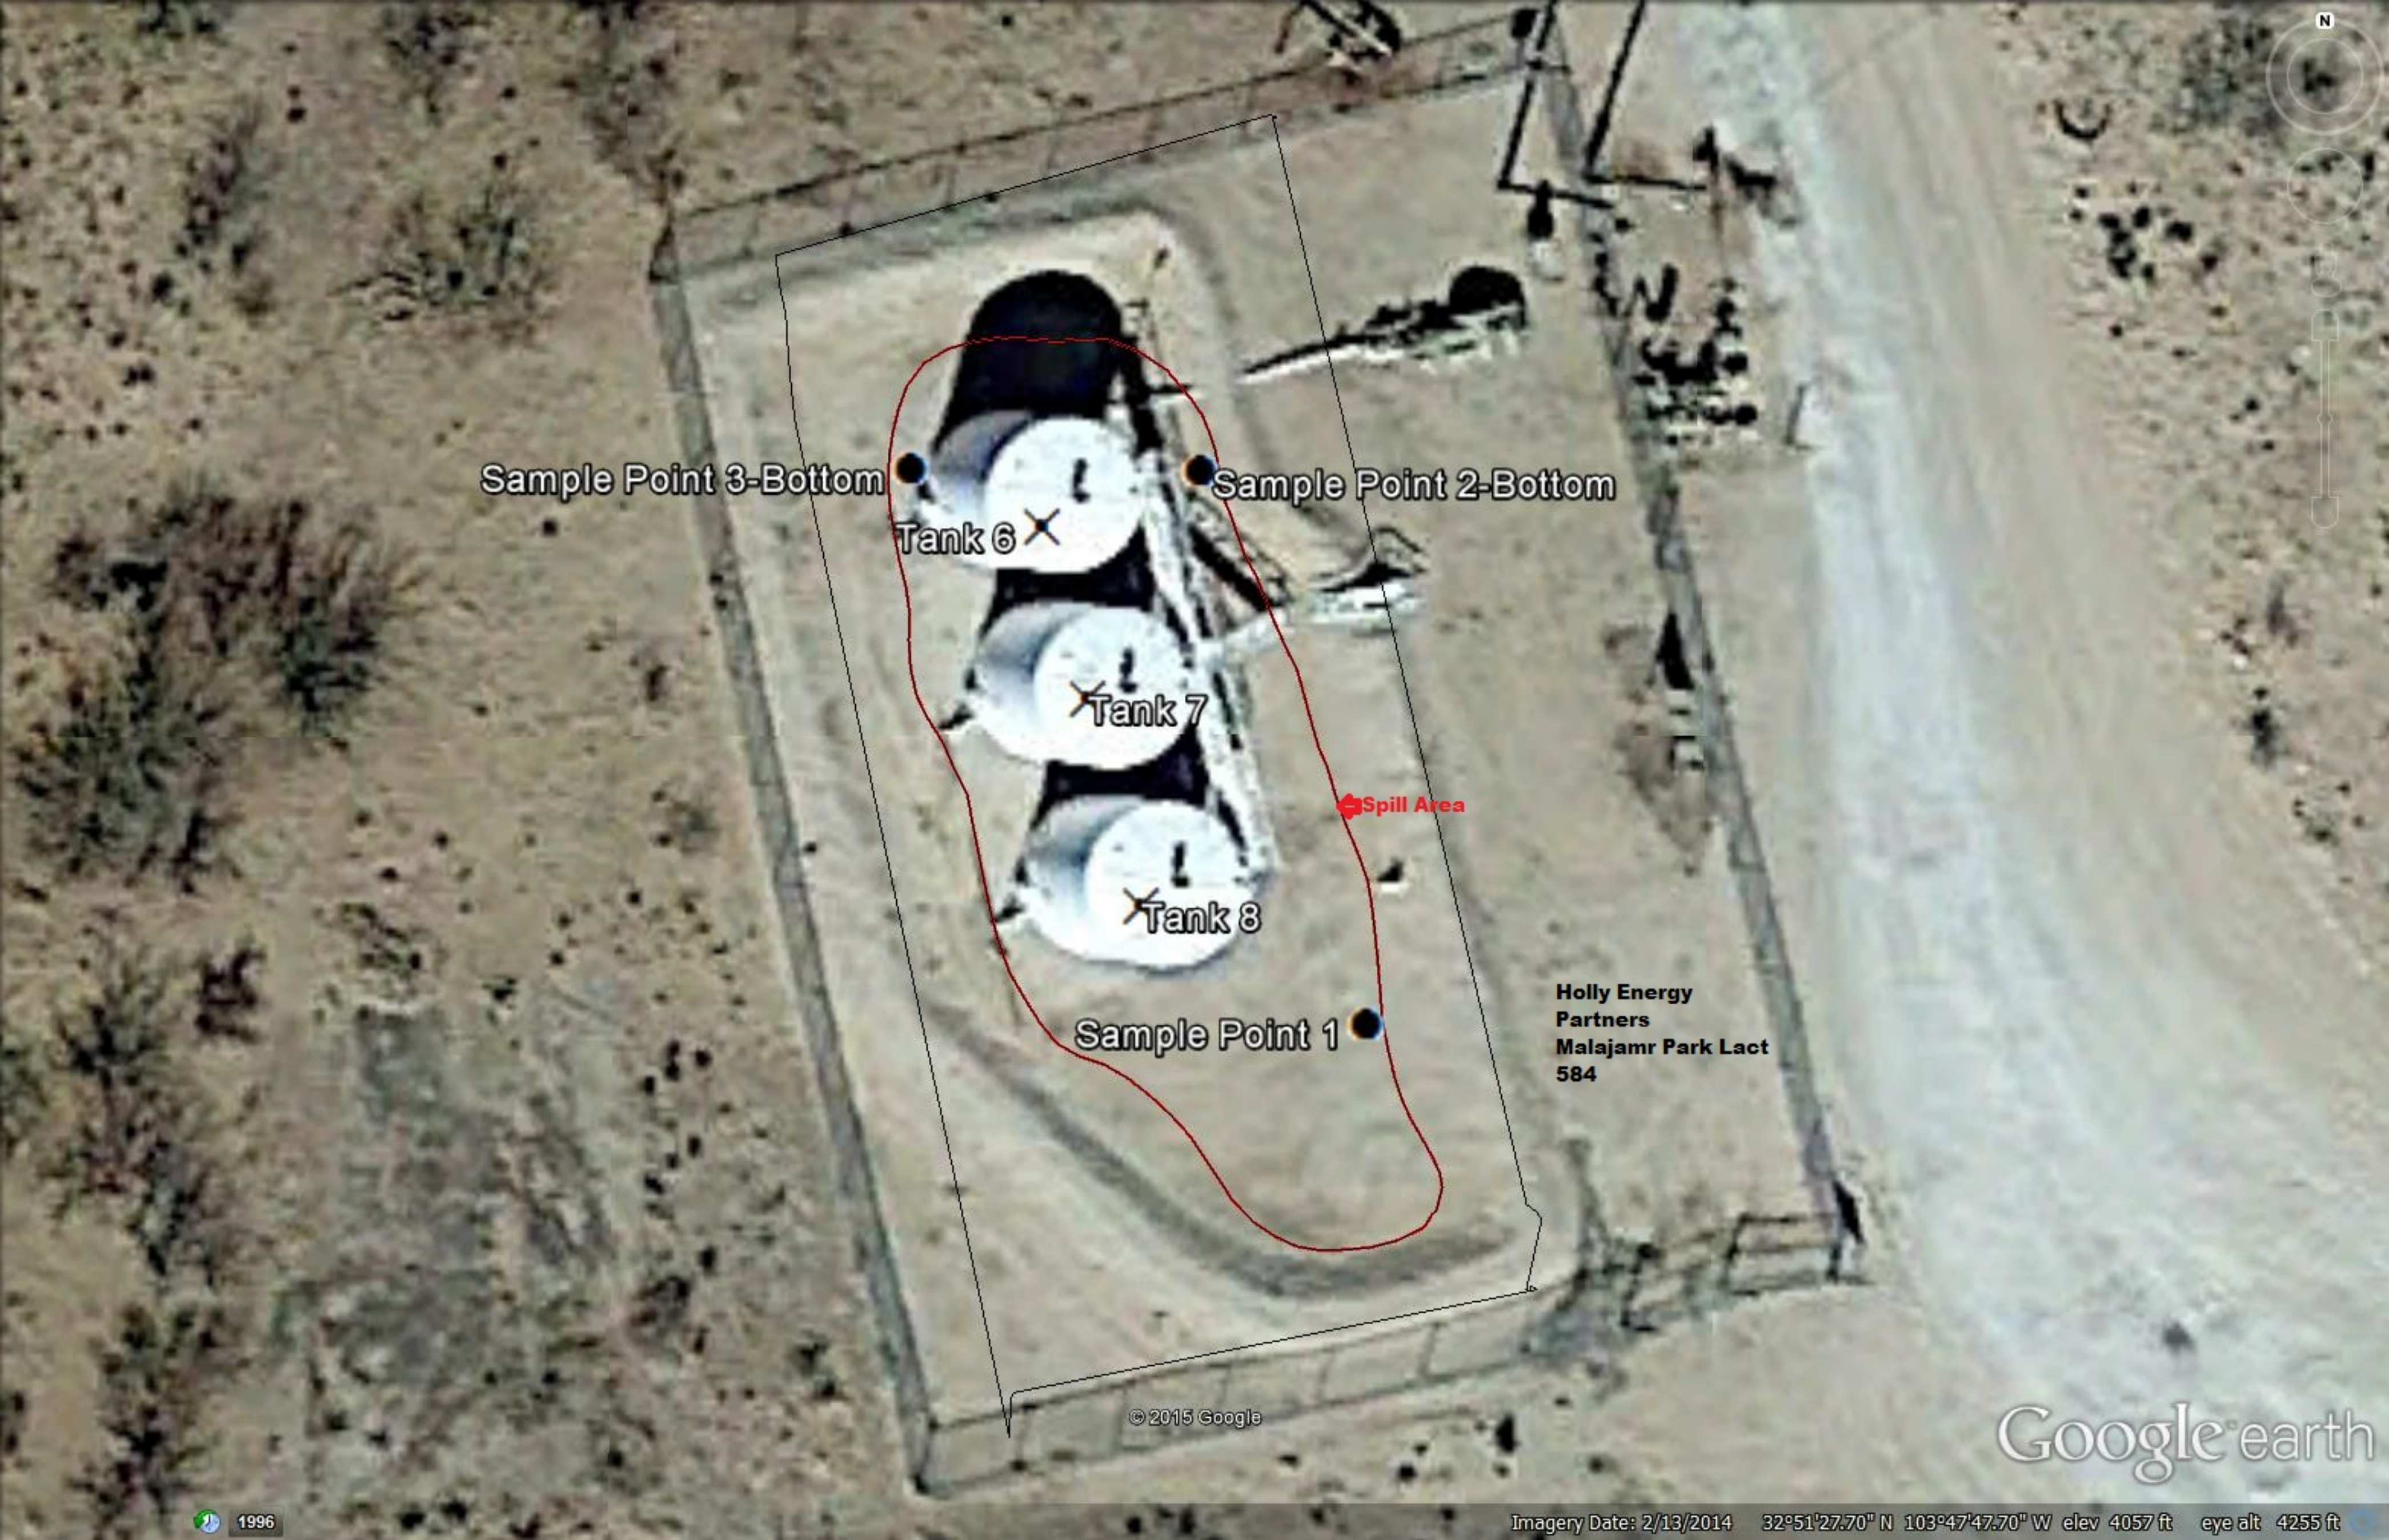
## **Figure 2**

### **Site Plan**

Sample Point 3-Bottom

Sample Point 2-Bottom

Spill Area

Sample Point 1

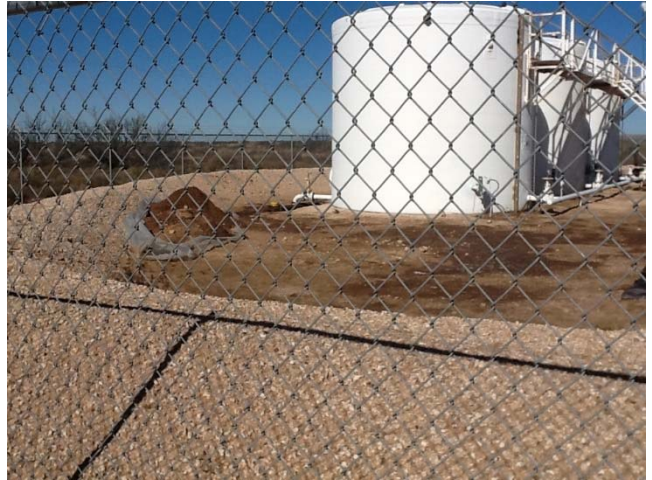
Southwest corner

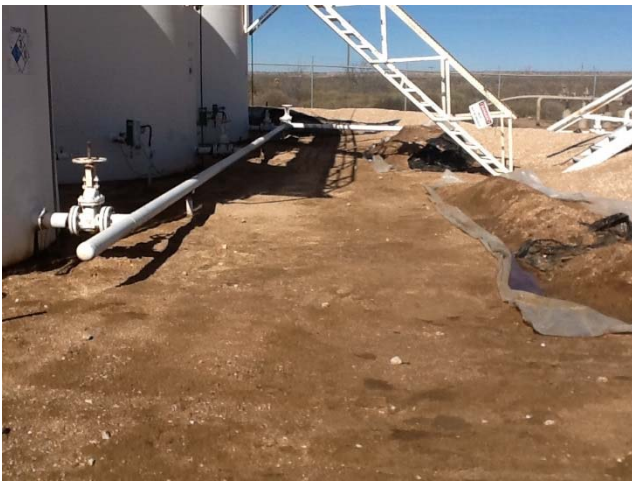
Looking North

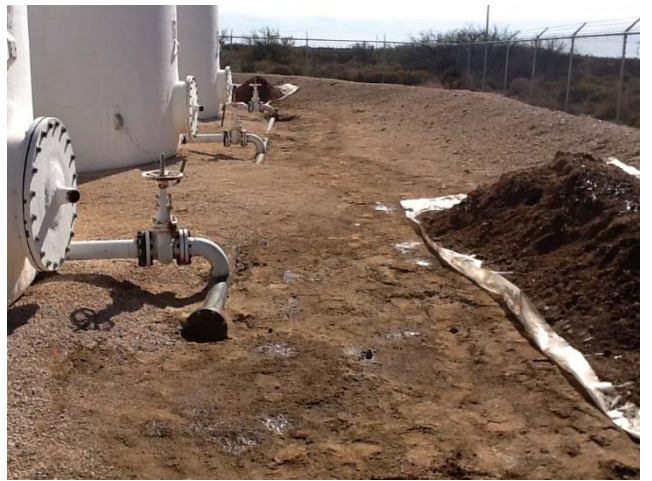
Stockpile at leak source for disposal

On January 07, 2016 a total of Twenty Four (24) yards of impacted soils are disposed of and the site is restored to grade with like materials to that removed according to NMOCD guidelines. SESI on behalf of Holly Energy Partners respectfully requests closure of the regulatory file for the environmental incident related to this site.

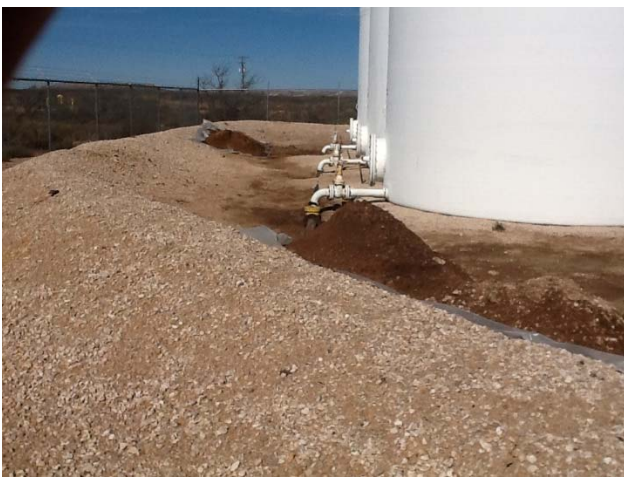
West side of tanks

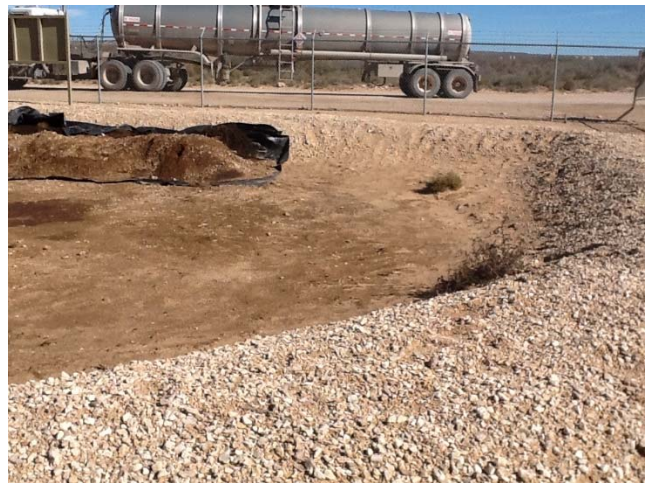
Southeast corner of stockpile

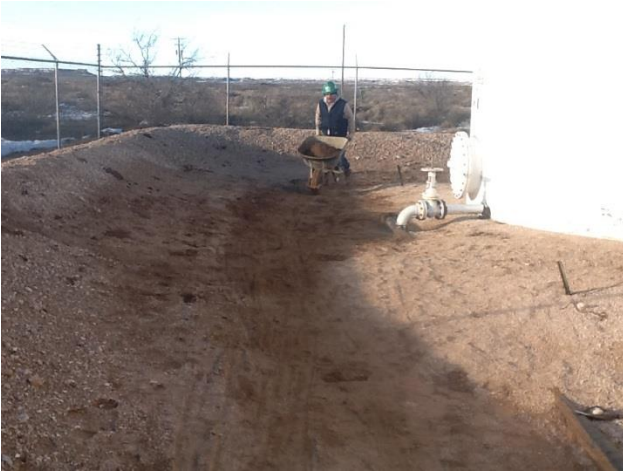
Hand removal West side of tanks

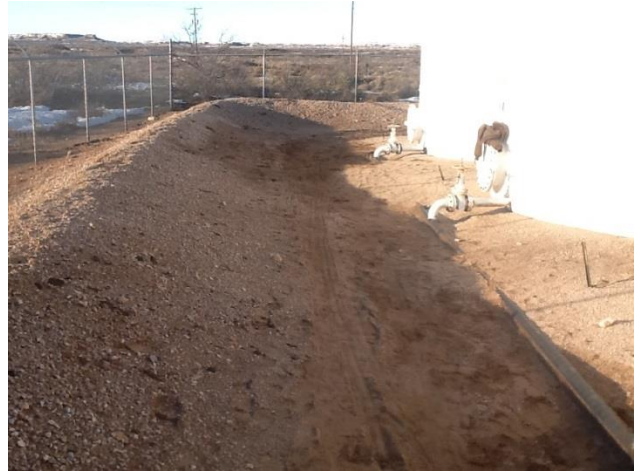
West side after removal of impact

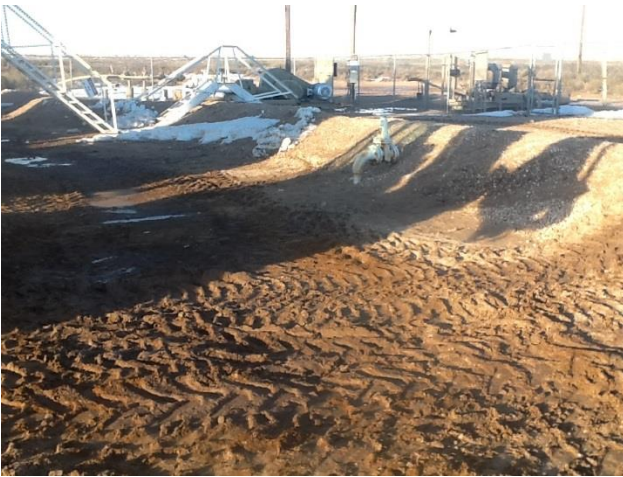
Looking North at completion

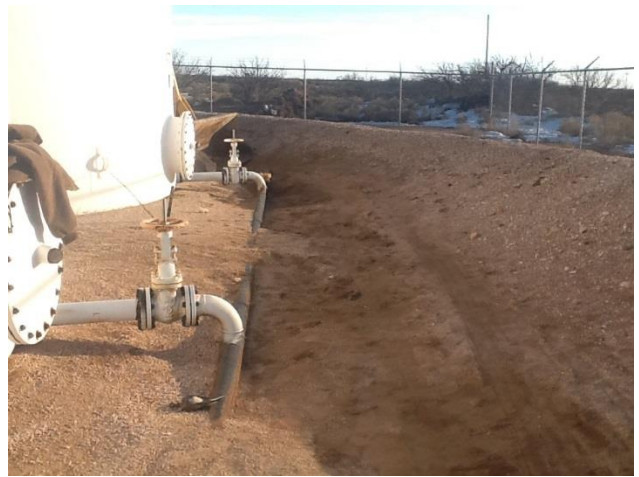
Leak source area at completion

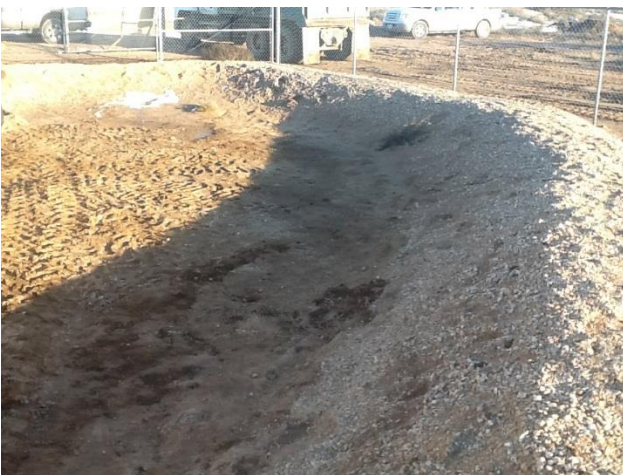
Southeast corner at completion

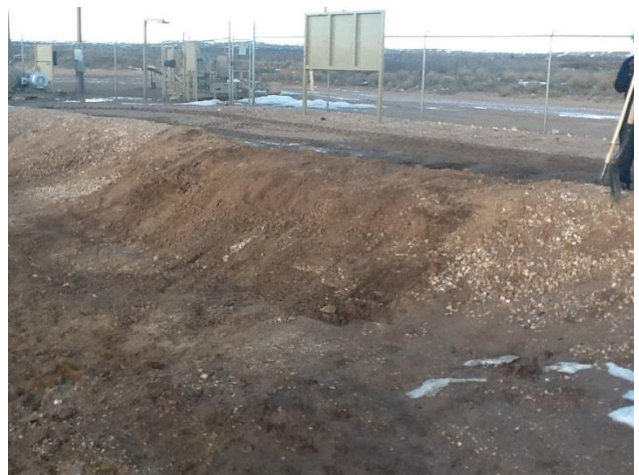
Restored berm at completion
