#### 1RP-4049

Investigation Summary and Remediation Plan XTO Energy, Inc., Perla Negra Fed Com #4H January 25, 2016

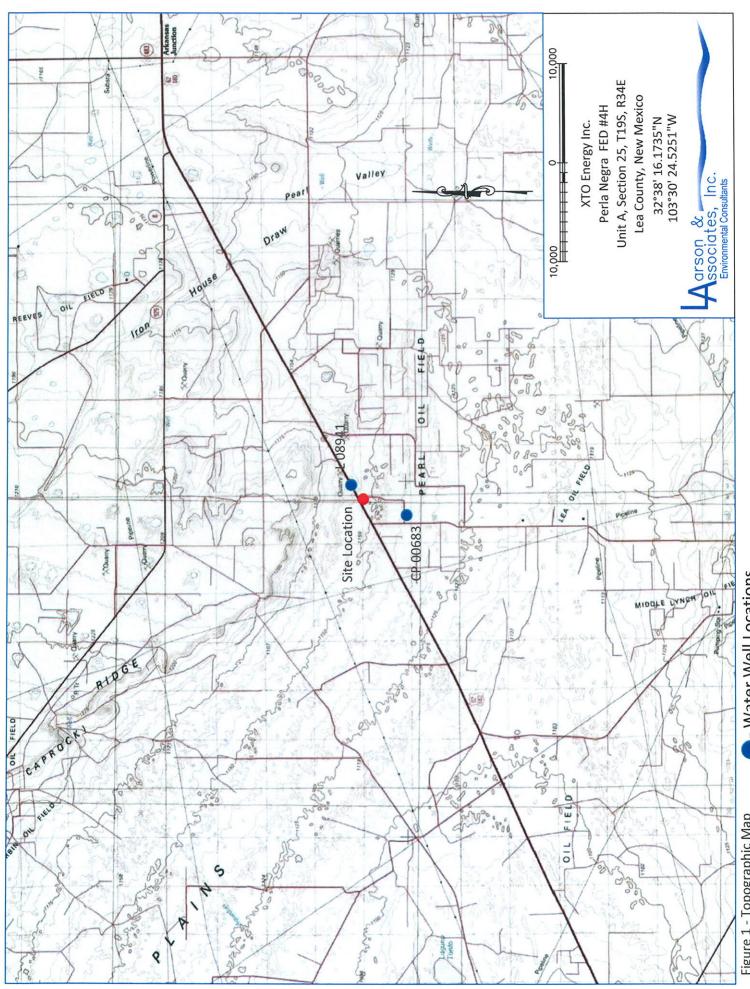
Figure 1 - Topographic Map

- Two (2) fresh water wells are located within 1-mile according to New Mexico State Engineer (NMOSE) records. The nearest well (CP 8941) is located about 2,000 feet northeast in Unit M (SW/4, SW/4), Section 19, Township 19 South and Range 35 East. Depth to groundwater is reported at 285 feet below ground surface (bgs). The furthest well (CP00583) is located about 5,100 feet southwest in Unit O (SW/4, SE/4), Section 25, Township 19 South, Range 34 East with depth to groundwater about 28 feet bgs. Figure 1 presents the approximate locations for the water wells.

- Water Well Locations

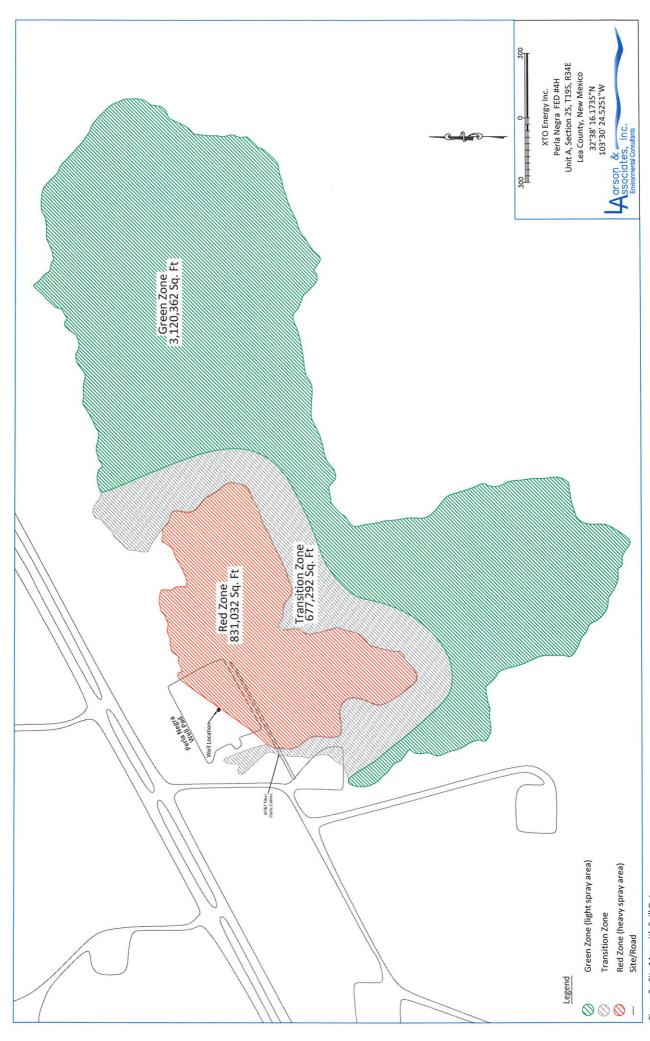
Figure 3 - Site Map with Spill Data

On December 3, 2015, LAI personnel mapped and recorded the boundary of the release using a Trimble® global position system (GPS) hand held receiver. Wind dispersed fluid east about 2,850 feet and about 2,100 feet south of the location. An area of heavy hydrocarbons identified as the "Red Zone" extends to about 750 feet east and 850 feet south of the location. The Red Zone encompasses about 835,916 square feet or approximately 19.2 acres. Beyond the "Red Zone" for a distance of about 250 feet is an area of lighter hydrocarbons identified as the "transition zone". The Transition Zone encompasses about 677,292 square feet or about 15.55 acres. Beyond the transition zone is the area of lightest hydrocarbons or mist which is identified as the "Green Zone". The Green Zone extends about 1,000 feet south and 1,700 feet east of the transition zone. The Green Zone encompasses about 3,120,362 square feet or about 71.63 acres. The total affected area, excluding the location, is about 4,630,863 square feet or about 106.3 acres. The affected portion of the location is about 64,728 square feet or about 1.48 acres. Figure 3 presents a map showing the approximate boundaries for the Red, Transition and Green Zones. Figure 4 presents a Site drawing with the hydrocarbon stained and scraped areas. Attachment B presents photographs.

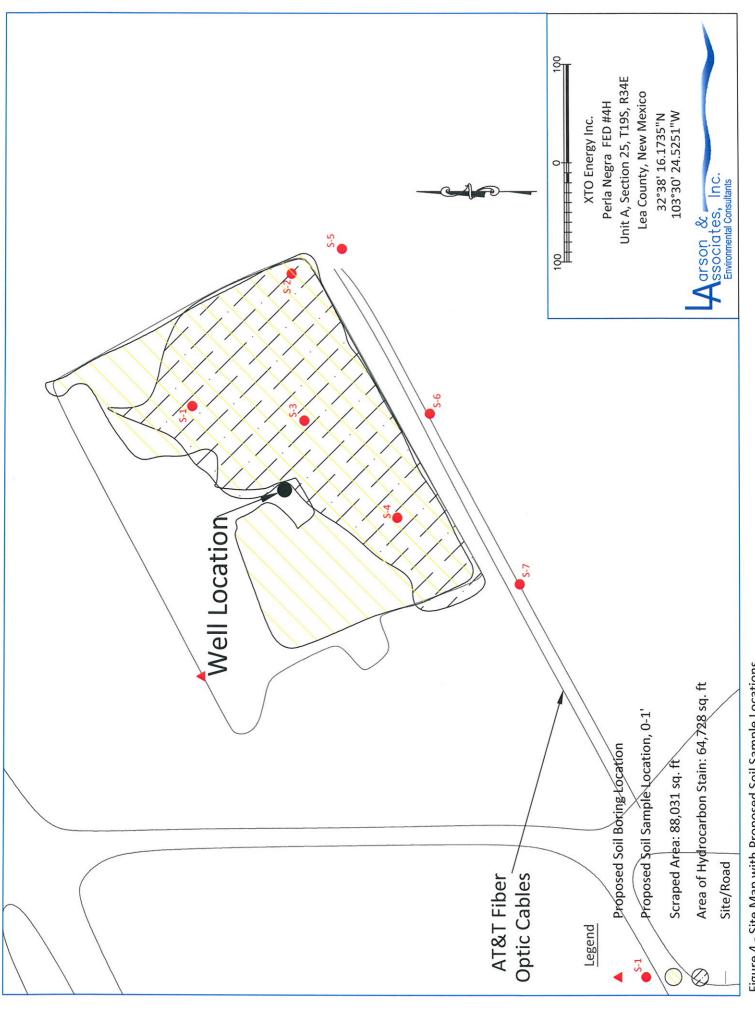
Figure 4 - Site Map with Proposed Soil Sample Locations

A boring will be drilled hydraulically up gradient (northwest) of the Site to determine depth to groundwater for calculating the RRAL. The boring will be drilled to a maximum depth of 100 feet and depth to groundwater will be gauged with an electronic water level meter. The boring will be plugged with bentonite. A permit will be obtained from the NMOSE. Figure 4 presents the proposed location for the boring.

Soil samples will be collected from the location and ROW south of the location to assess remedial actions. Four (4) samples (S-1 through S-4) will be collected from the location and 3 samples (S-5 through S-7) will be collected from the ROW. The samples will be collected with a stainless steel hand auger from about 0 to 1 foot bgs. The samples will be analyzed for total petroleum hydrocarbons (TPH) and chloride by EPA SW-846 methods 8015, including gasoline (GRO) and diesel (DRO) organic fractions and chloride by method 300. Figure 4 presents the proposed sample locations;

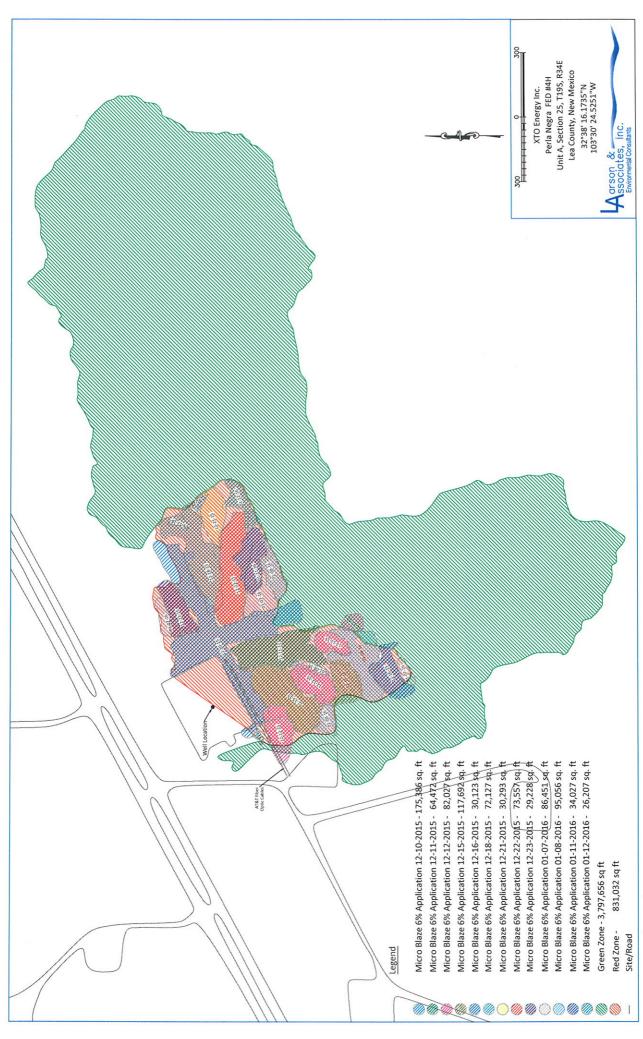
Figure 5 - Site Map with Treated Areas

Beginning on December 5, 2015, LAI personnel applied a solution (6%) of Micro-Blaze<sup>®</sup> microbial amendment to the Red Zone. The amendment was hand applied using a low impact all terrain vehicle and tank. The treated area was mapped each day with the Trimble GPS receiver. Figure 5 presents the Micro-Blaze<sup>®</sup> treatment areas by date.

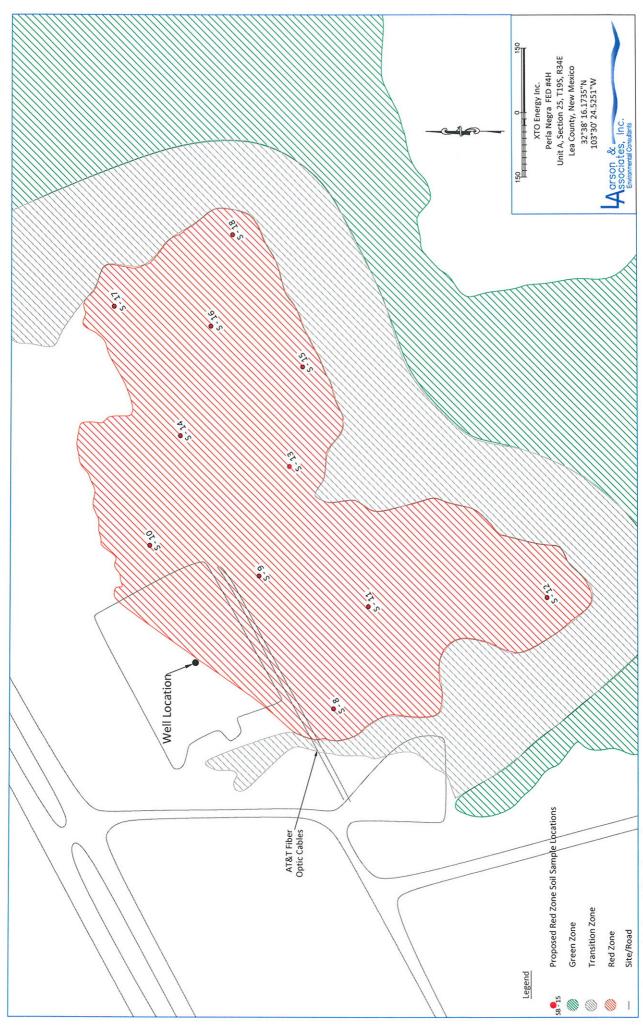
Figure 6 - Proposed Red Zone Soil Sample Locations Map

Soil samples will be collected from the Red Zone to assess microbial reduction of hydrocarbons by Micro-Blaze® microbial amendment. Eleven (11) samples (S-8 to S-18) will be collected at the approximate locations shown on Figure 6. Each sample will be collected with a stainless steel hand auger from about 0 to 1 foot bgs and analyzed for TPH and chloride by EPA SW-846 method 8015 and 300, respectively.

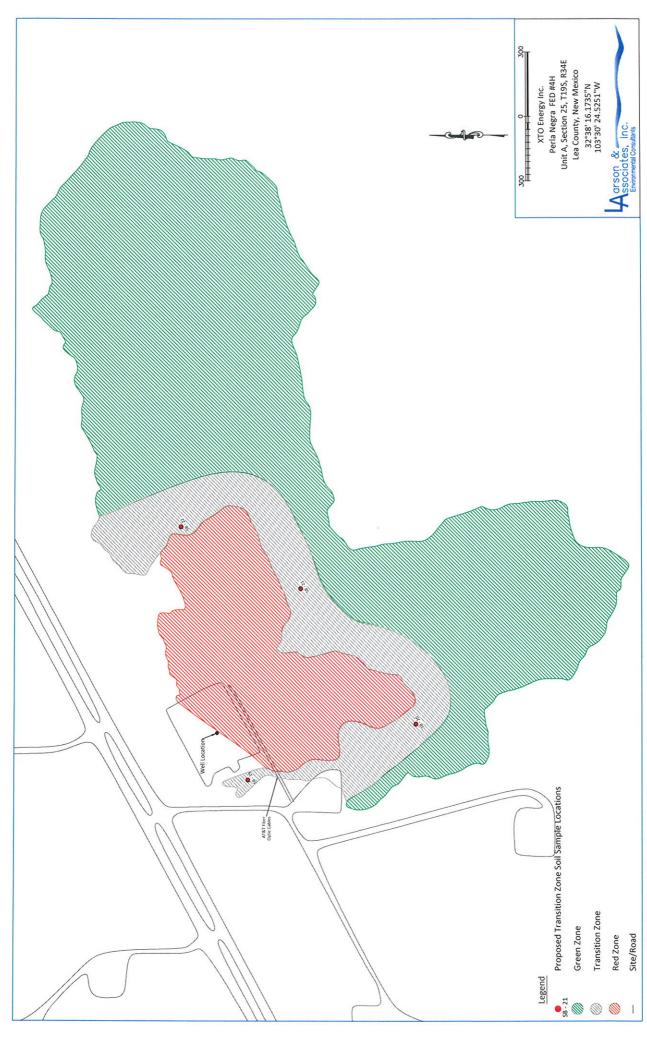
Figure 7 - Proposed Transition Zone Soil Sample Locations Map

Micro-Blaze<sup>®</sup> microbial amendment (3%) will be applied to the Transition Zone by similar methods as the Red Zone. Soil samples will be collected at four (4) locations (S-19 through S-22) about 30 days after treatment. The samples will be collected at the approximate locations shown on Figure 7. Each sample will be collected with a stainless steel hand auger from about 0 to 1 foot bgs and analyzed for TPH and chloride by EPA SW-846 method 8015 and 300, respectively. No treatment or soil sampling is proposed for the Green Zone.
