Ruby Federal Battery
(1RP-3399)

Termination Request

**RE: Termination Request
ConocoPhillips Ruby Federal Battery (1RP-3399)
UL/L sec. 17 T17S R32E
API No. 30-025-20792**

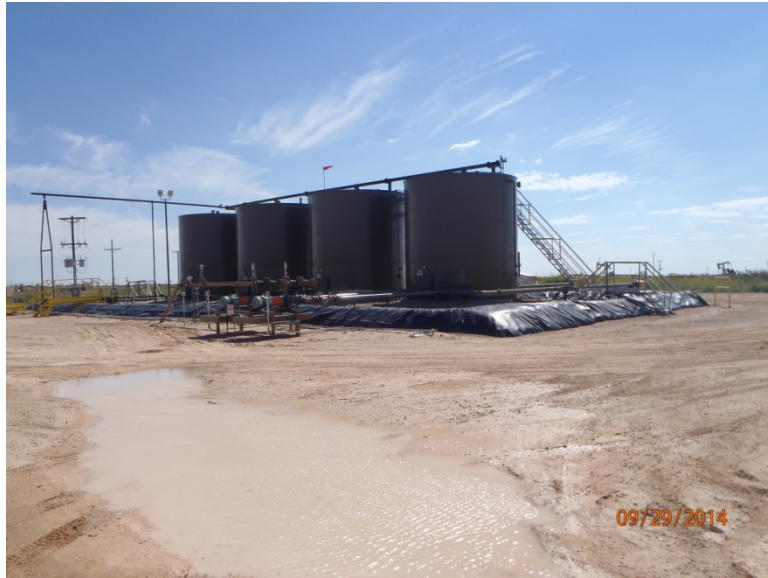
Initial release area, facing southwest

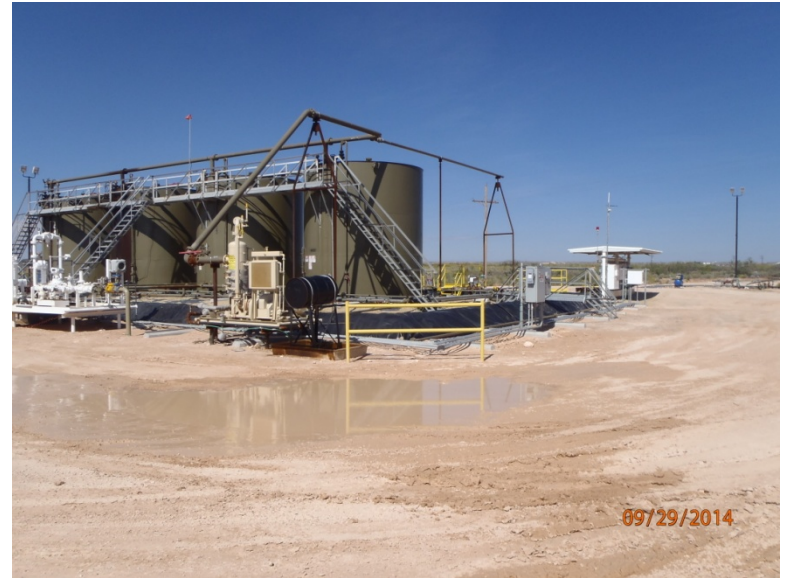
Initial release area, facing northeast

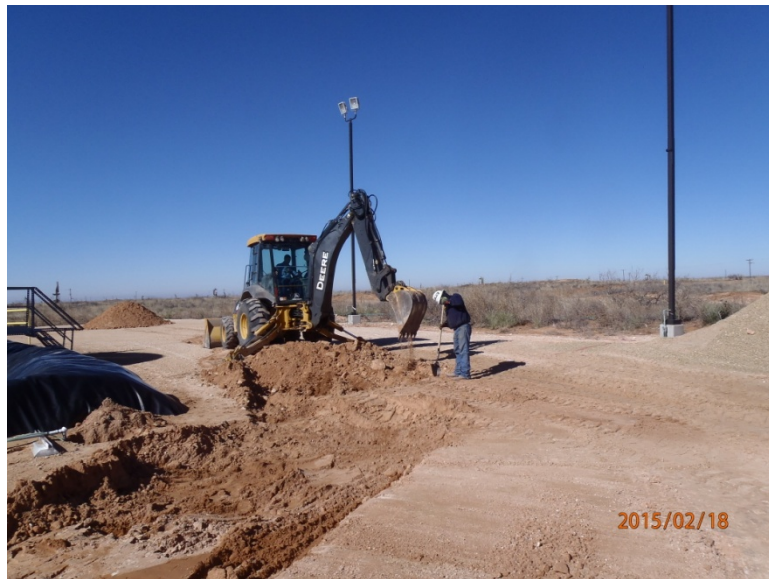
Scraping release, facing northwest

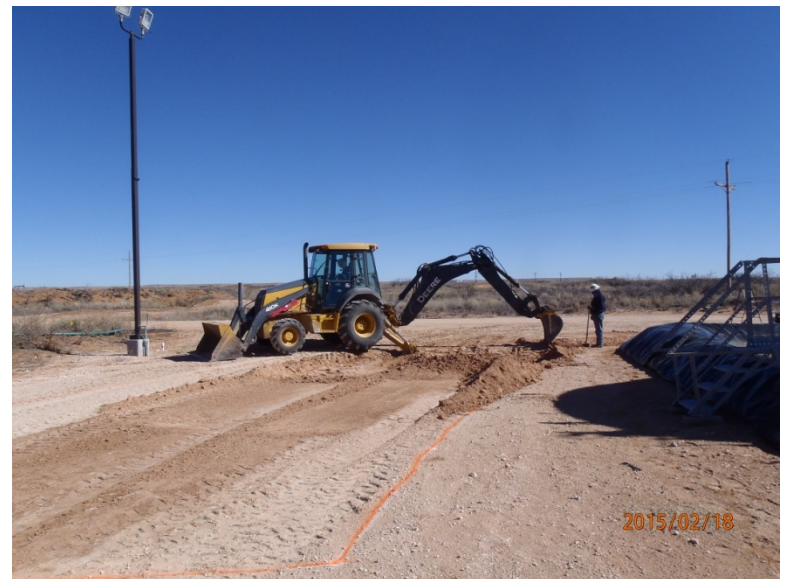
Scraping release, facing east

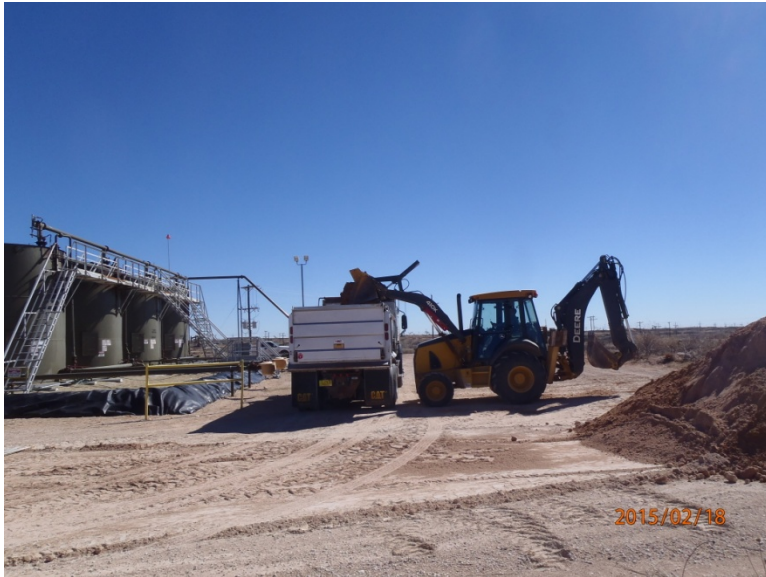
Exporting soil, facing south

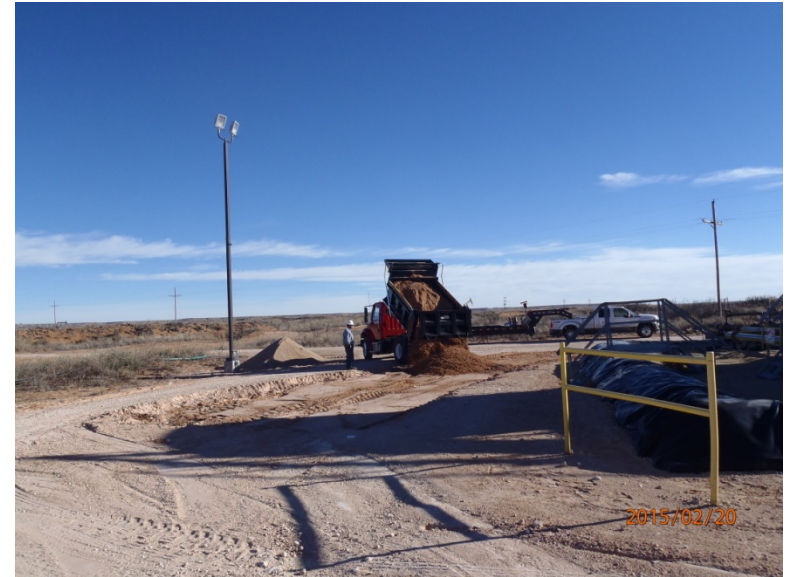
Importing soil, facing east

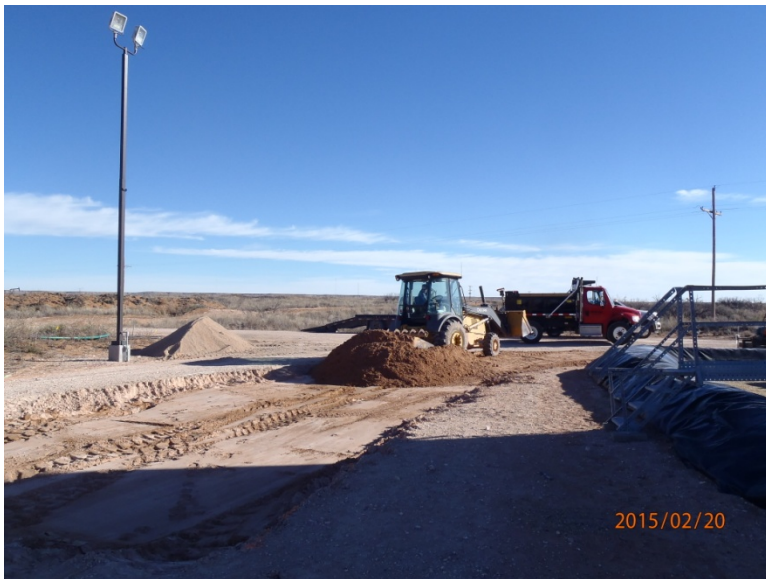
Backfilling scrape, facing east

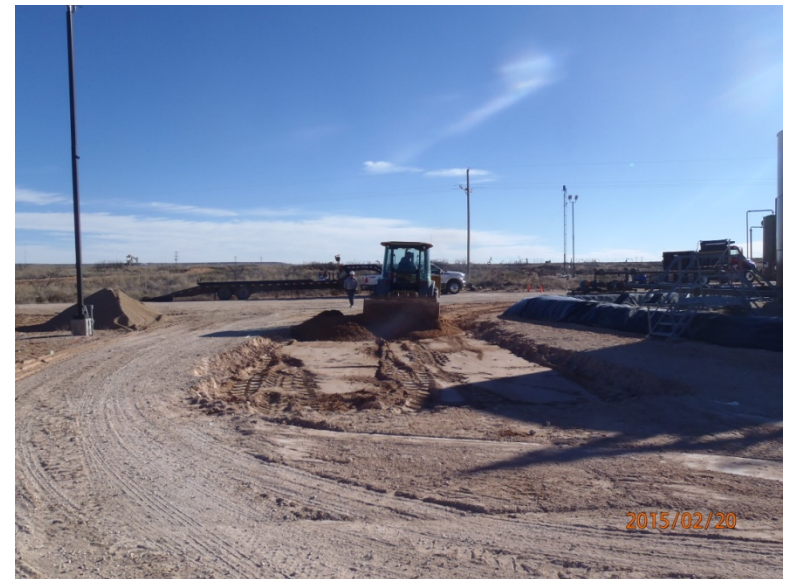
Backfilling scrape, facing southeast

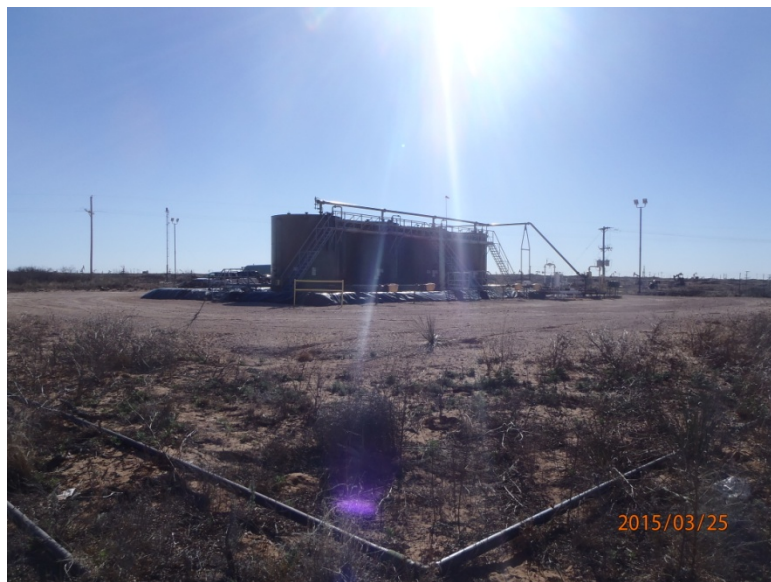
Completed site, facing southeast

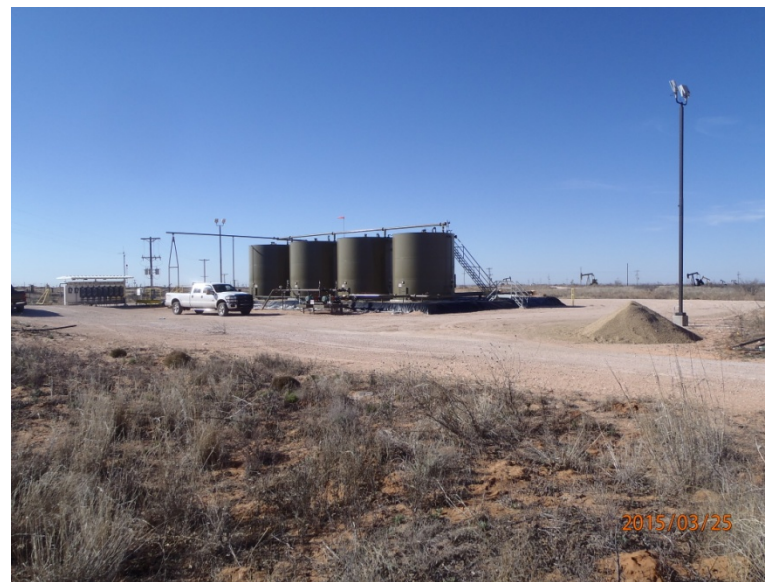
Completed site, facing southwest
